Technical Service Bulletin

Transaction No.: **2031473/6**

00 Service info: foreign object from car wash (bristle or similar) trapped in area of headlight

Release date: Apr 15, 2025

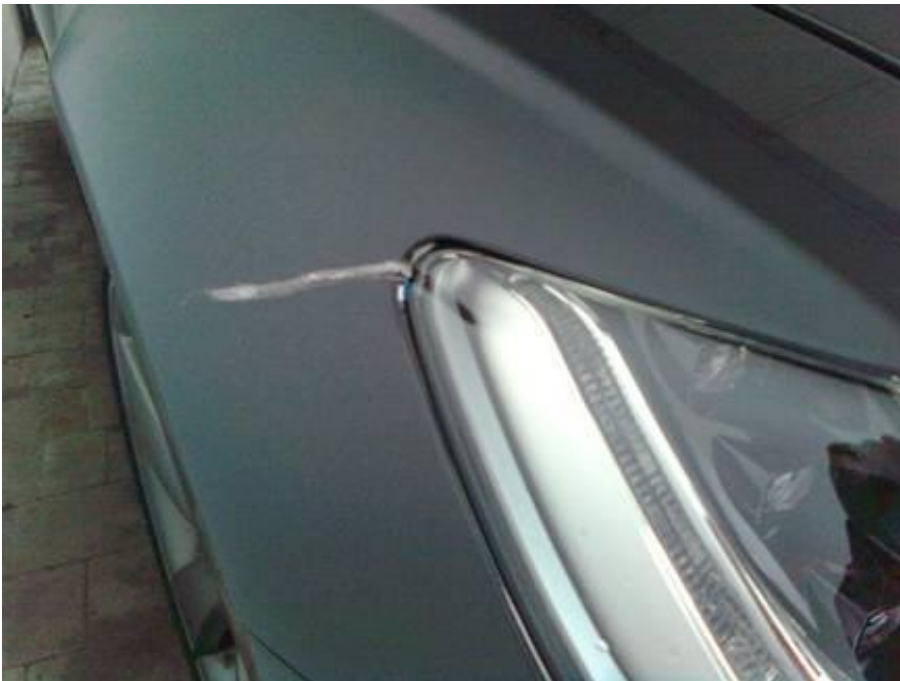
- Bristles from car wash stuck between headlight and the front fender (Figure 1).

Figure 1. Car wash bristle(s) stuck between headlight and the front fender.

Because of the vehicle design and low gap widths, foreign objects can get between the headlight(s) and the wing in a car wash in certain circumstances.

Remove the foreign object from the headlight(s) and do not carry out any further repairs.
