All Vehicles Equipped with M139: CEL for P012800 - The coolant temperature is below the coolant thermostat specified temperature.

| Topic number | LI20.10-P-076206 |
| Function group | 20.10 - Coolant pump, coolant thermostat |

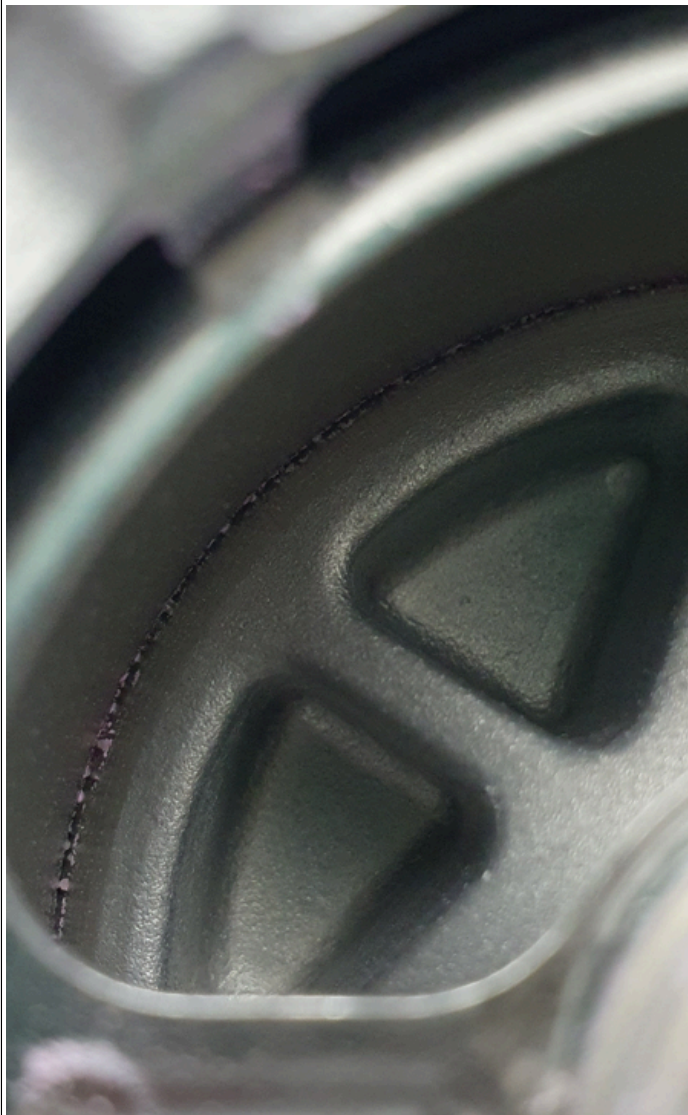
Debris at Interior Sealing Surface of Thermostat.png

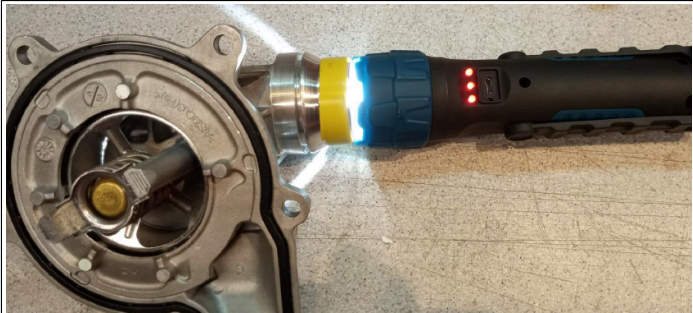
Using Light Source to Detect Debris.png

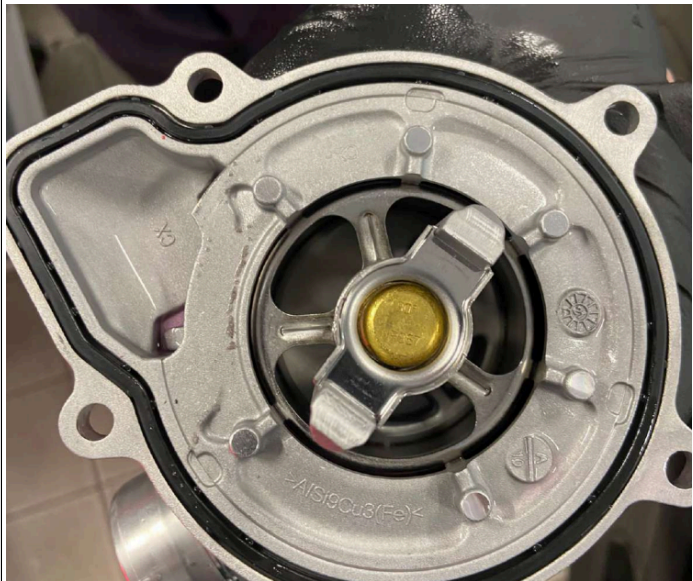
Debris near Mating Surface of Thermostat.png
