## External Fuse & Relay Center (EFRC) Cover Replacement

**Section** Function Group 372

### Introduction

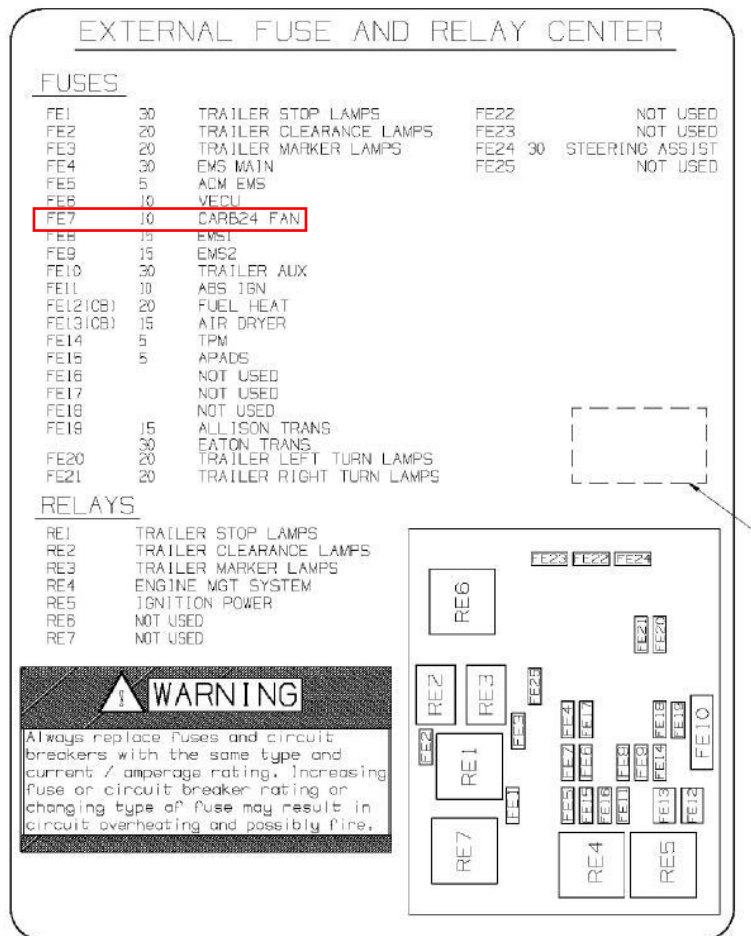
1. Secure the vehicle for service.
2. Locate and remove the incorrectly labeled EFRC cover that shows 20A in the FE7 position.
3. Verify 10A fuse is installed in the FE7 location.
4. Install new, correctly labeled EFRC cover that reflects the 10A fuse located in the FE7 position.
