Bulletin #: 2511

# 9YA/9YB, YAA, 992, Y1A/Y1B - PCM (Center & Passenger) Display Malfunction

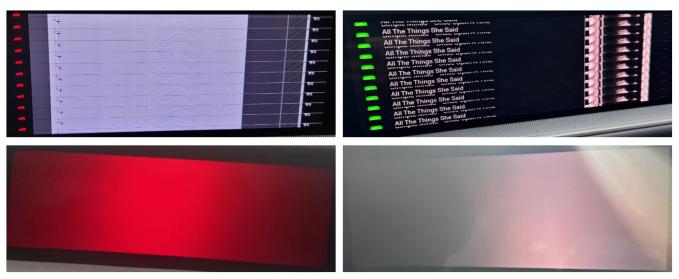
Figure 1 - PCM Display Failures

Customer complains of the PCM display(s) either flickering, going black, appears distorted, or shows wrong colors (refer to the examples below).

The operating frequency of an internal processing chip within the PCM display causes interference against the incoming video signal from the PCM control unit. This is further influenced by hardware tolerances of the PCM display and PCM control unit in the display's operability.

- 1. Create a Pre-VAL.
- 2. Verify the concern is isolated to the PCM display with no existing influential fault code.
- 3. Replace the PCM display.
- 4. Verify operation of the PCM after the repair has been completed.
