GENERAL MOTORS
DCS 7214
URGENT - DISTRIBUTE IMMEDIATELY

Subject: N242491090 - Service Update
Metal Split In Front Door

Models: 2025 Cadillac ESCALADE IQ

N242491090 – Metal Split In Front Door

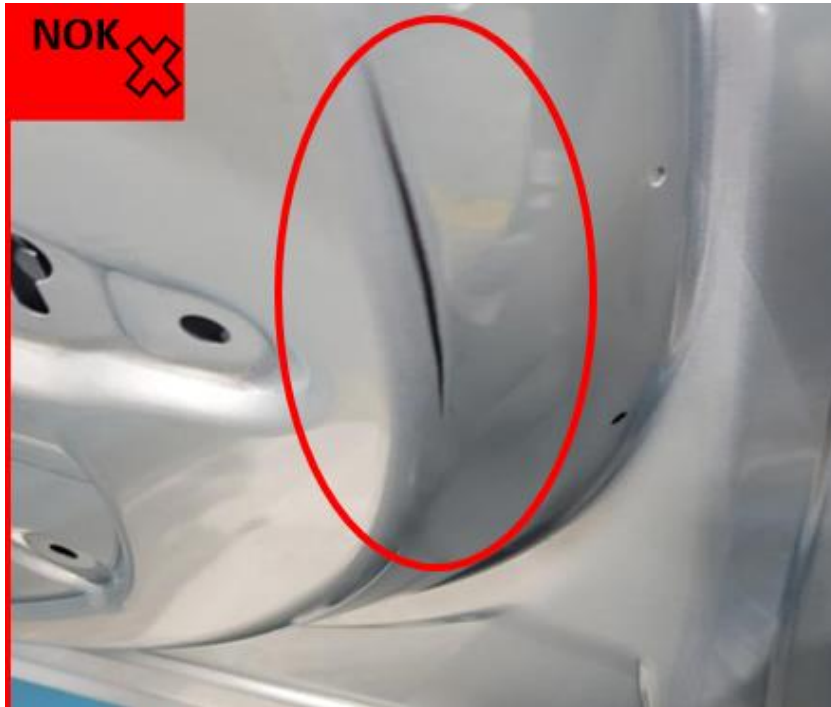
6907719

Condition	Certain vehicles listed above may have a condition in which the metal at the front door inner panel may be split.
Correction	Dealers are to inspect the front side doors and replace the door as necessary.

2. Inspect both front side doors for a split in the sheet metal at the inner bottom rearward corner as pictured above.
 - 2.1 If a split is NOT found, no further action is necessary. Reinstall the Front Side Door Trim. Refer to *Right Front Side Door Trim Removal and Installation* in SI.
 - 2.2 If a split IS found, proceed to step 3.
3. Remove the Front Side Door that has a split and remove all transferable components. Set the transferable components aside to transfer to the new door. Refer to *Front Side Door Replacement* in SI.
4. Prepare the NEW door for painting.
5. Paint the new door. Refer to *Basecoat/Clearcoat Paint Systems* in SI.
6. Clear coat the entire new door.
7. Transfer all components to the new door as necessary and install the NEW door.
