Technical Service Bulletin

SUBJECT:			No: TSB-25-51-001
ROOF RACK CENTER COVER MAY DETACH DURING USE			DATE: April 2025
			MODEL: See below
CIRCULATE TO:	<input type="checkbox"/> GENERAL MANAGER	<input checked="" type="checkbox"/> PARTS MANAGER	<input checked="" type="checkbox"/> TECHNICIAN
<input checked="" type="checkbox"/> SERVICE ADVISOR	<input checked="" type="checkbox"/> SERVICE MANAGER	<input checked="" type="checkbox"/> WARRANTY PROCESSOR	<input type="checkbox"/> SALES MANAGER

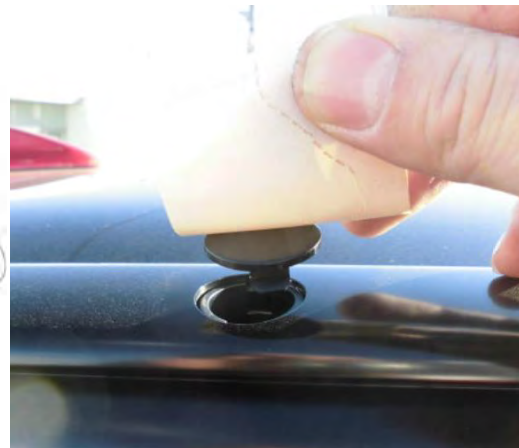
Due to quality concerns the rail hook and cover may not engage together fully, resulting in a false locking condition. To resolve this, the structure of the Roof Rack Center cover has been changed.

This TSB provides instructions on how to remedy a Roof Rack Center cover detaching during use. Replace the Roof Rack Center cover with a new countermeasure part on a customer complaint basis. If the Roof Rack Front and Rear covers have deteriorated and are different in color from the new Roof Rack, you may replace the covers with new ones at the same time.

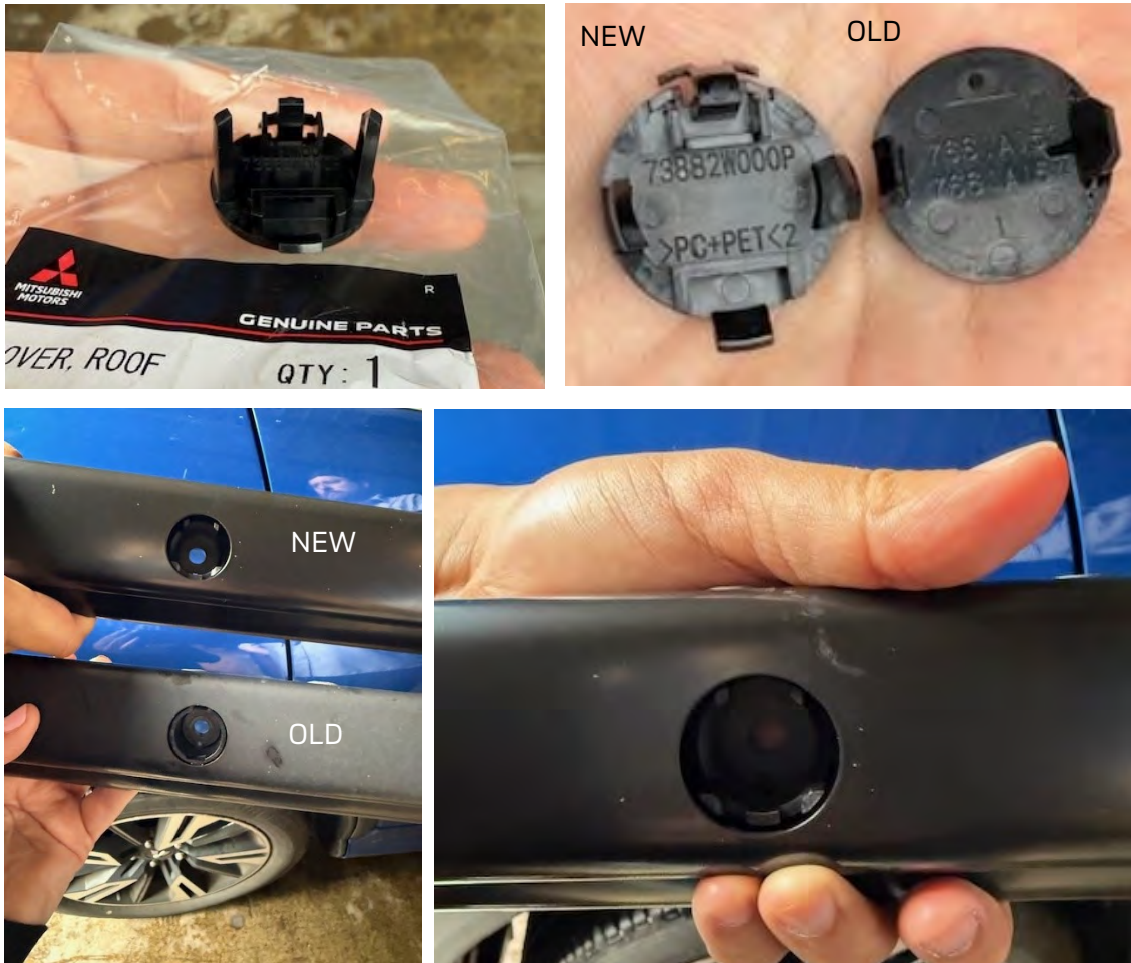
PLEASE NOTE: Changes have been made to the Roof Rack and Center covers. The old covers will not fit on the new Roof Rack.

Please refer to the Service Manual (pages 3-4 of this bulletin) to replace the Roof Rack and cover(s) as appropriate.

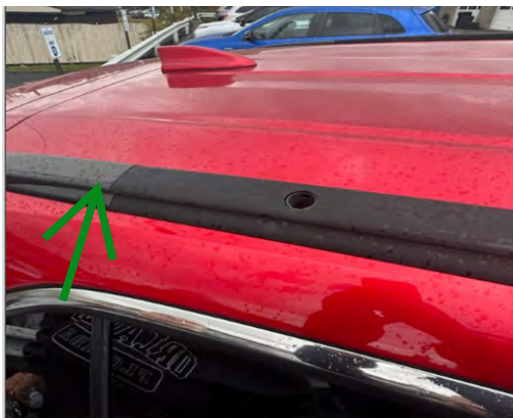
If there is deterioration in color, it may be necessary to replace the front and rear Roof Rack covers:

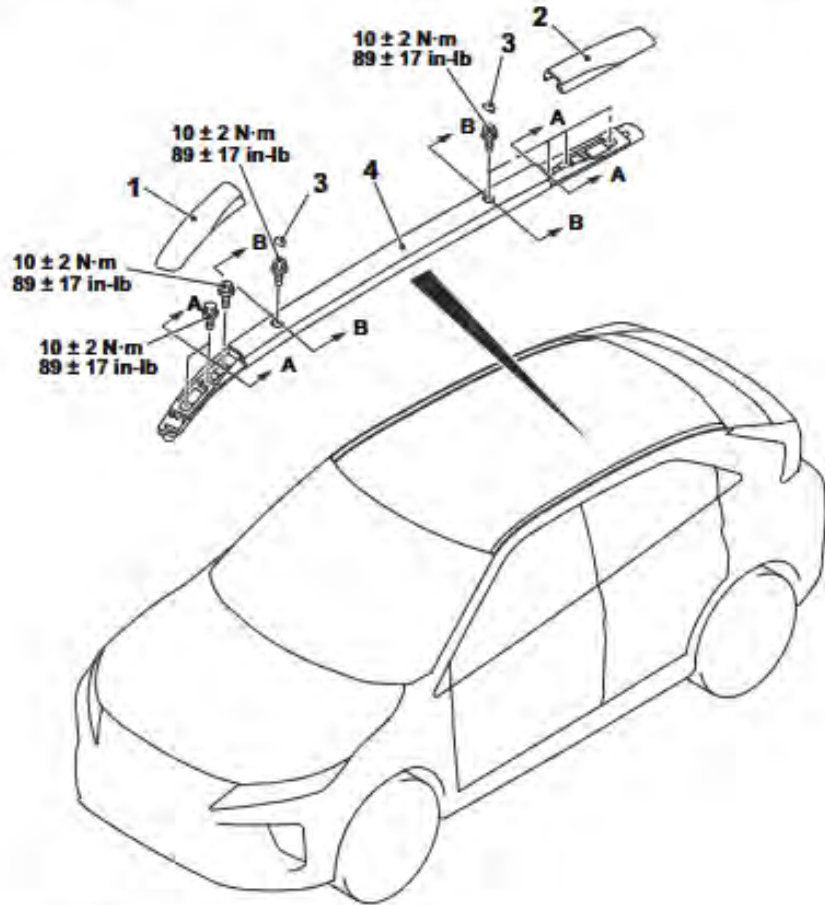
BCKA3464AB

- <<A>> Removal steps
 1. Roof rack front cover
 <<A>> 2. Roof rack rear cover

- Removal steps
 3. Roof rack center cover
 >>A<< 4. Roof rack

Remove the engagement between claws, and then pull out the cover toward the outside of the vehicle.

Tightening the roof rack bolts in the numerical order to 10 ± 2 N·m (89 ± 17 in·lb).

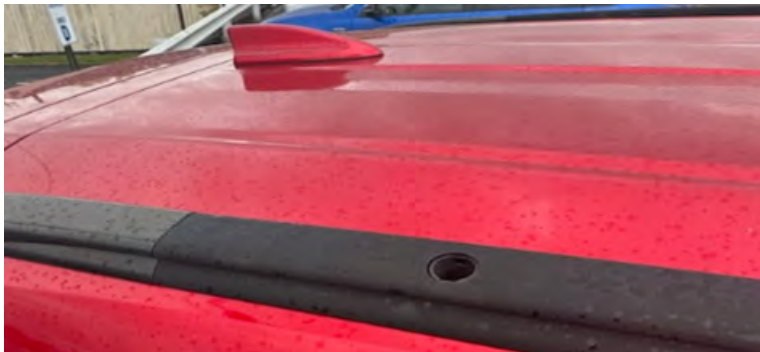
Example of discoloration

PLEASE NOTE: If the Roof Rack Front cover and Roof Rack Rear cover have deteriorated and are different in color from the new Roof Rack, you may replace the covers with new ones at the same time.
