# Technical Service Bulletin

SUBJECT:		No:	<b>TSB-25-17-001</b>
<b>IN-CABIN FUEL SMELL WHEN VEHICLE IS IDLING OR BEING DRIVEN</b>		DATE:	<b>April 2025</b>
		MODEL:	<b>See below</b>
<b>CIRCULATE TO:</b>	<input type="checkbox"/> GENERAL MANAGER	<input checked="" type="checkbox"/> PARTS MANAGER	<input checked="" type="checkbox"/> TECHNICIAN
<input checked="" type="checkbox"/> SERVICE ADVISOR	<input checked="" type="checkbox"/> SERVICE MANAGER	<input checked="" type="checkbox"/> WARRANTY PROCESSOR	<input type="checkbox"/> SALES MANAGER

Fuel evaporation may cause a fuel smell to be present inside the vehicle cabin while the vehicle is idling or being driven. This is a result of the canister vent positioned on a side-member that is connected to the vehicle cabin. The concern is resolved by changing the structure of the vent pipe and positioning it to the rear wheel house.

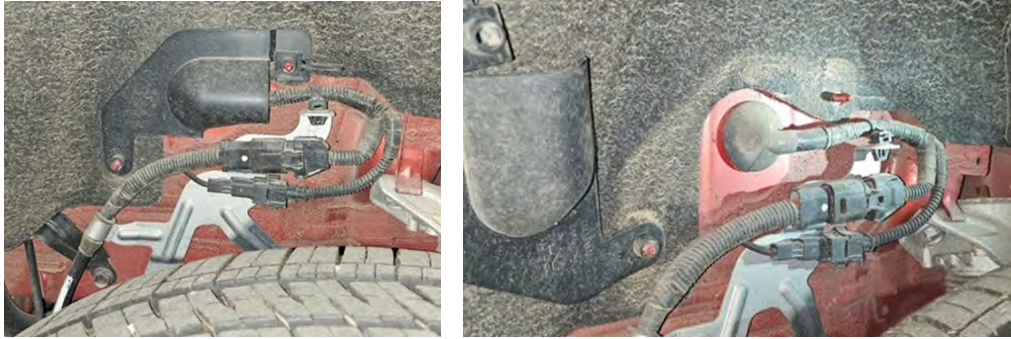
- Remove Harness Grommet Cover.

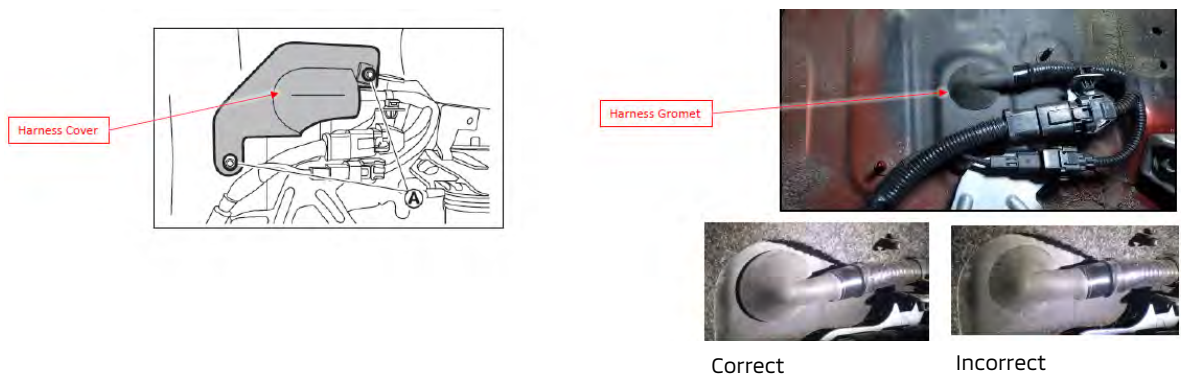
- Make sure the harness grommet is seated correctly. The grommet may be pushed in too far as shown below. Remove and reinsert if improperly seated.

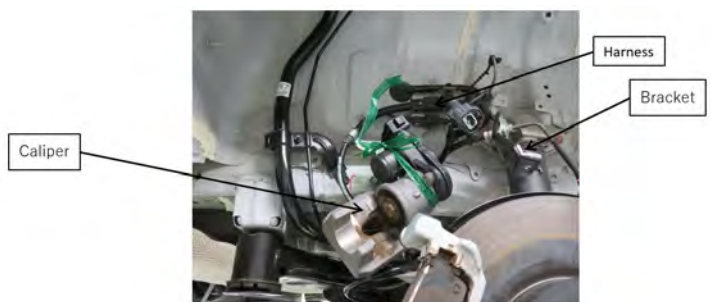
- Remove main muffler according to Service Manual: Engine - Exhaust System, Exhaust System.
- Remove under cover according to Service Manual: Engine - Fuel System, Removal and Installation.
- Remove rear suspension member stay protector according to Service Manual: Suspension, Rear Suspension, Removal and Installation.
- FOR 4WD ONLY: Remove propeller shaft and heat insulator according to Service Manual: Transmission & Driveline - Driveline, Rear Propeller Shaft
- Removal of rear suspension member and differential assembly:
  - Remove harness
  - Remove bracket of brake piping
  - Remove brake caliper
  - Tie up these components with string (refer to Figure 1 - green string):

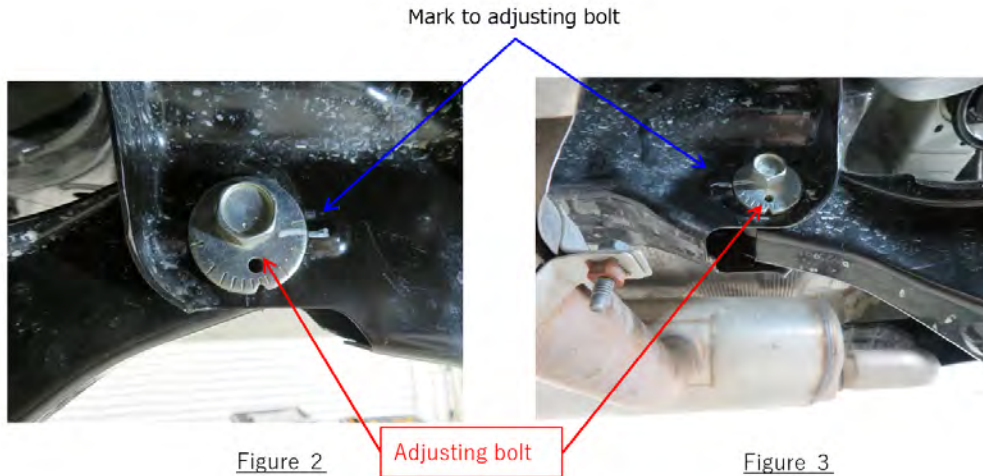
- Place a mark on the adjusting bolt before removing rear lower link (refer to Figure 2 & 3). This mark is for alignment to the original position when re-assembling.

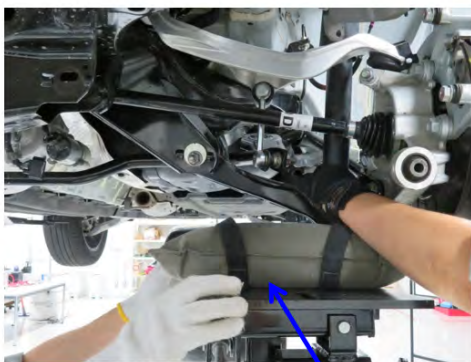
Figure 4

- Use jack for rear lower link (Figure 4)
- Loosen the rear lower link mounting bolts
- Remove coil spring
- Remove shock absorber
- Remove rear lower link
- Remove harness clip from rear suspension member (Figure 5)
- Refer to Service Manual: Rear Suspension, Coil Spring, Rear Shock Absorber

Put cushioning material to prevent slippage

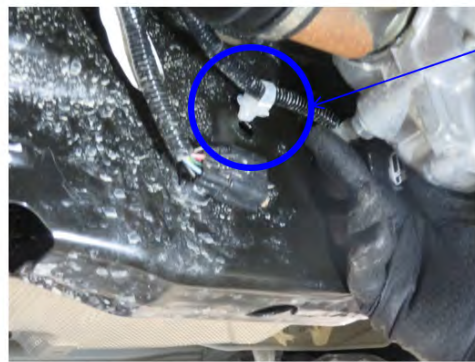
Figure 5

Remove clip

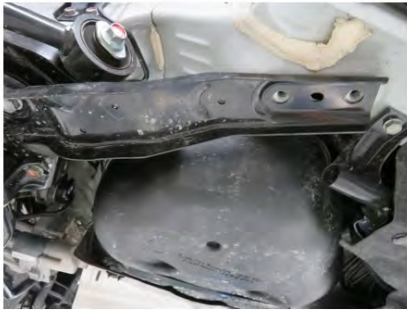
Figure 6

- Remove rear suspension member stay (Figure 6)
- Set jack under the rear suspension member (Figure 7, 8)
- Remove rear suspension member mounting (4) bolts (Figure 9)
- Remove rear suspension member together with differential assembly (Figure 10)

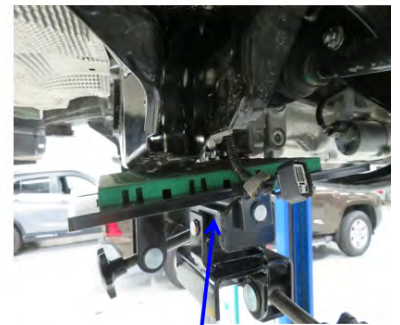
Figure 8

Insert cushioning material to prevent slipping

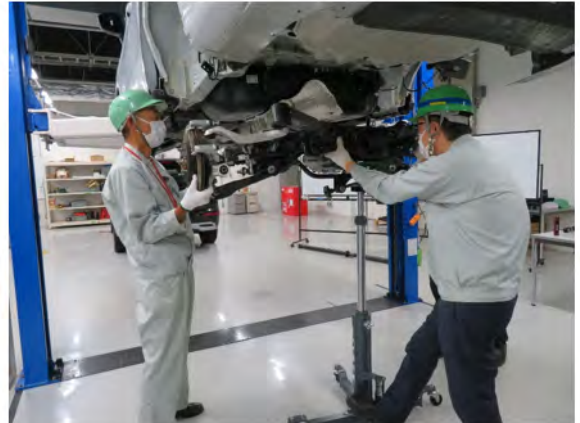
Figure 10

**NOTE: Additional technician support is recommended due to heaviness of the differential assembly**

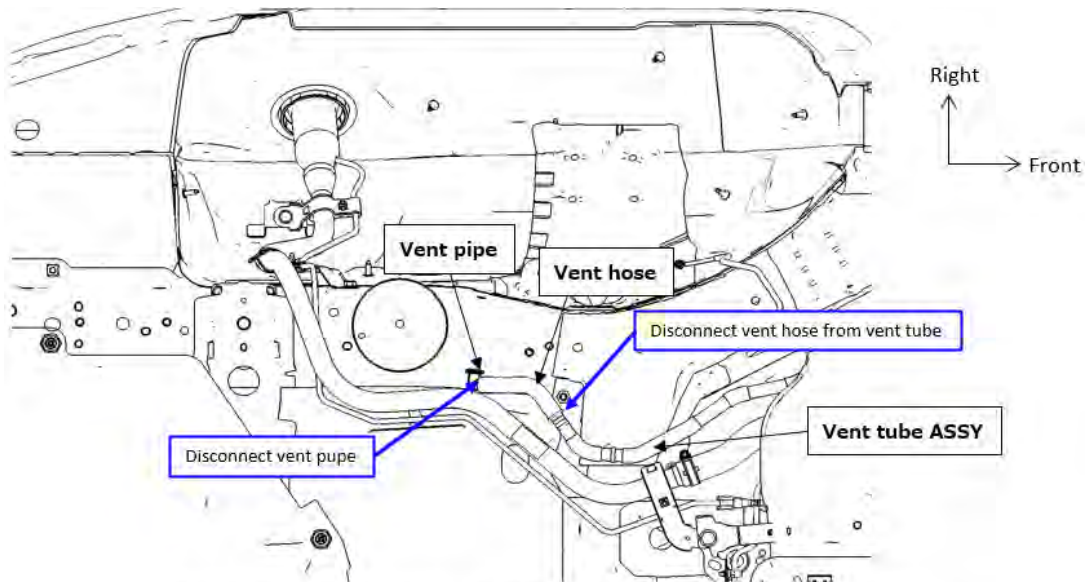
8. Disconnect vent pipe and vent hose.
  - Remove vent pipe fixing on side member (Figure 11)
  - Disconnect vent hose from vent tube assembly (Figure 11)

Figure 11 : Bottom view / Disconnect vent hose and vent pipe

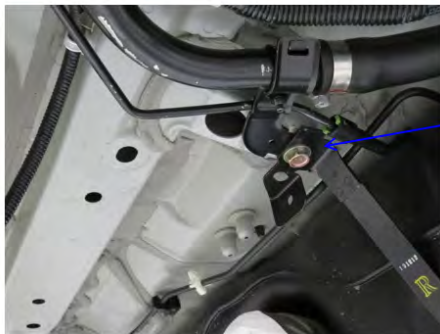
Figure 12

- Support center of fuel tank with suitable jack (Figure 12, 13)

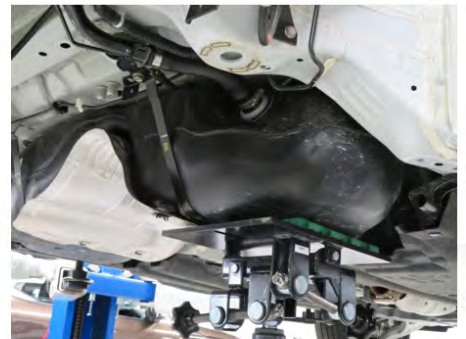
Figure 13

Setup jack under fuel tank because filler neck bracket and fuel tank's band is tightend together

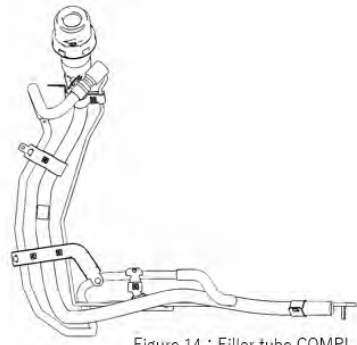
- Replace filler tube COMPL (Figure 14, 15)
- For installation position and tightening torque of filler tube COMPL refer to the Service Manual, Engine - Fuel System, Fuel Tank (removal/installation of the fuel tank is not necessary)
- Connect filler tube COMPL and filler hose (Figure 16)
- Connect filler tube COMPL and vent tube (Figure 16)
  - Yellow mark on vent hose should be set facing the underside of the vehicle (Figure 16)
- Reference TSB-23-13-005

Figure 14 : Filler tube COMPL

Part Name	Part Number	Quantity	Remarks
TUBE COMPL – FILLER	17220W030P	1	New part number

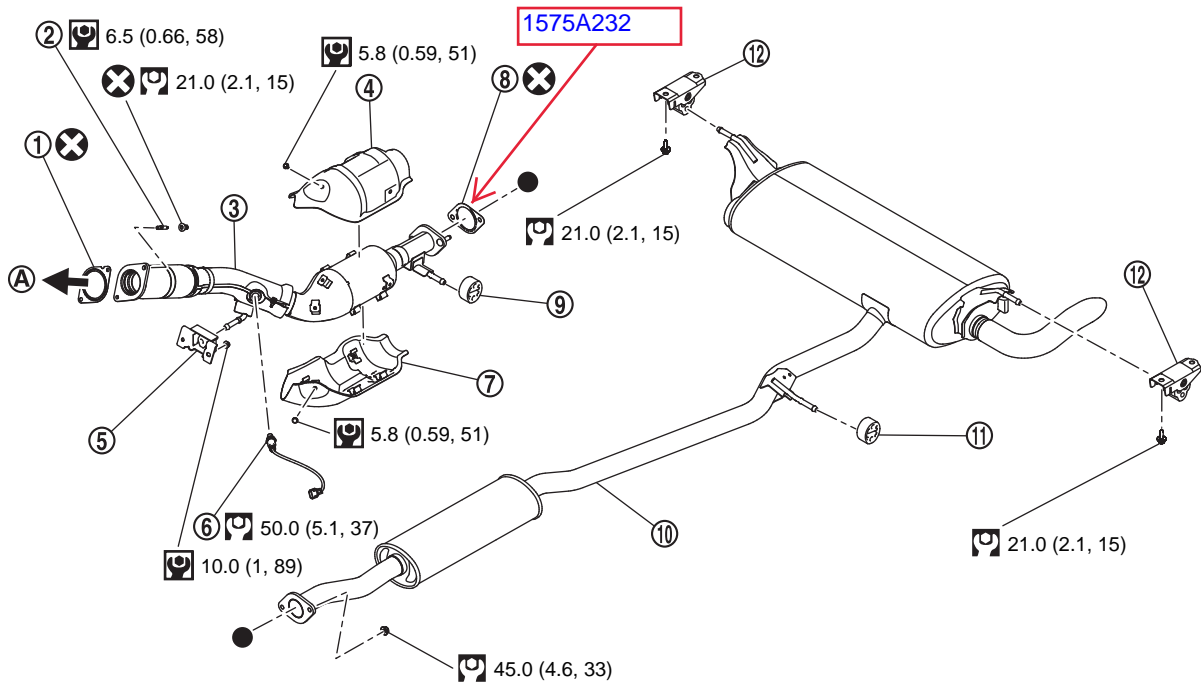
CF100A1GAA00USA

①	Gasket	②	Stud bolt	③	Exhaust front tube
④	Heat insulator (upper)	⑤	Mounting rubber	⑥	Heated oxygen sensor 2
⑦	Heat insulator (lower)	⑧	Gasket	⑨	Mounting rubber
⑩	Main muffler	⑪	Mounting rubber	⑫	Mounting rubber
Ⓐ	To exhaust manifold. Refer to <a href="#">Exploded View</a> .				
⊗	: Always replace after every disassembly.				
Ⓜ	: Nm (kg-m, in-lb)				
Ⓜ	: N-m (kg-m, ft-lb)				
●	: Indicates that the part is connected at points with same symbol in actual vehicle.

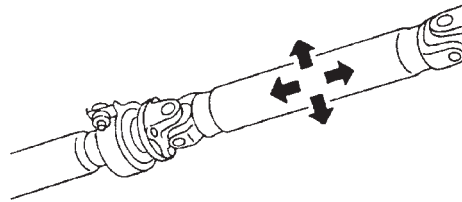
CF100ABEAA00USA

Move the shaft near center bearing up and down and from side to side (axial direction of shaft and right angle to shaft) to check that the bearing has no backlash. If the bearing has a malfunction, remove propeller shaft and perform inspection.

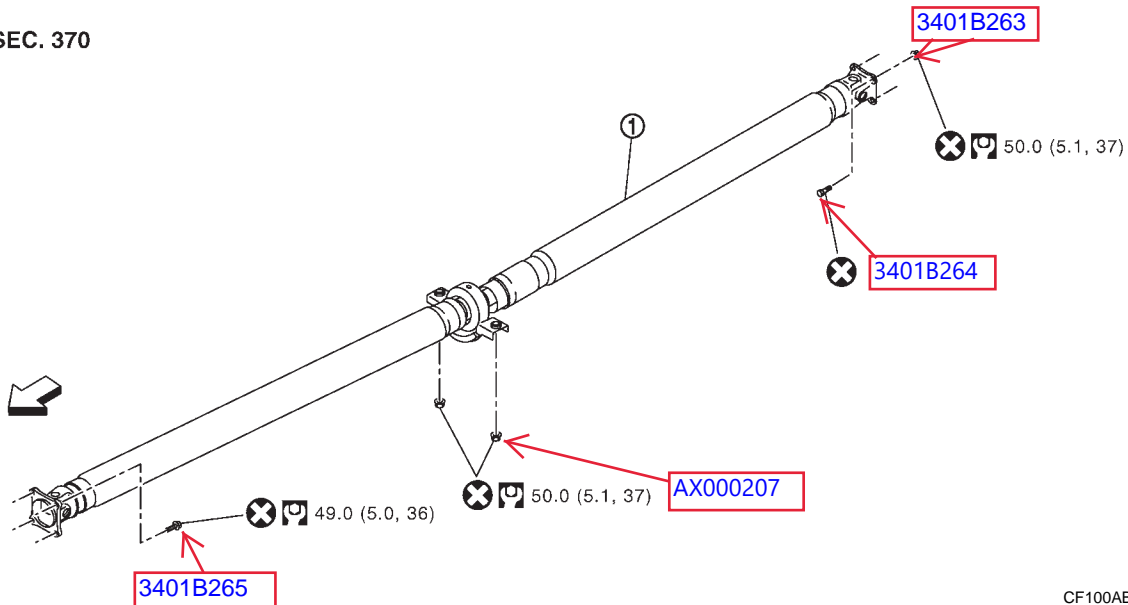
CF100ABFAA00USA

①	Propeller shaft assembly			
←	: Vehicle front			
Ⓜ	: N·m (kg·m, ft·lb)			
⊗	: Always replace after every disassembly.

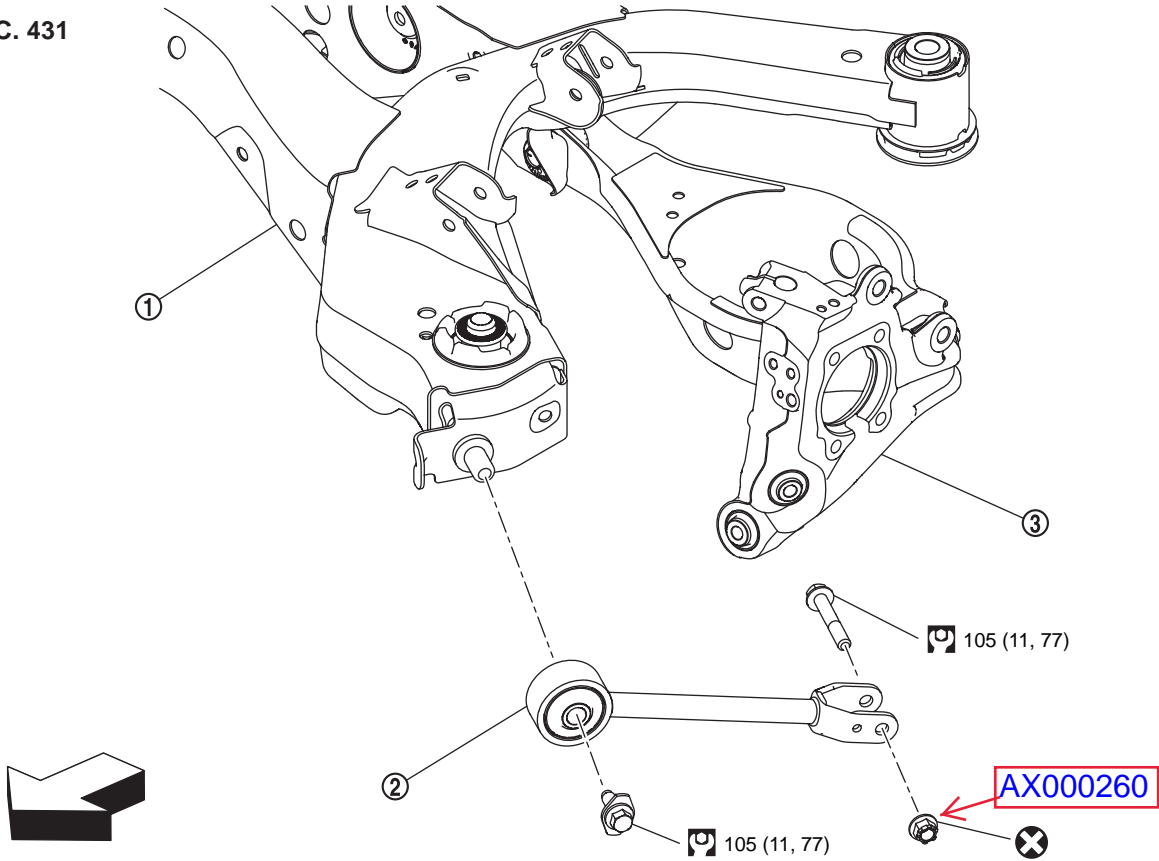
DF100AHWAA00USA

①	Rear suspension member	②	Radius rod	③	Axle housing
←	: Vehicle front				
⊗	: N·m (kg-m, ft-lb)				
⊗	: Always replace after every disassembly.

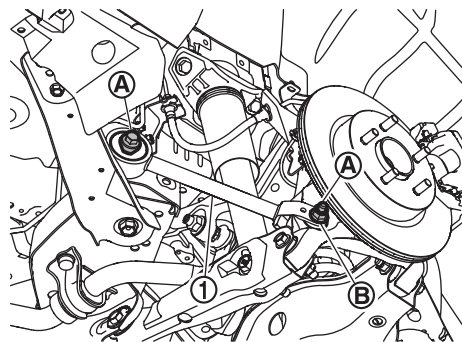
CF100AHXAA00USA

2.Remove radius rod ① mounting bolts (A) and nut (B).

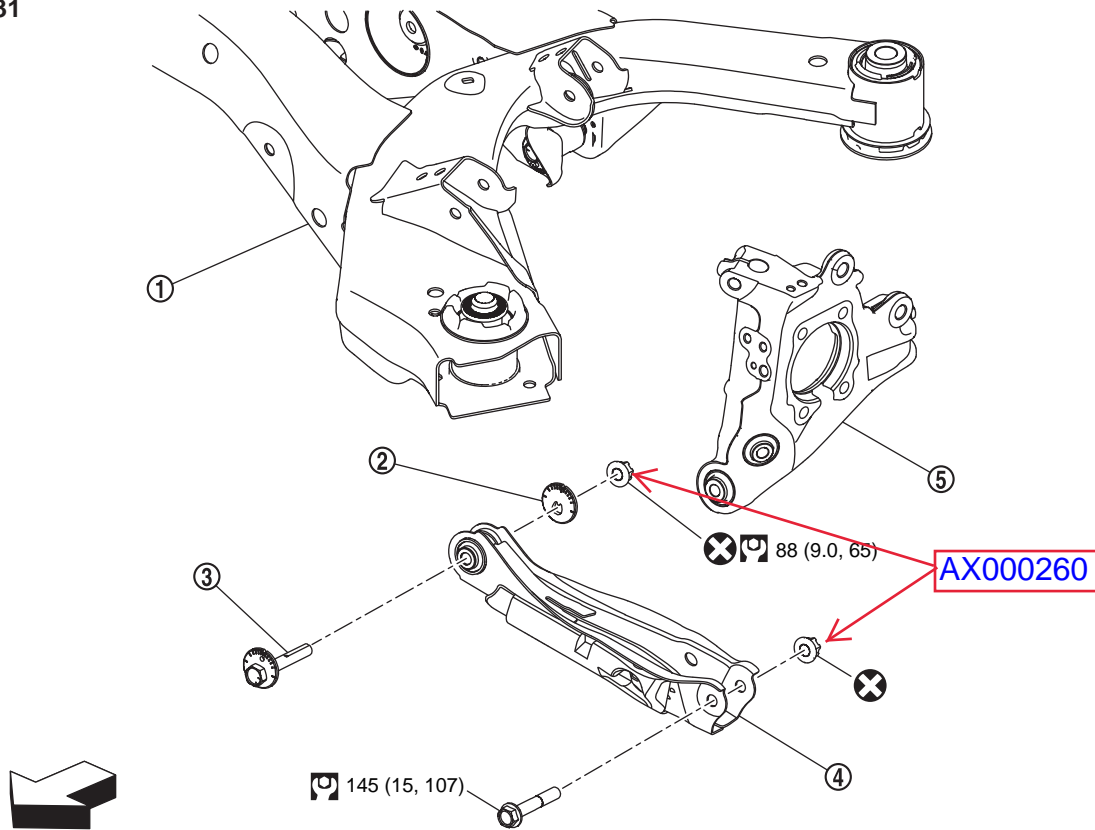
DF100AHYAA00USA

①	Rear suspension member	②	Eccentric disk	③	Adjusting bolt
④	Front lower link	⑤	Axel housing		
←	: Vehicle front				
⊞	: N·m (kg·m, ft·lb)				
⊗	: Always replace after every disassembly.

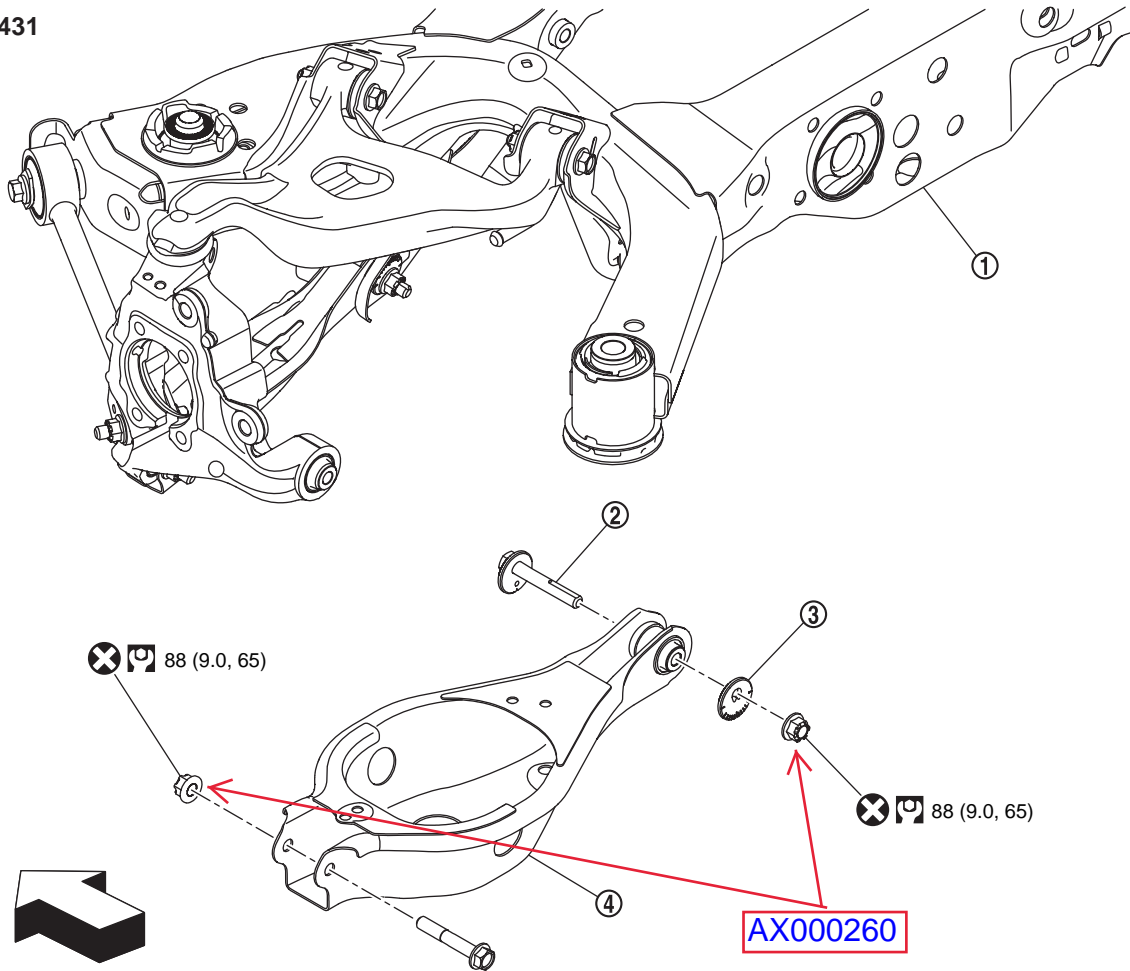
DF100AI0AA00USA

①	Rear suspension member	②	Adjusting bolt	③	Eccentric disk
④	Rear lower link				
←	: Vehicle front				
⊗	: N·m (kg-m, ft-lb)				
⊗	: Always replace after every disassembly.

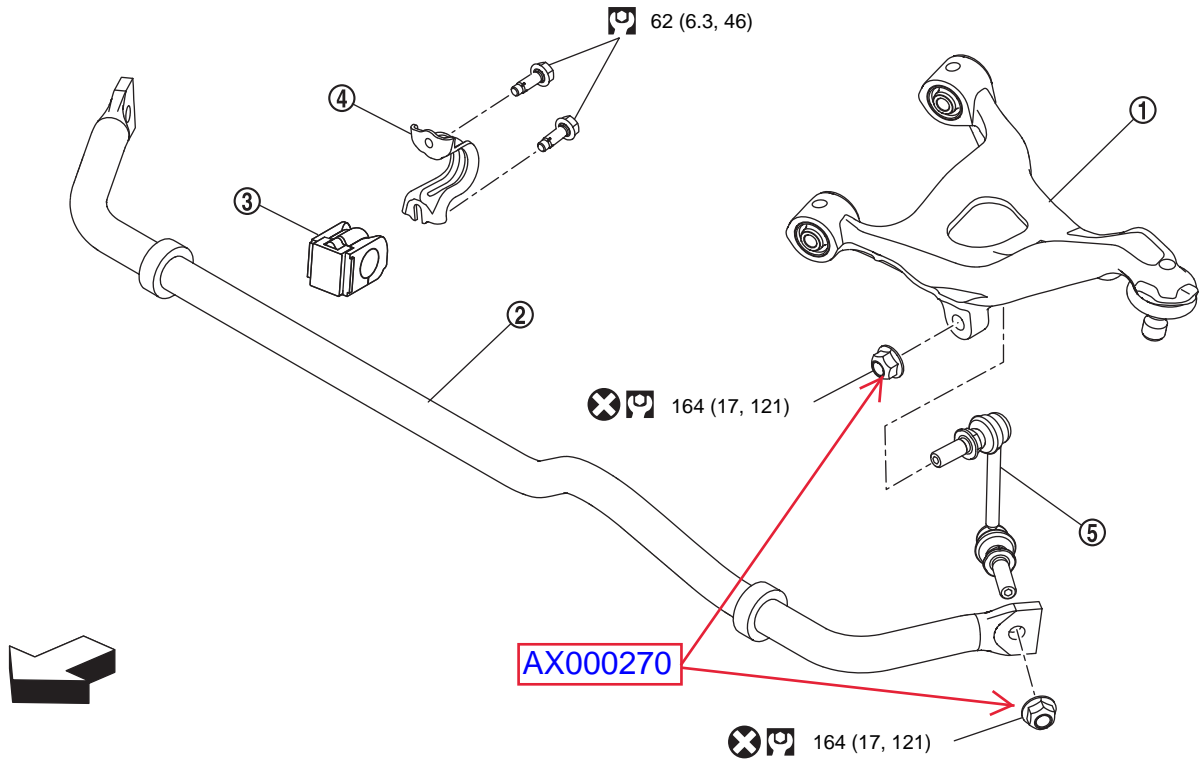
DF100AI2AA00USA

①	Rear suspension arm	②	Rear stabilizer bar	③	Rear stabilizer bushing
④	Rear stabilizer clamp	⑤	Rear stabilizer connecting rod		
←	: Vehicle front				
Ⓜ	: N·m (kg-m, ft-lb)				
⊗	: Always replace after every disassembly.
