Technical Service Bulletin

Topic	Surface Contamination "A" Post Water Deflector Bentayga 17MY - 25MY
Market area	Hongkong-Macau (5HK),Australia E04 Bentley rest Asia and Australia (6E04),China 723 Volkswagen (Anhui) Automotive CO (6723),China 796 VW Import Comp. Ltd (Vico), Beijing (6796),Germany E02 Bentley rest Europe (6E02),Japan E03 Bentley Japan (6E03),Korea, (South) E08 Bentley South Korea (6E08),United Arab Emirates E06 Bentley Middle East and Africa (6E06),United Kingdom E01 Bentley UK (6E01),United States E05 Bentley USA and rest America (6E05)
Brand	Bentley
Transaction No.	2049193/3
Level	EH
Status	Released for publishing
Release date	Apr 7, 2025

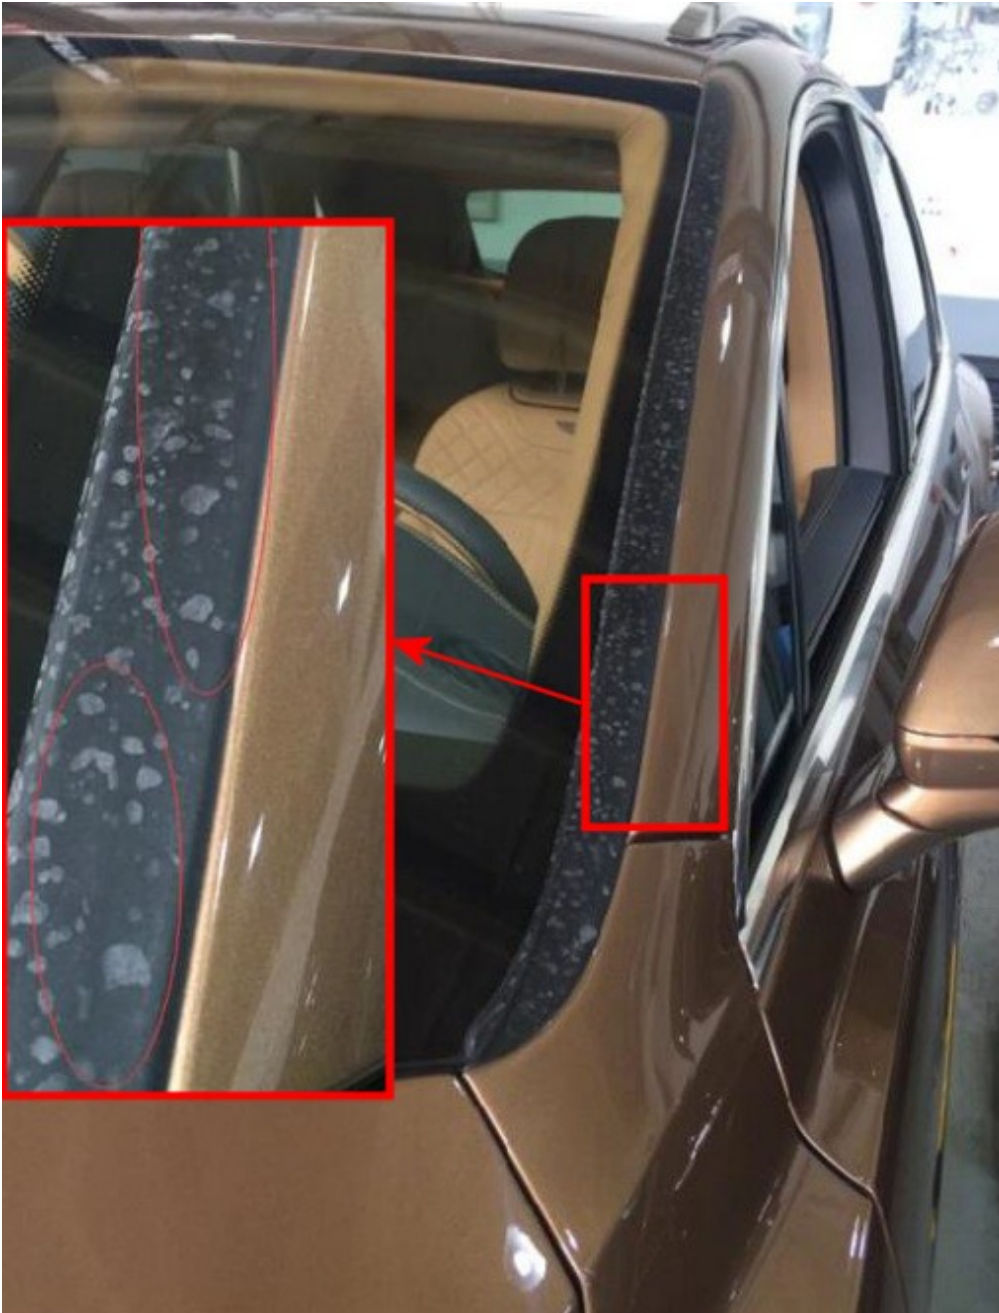
Mottled appearance on "A" post water deflectors.

Surface deposits on "A" post water deflectors cannot be removed by washing with car shampoo.

Surface deposits are caused by UV protection additives contained within the "A" post water deflector migrating to the surface. This migration process is intentionally designed to protect parts from brittleness and ageing, the mottled appearance may occur after a certain length of time and is also dependent on temperature and humidity.

Wash the "A" post water deflectors to remove loose dirt and dust using the Bentley approved car shampoo. The Bentley approved rubber conditioner should then be used to remove deposits and the mottled appearance.
