# TECHNICAL SERVICE BULLETIN

## Driver Seat Cushion Sagging

**25-2182**

<b>Ford</b> 2019-2021 Transit	Built on or before 11-Feb-2021
----------------------------------	--------------------------------

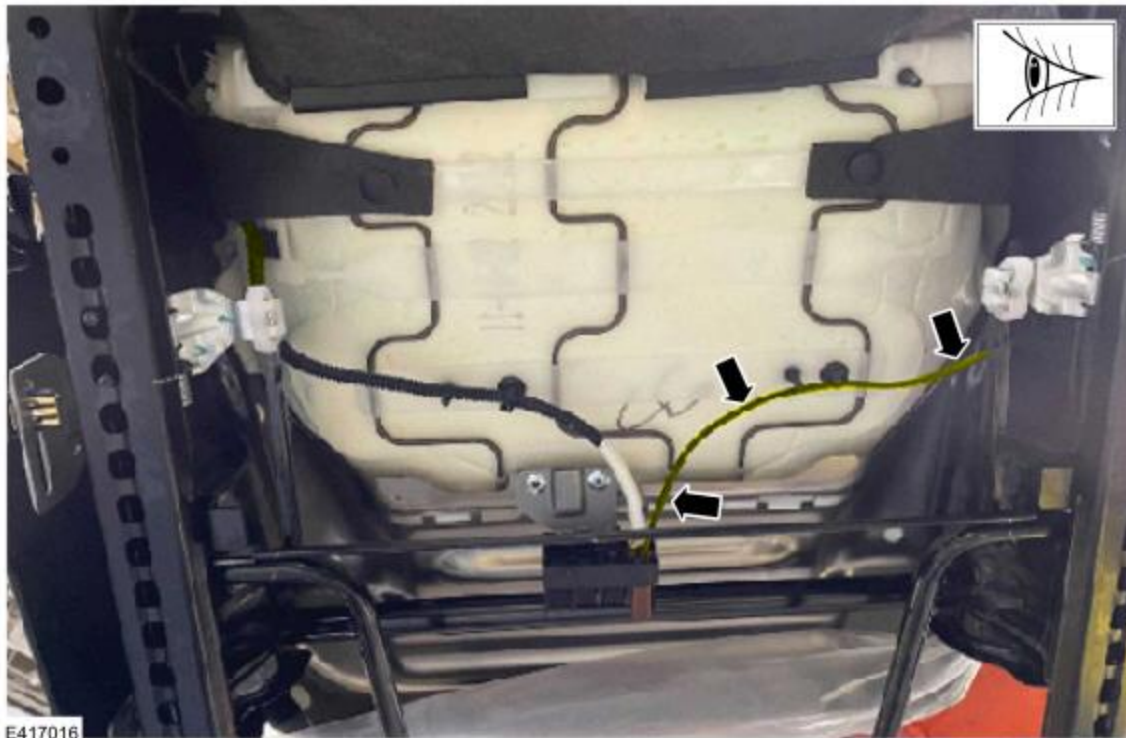
Figure 1

1. Remove the affected driver seat track. Refer to WSM, Section 501-10A, starting with Step 2.
2. Inspect the seat airbag deployment circuit for damage as shown in Figure 1. If damage is present, replace the side airbag. Refer to WSM, Section 501-20B.

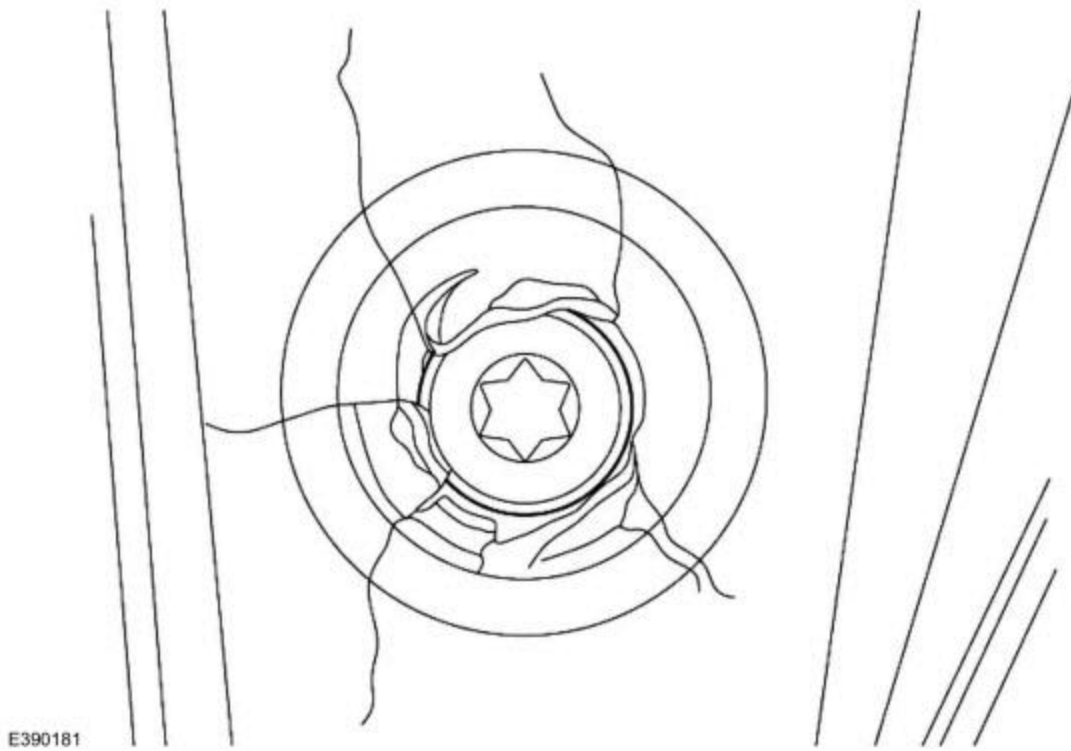
Figure 2

3. Inspect the driver seat track assembly for damage. Is the driver seat track assembly damaged?

**NOTE: Small cracks around the bolt are considered normal. (Figure 2)**

(1). Yes - replace the seat track assembly. Refer to WSM, Section 501-10A Front Seats > Removal and Installation > Front Seat Track. Proceed to Step 5.

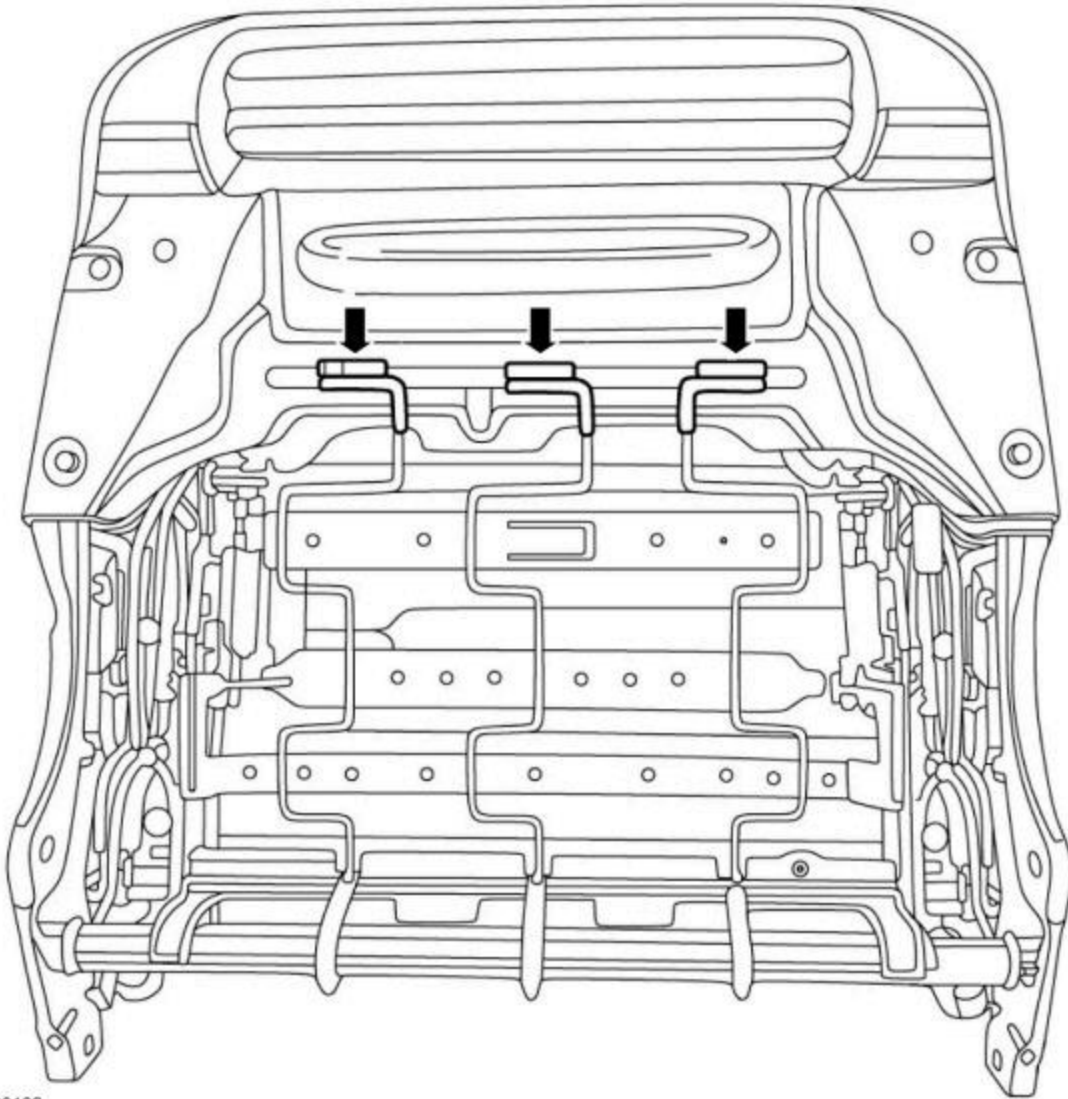
Figure 3

(2). Disengage the 3 suspension mat assembly forward attachments from the cushion pan. (Figure 3)

(3). Remove the suspension mat assembly 3 rearward attachments. The suspension mat assembly has a snap fit on the rear tube. (Figure 3)

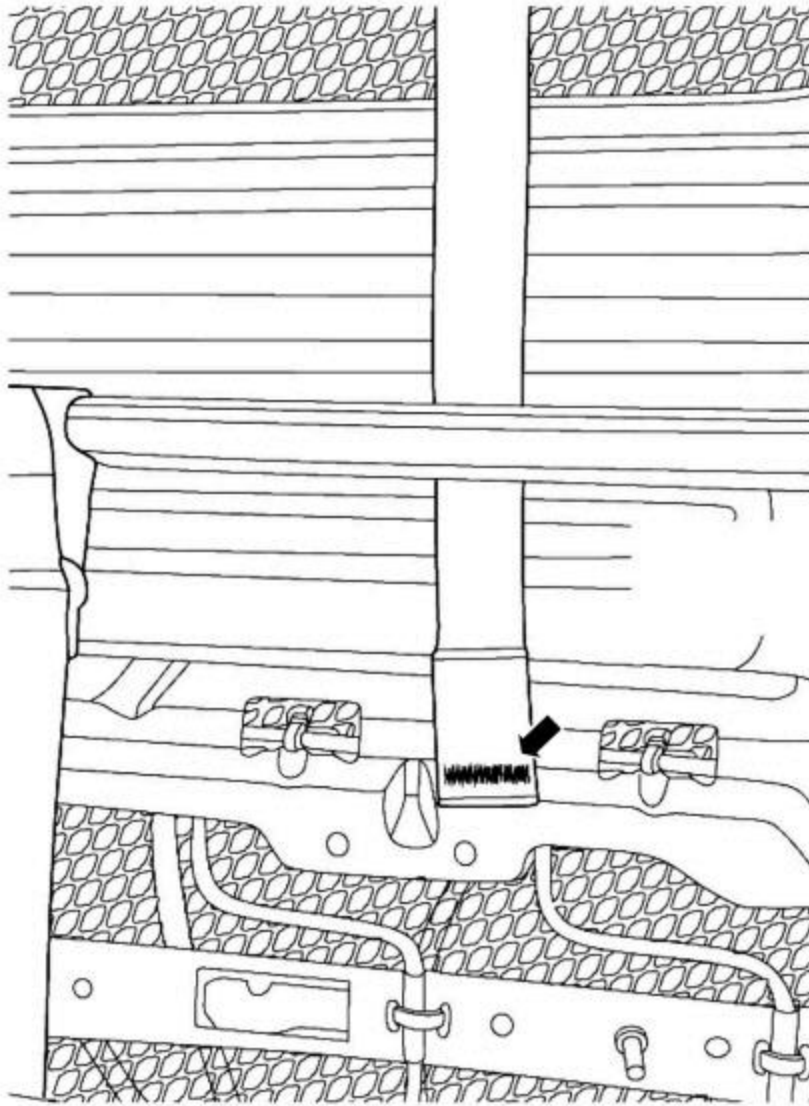
Figure 4

(1). With the red thread visible, route the end of the 1st webbing strap assembly without the metal ring between the cushion pan and the front cross-car tube. (Figure 4)

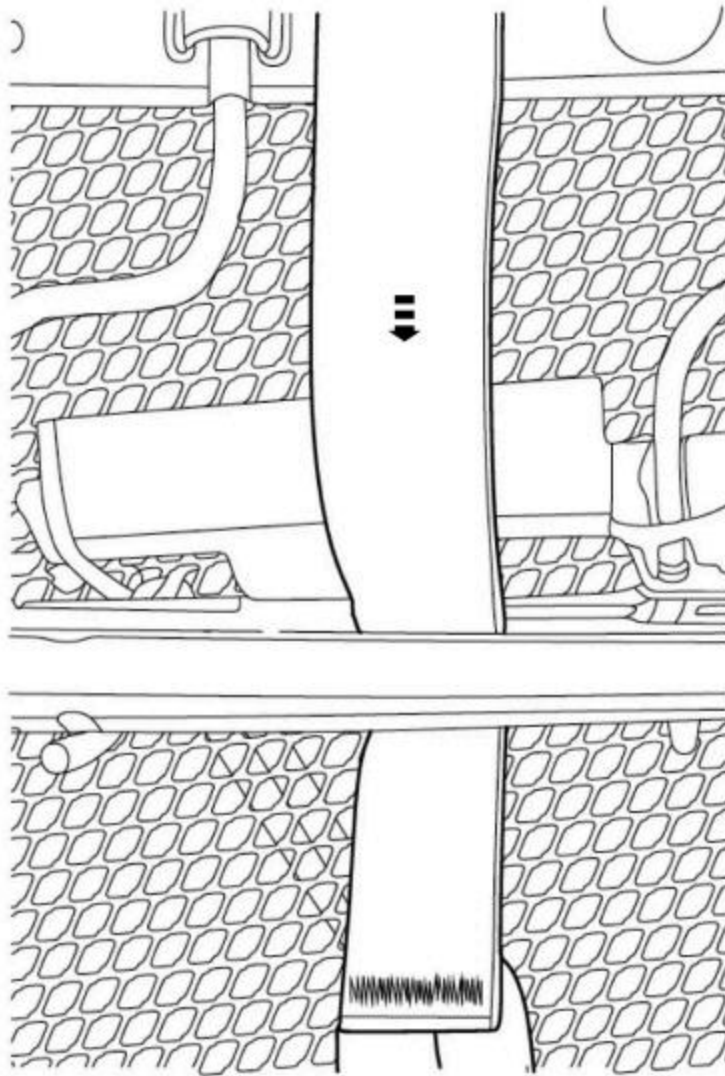
Figure 5

(2). Continue rearward and route the webbing strap assembly between the suspension mat assembly and the rear tube. (Figure 5)

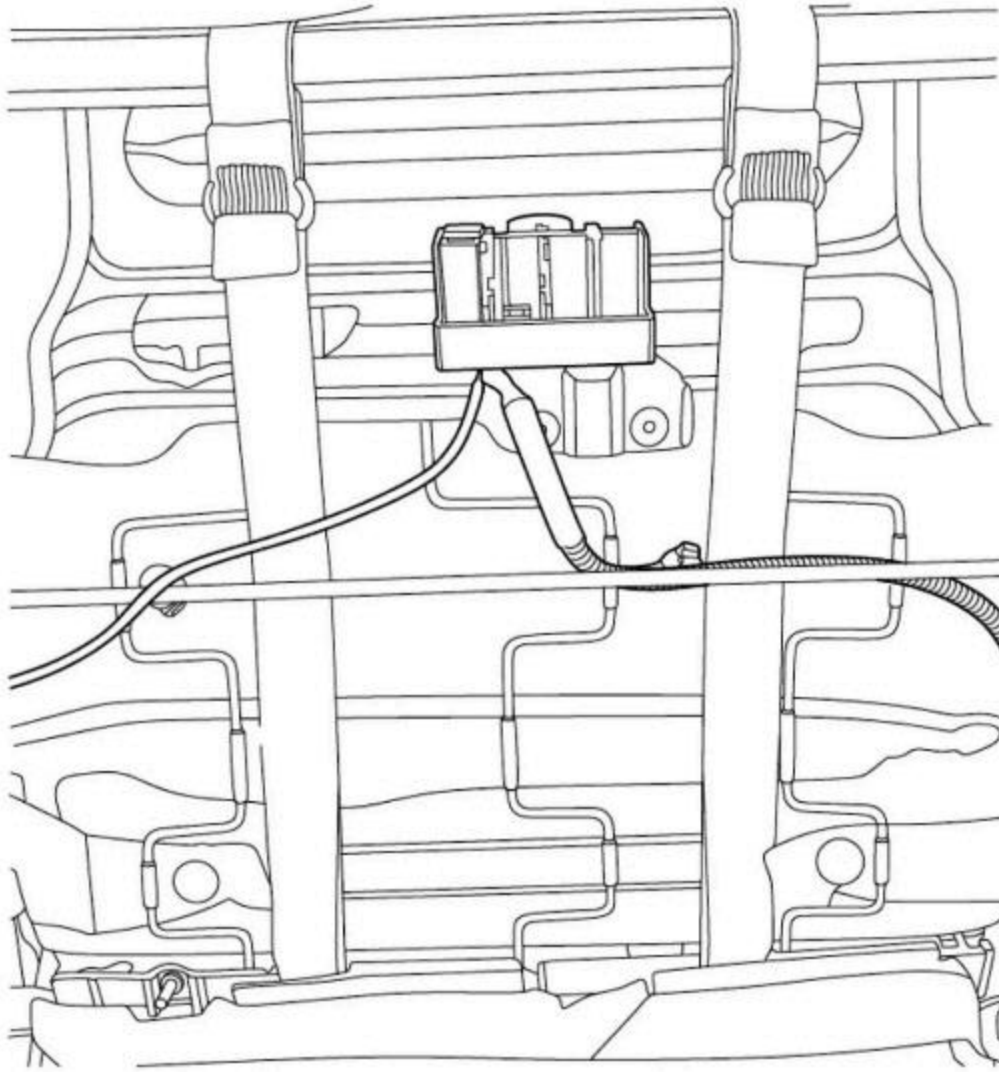
Figure 6

(3). Make sure all electrical harnesses are below the webbing. The final assembly will have the suspension mat on top (closest to the seat cushion), then the webbing straps, and then the wire harnesses on the bottom. (Figure 6)

**NOTE:** Make sure all electrical harnesses hang below the webbing and not between the webbing and suspension mat. When the final assembly is installed in the vehicle, it will have the suspension mat on top (closest to the cushion), then the webbing straps, and then the wire harnesses on the bottom. (Figure 6)

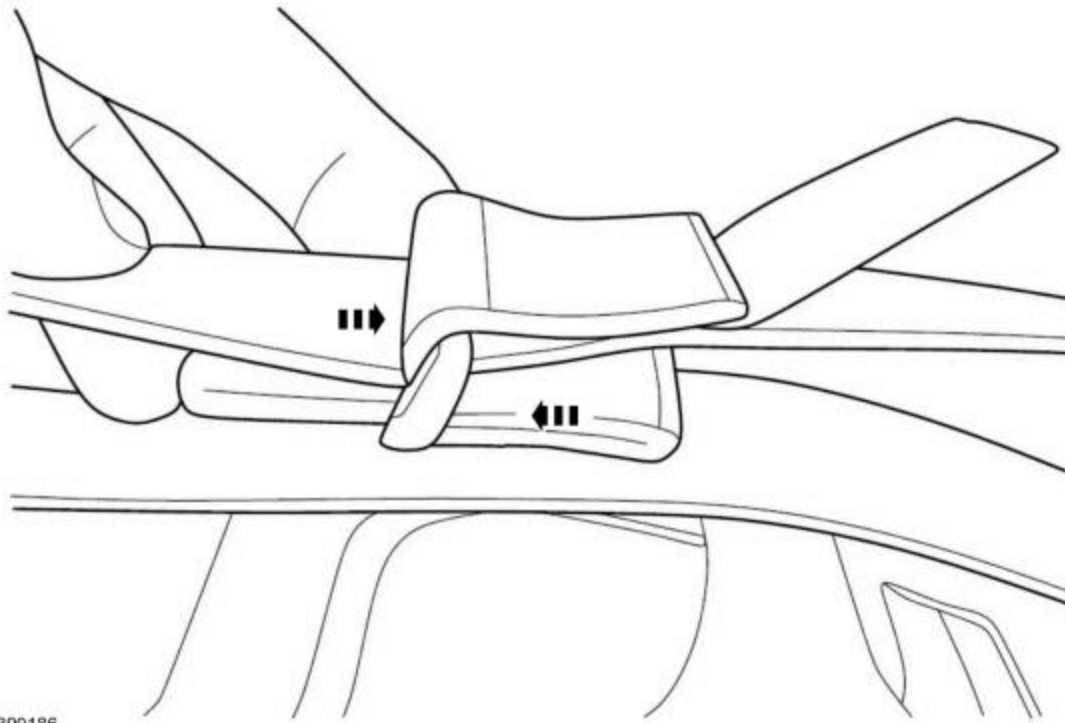
Figure 7

(4). Bring the webbing strap assembly to the metal ring and insert it. After the fold is all the way through the ring, pull the retention fold back and into position. (Figure 7)

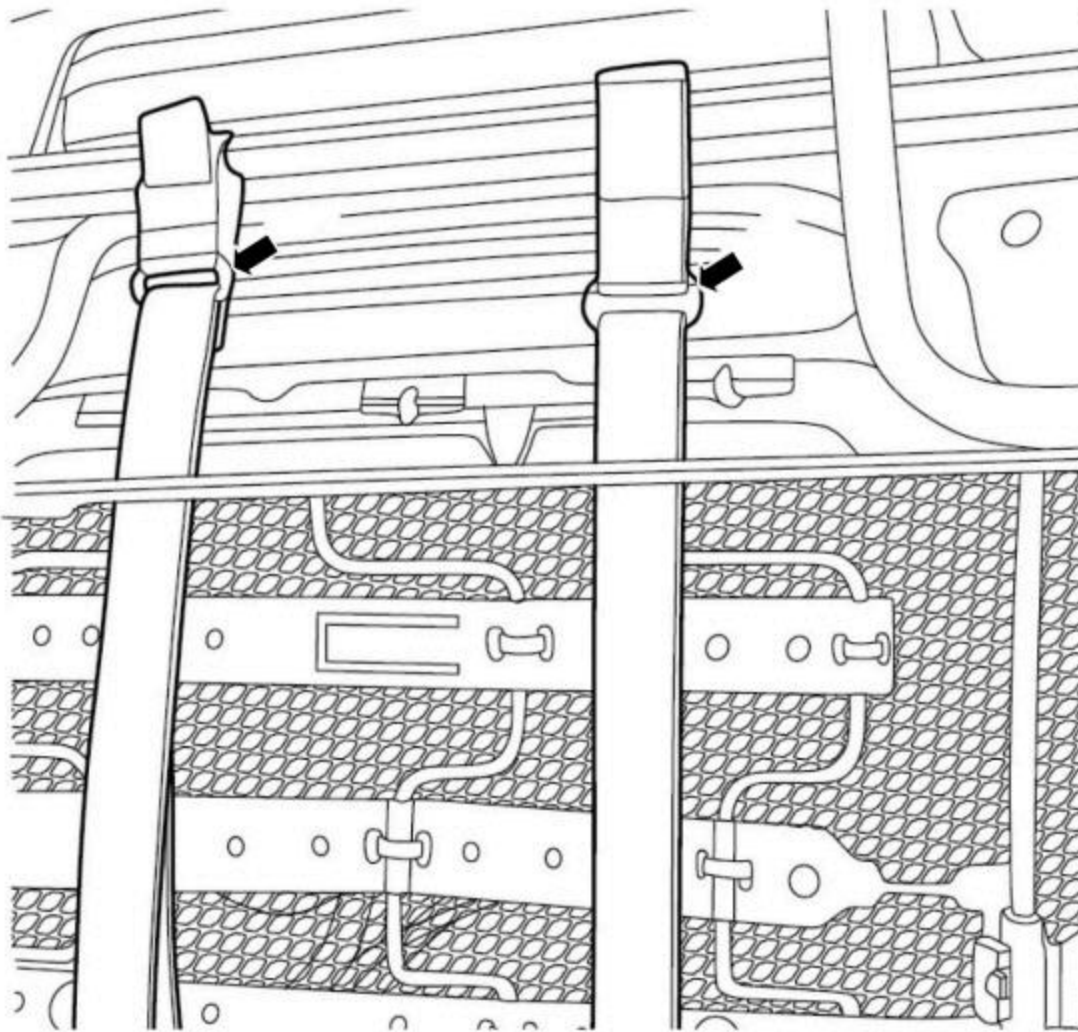
Figure 8

- (5). Repeat the process to install the second webbing strap assembly.
- (6). The metal ring should be positioned forward in vehicle. (Figure 8)

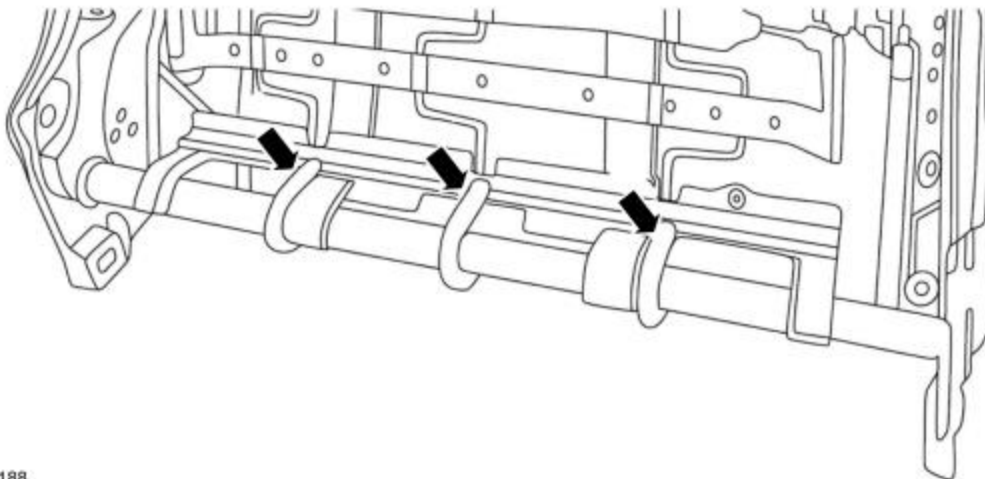
Figure 9

- (1). Locate the suspension mat to the cushion and webbing assembly.
- (2). At the rear tube verify one webbing is located between the left and center suspension attachment and the other is between the center and right suspension attachment. (Figure 9)

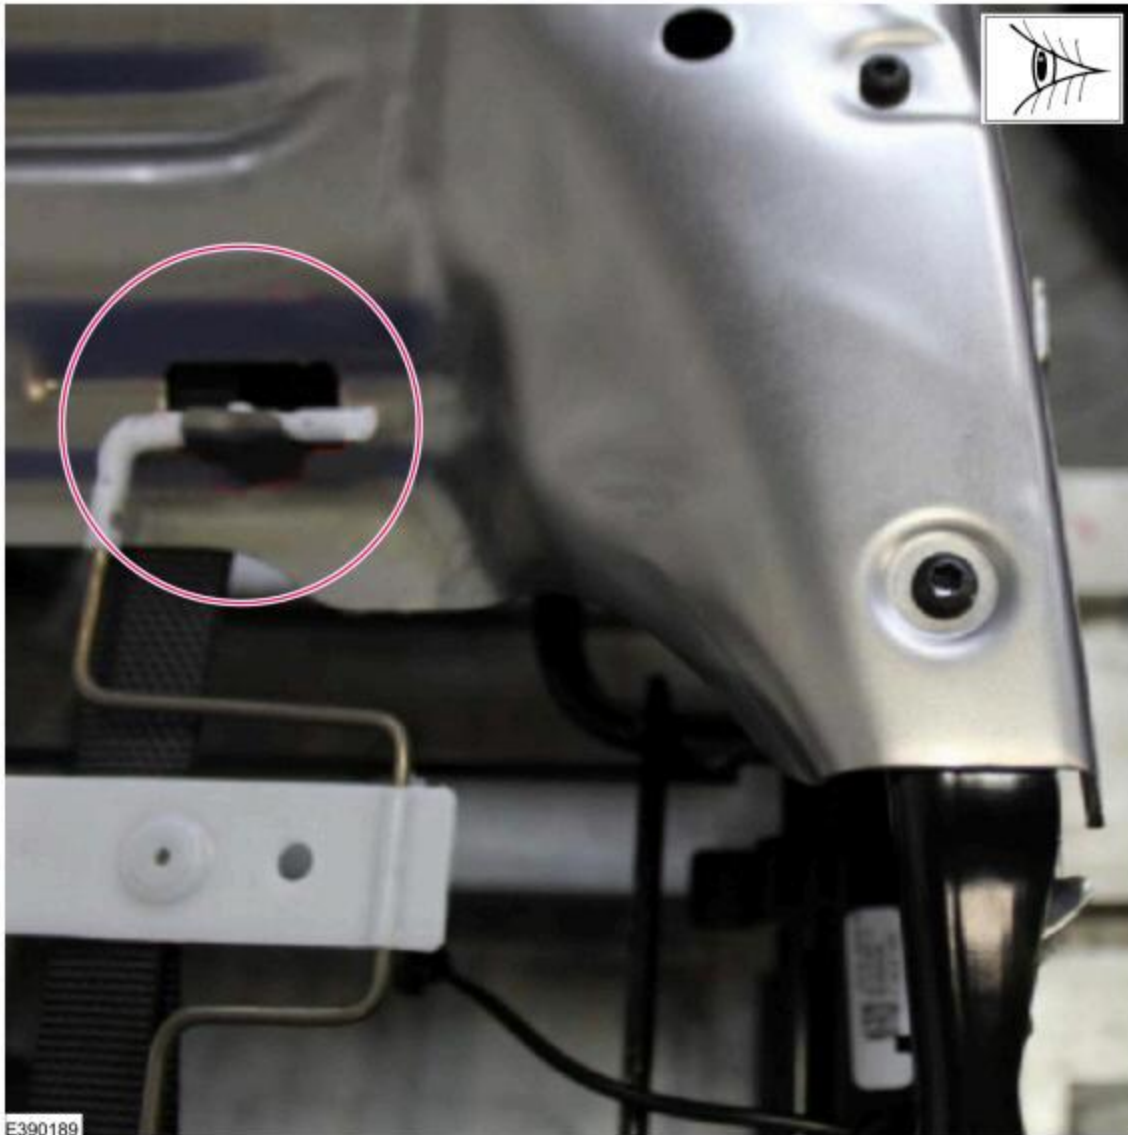
Figure 10

(4). Secure the front of the suspension mat to the retaining tabs on the cushion pan (no tools required). (Figure 10)

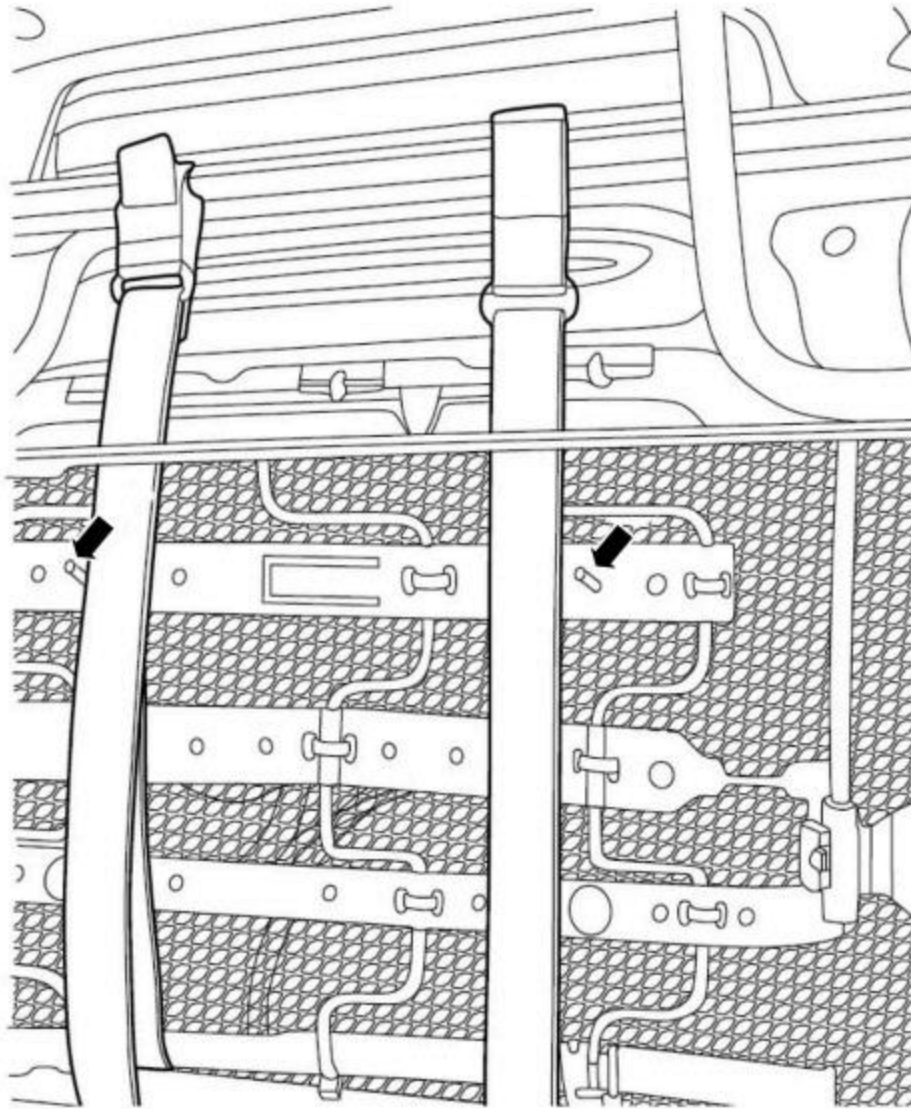
Figure 11

(5). Verify the cross-car position of the webbings. The position should be aligned with the stud on the suspension mat. (Figure 11)

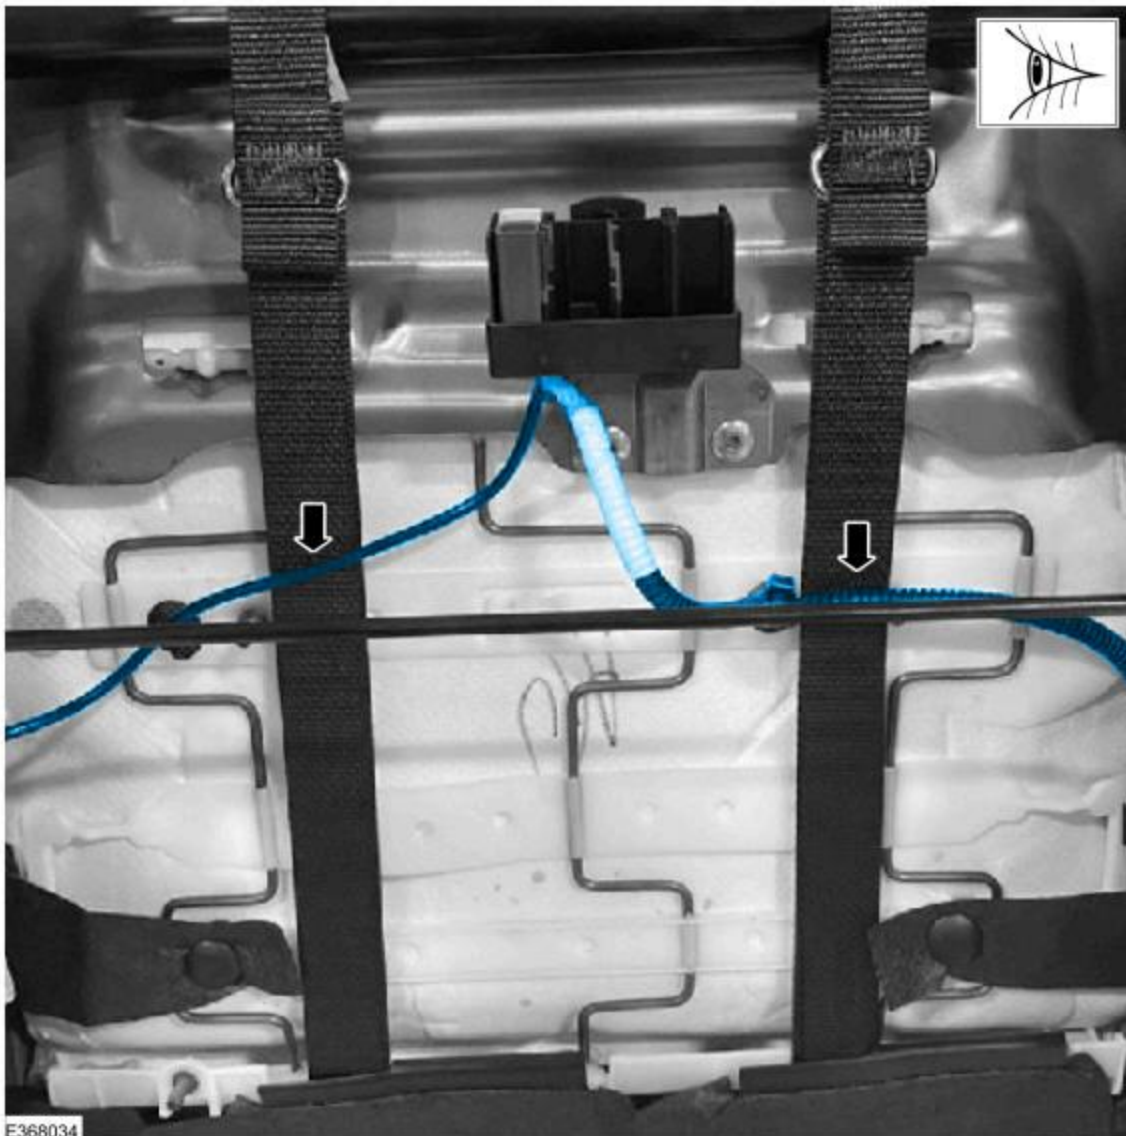
Figure 12

(6). Secure the wire harness(es) to the suspension mat. (Figure 12)

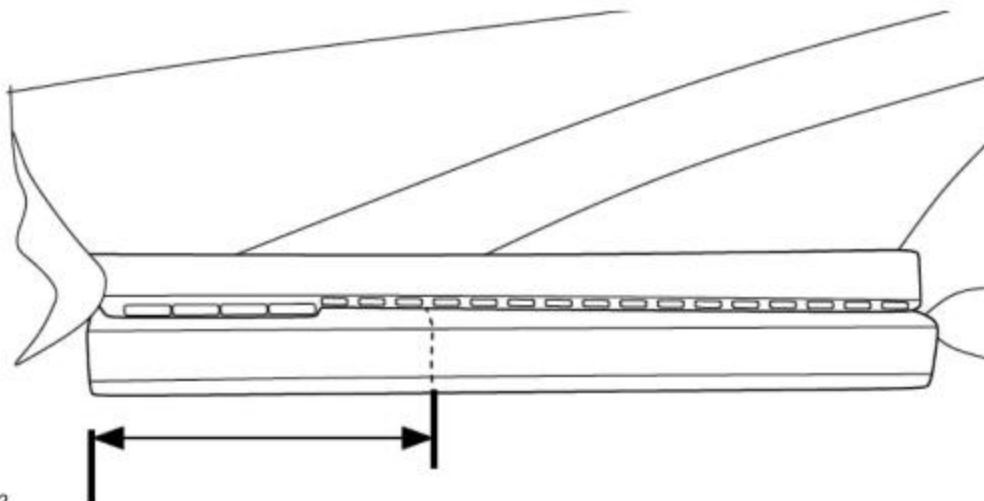
Figure 13

(1). Measure 1 3/4 in. (45 mm) and cut with a knife along the dotted line. (Figure 13)

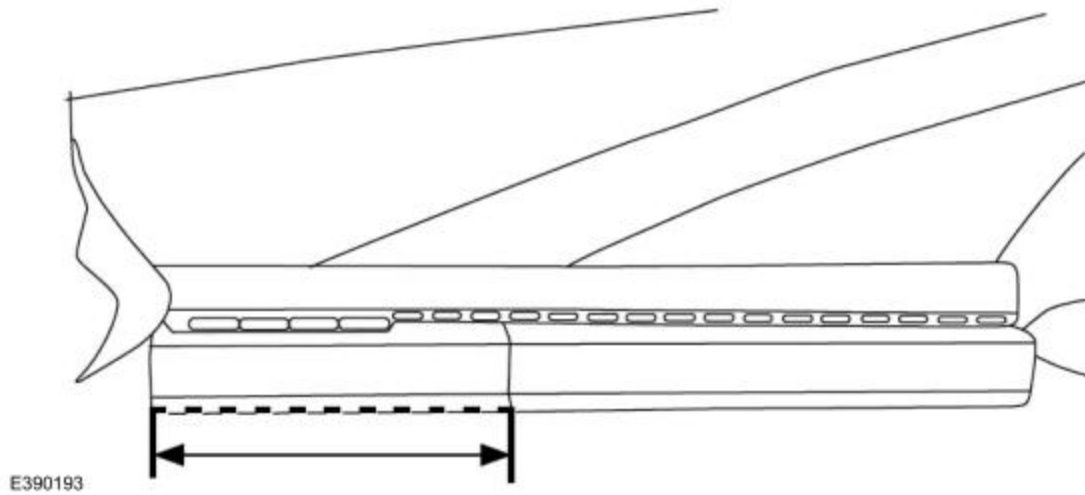
Figure 14

(2). Cut along the dotted line (Figures 14-15), perpendicular to the previous cut, so that the portion of the J retainer in Figures 16 and 17 can be removed.
