FRESCO WINDOW SLIDER TAB

Bulletin Type:	SRP	Publication Date:	May 2025
Bulletin #(s):	25-006	Make(s):	Jayco, Entegra Coach
Job Code(s):	<i>**If affected unit has a warranty remaining, submit your claim following the normal process.</i>	Model(s):	Terrain (19L, 19Y, 19YG) Launch (19L, 19Y, 19YG)
Flat Rate(s):		Model Year(s):	2021 - 2026

Incident:	Broken Slider Tab on the Driver's Side Front Power Fresco Window
Affected Units:	2021-2026 Jayco Terrain and 2021-2026 Entegra Coach Launch
Parts List	2 - PIN,GDE LGE PIN B WDO FRSCO (Jayco Part #2072537)
Misc. Tools & Supplies:	Screw Gun with Phillips Bit Drill with 1/16" Drill Bit Hook Tool Flat Head Screwdriver
Parts Return Information:	N/A

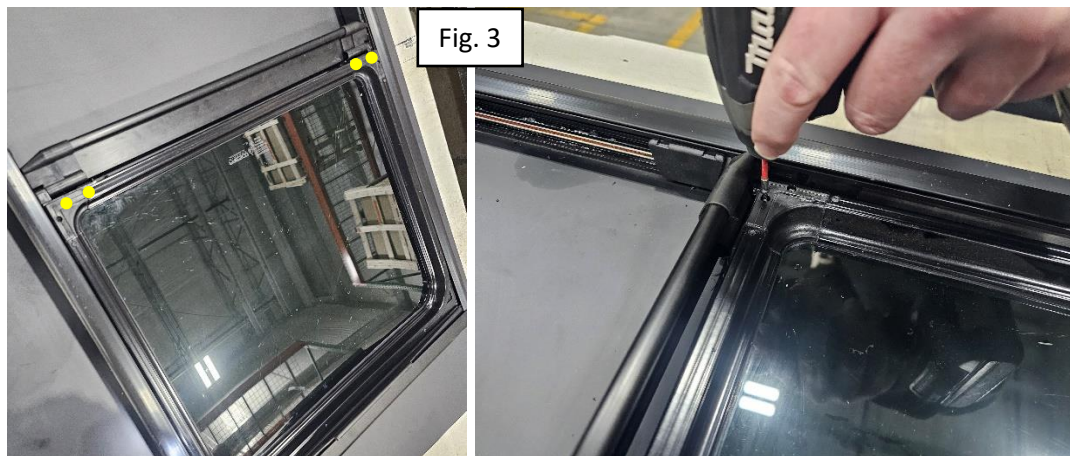
5. Open the window again slightly, using the wall switch. The window handle should now be fully open. You will need to remove 4 more screws that are now visible with the window handle open. (Figure 3)

17. Use a 1/16" drill bit to go through the now visible pilot holes.
18. Re-secure the final 4 screws below the handle. (Figure 3 - Above)
19. Fully close window.

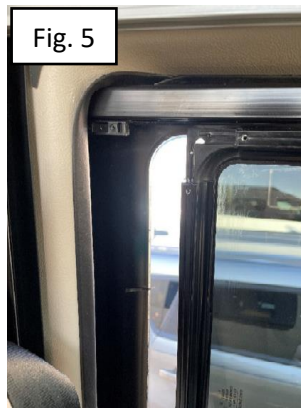
7. With the clips removed you will be able to free the window from the L Trim and handle. You can separate the slider from the slide components by holding onto the slider using the hook tool and moving them rear ward. (Figure 5)

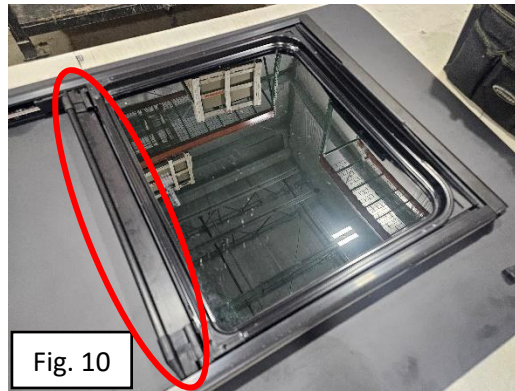
16. Slightly re-open the window so the handle pops open. (Figure 10)
