Maserati

Grecale Driveshaft Flex Disc Characteristics

This Technical bulletin serves as a guide and provides info regarding wear characteristics of the driveshaft "Flex Disc" and to recognize which condition of this component is considered compliant and therefore avoid unnecessary replacements.

MODELS: Grecale M182 All MY).

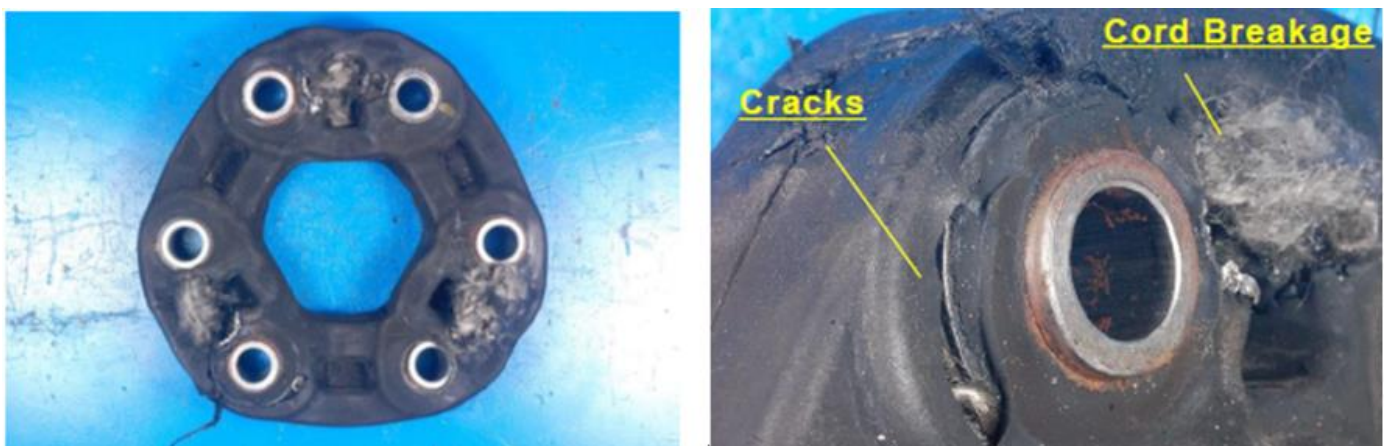
ABNORMAL (DAMAGE)

The images below show a damaged Flex Disc, which has the following two problems:

- Deformation (ovalization).
- Exposed and/or damaged aramid fibers.

In this case, replacing the drive shaft is the only technical solution allowed.

Warranty claims must include detailed photos (with date and time stamps) of the damage, as well as any accompanying comments.
