MAS004706 RU 25-12

Rapid Update 689

Grecale – RFHM antenna repositioning

Certain Maserati Grecale (M182) MY23 MY24 listed in MODISCS+ are involved in a Rapid Update to reposition the RFHM antenna.

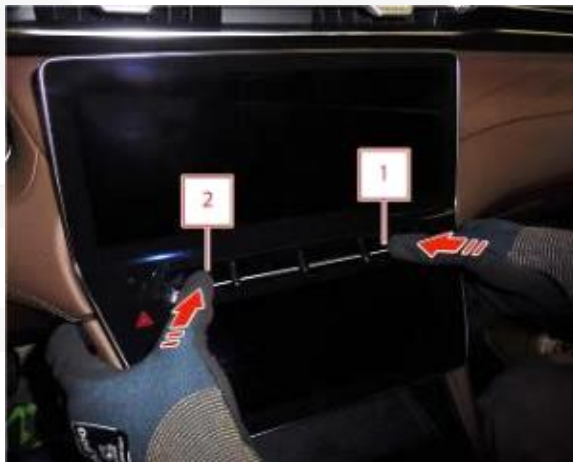
1. Always check ModisCS+ to see if the vehicle is involved in this action and if it has not been previously performed.
2. Considering that the work will take place inside the vehicle, take the necessary precautions to avoid any damage.
3. Before replacing the antenna, disconnect the battery, following the instructions in the workshop manual. **8.20.001 BATTERY Disconnect-Power Supply Connection.**
4. Press the right point first(1) and then the left point (2) without releasing point (1) to release the drive-by-wire transmission panel from the center console.

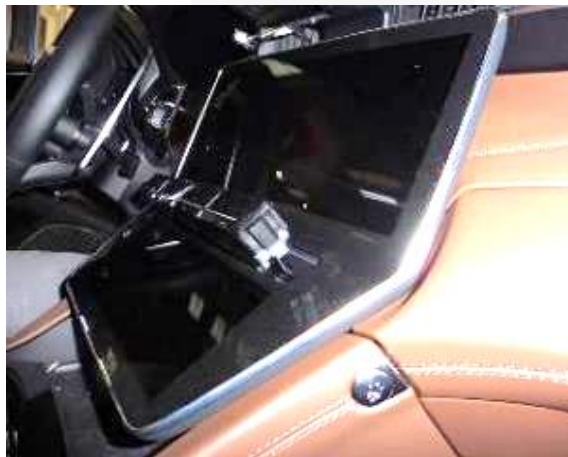
5. Pull out and remove the drive-by-wire transmission panel from the center console.

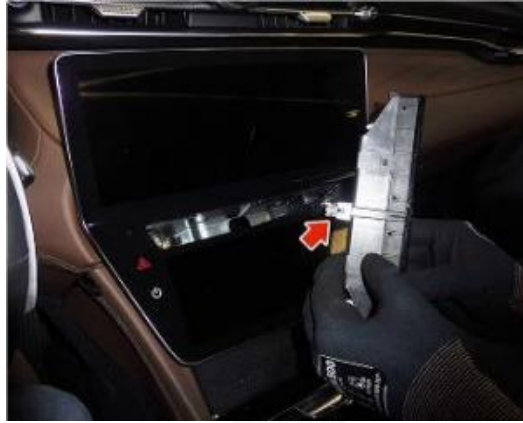
6. Disconnect the connector.

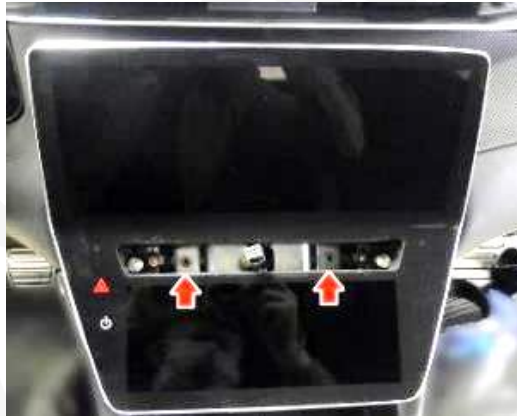
7. Remove the screws as shown.

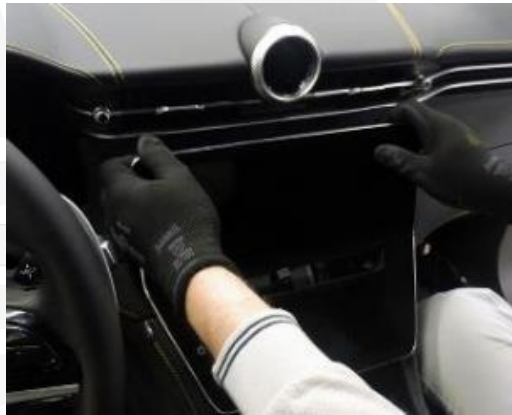
8. Pull out the display as shown.

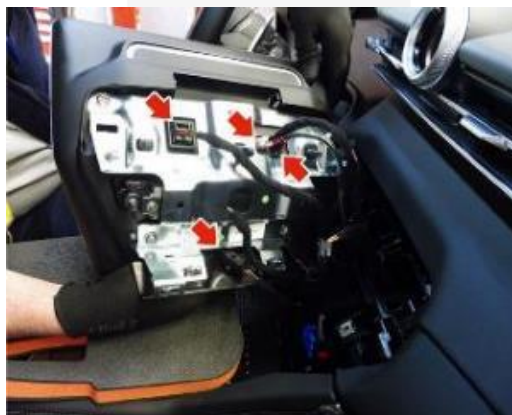
9. Move the display and disconnect the indicated connector.

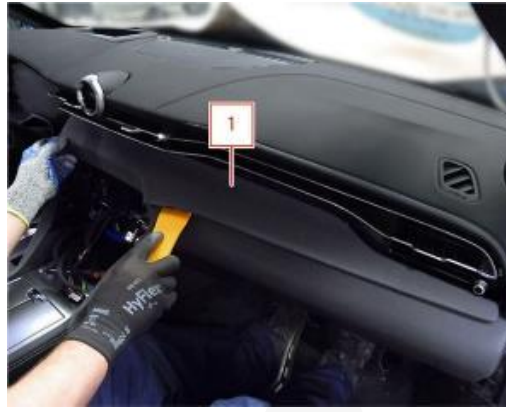
10. Release the passenger-side dashboard trim panel (1) with a suitable Teflon tool.

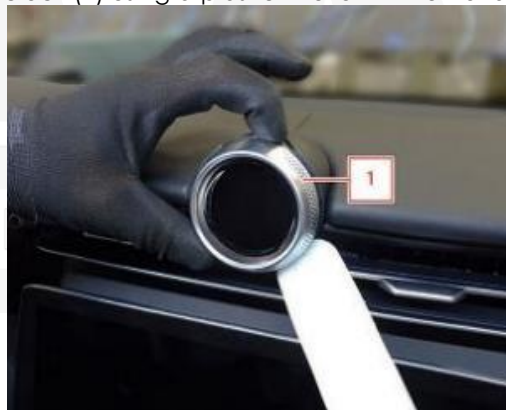
12. Remove the dashboard clock (1) using a plastic interior trim removal tool.

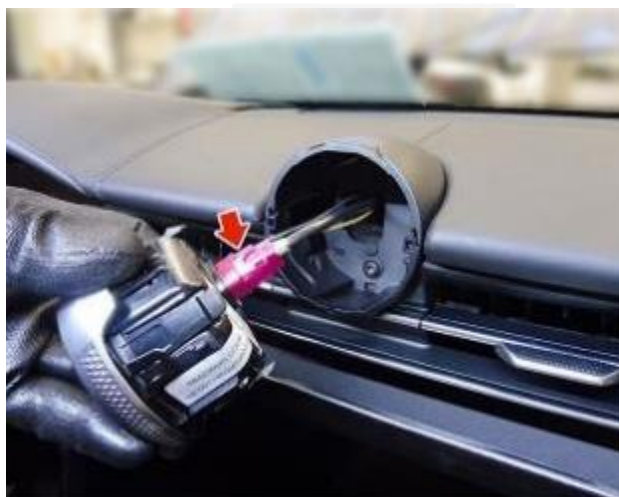
13. Disconnect the indicated connector and remove the clock on the dashboard

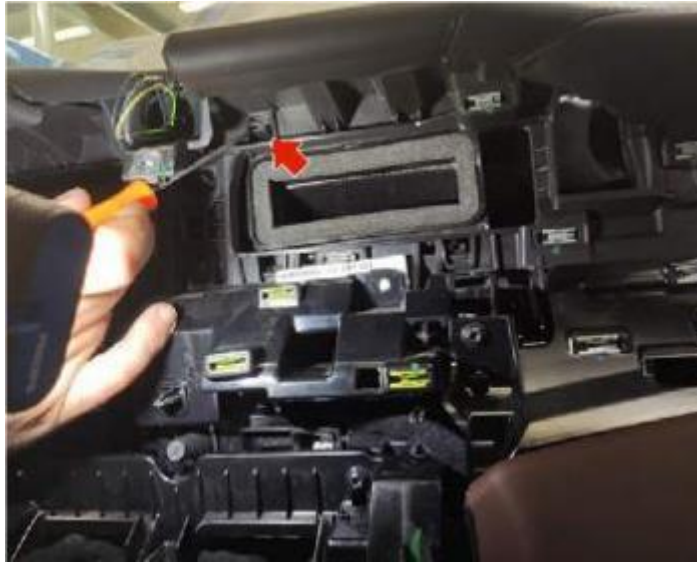
17. Release the clip shown.

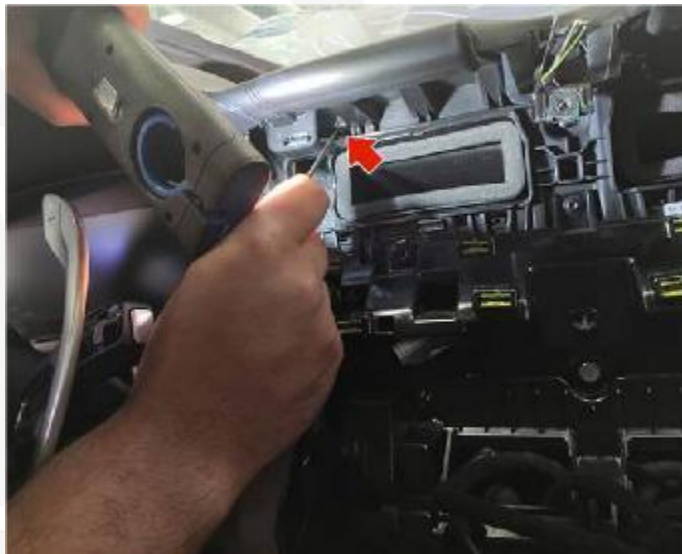
18. Release the clip shown.

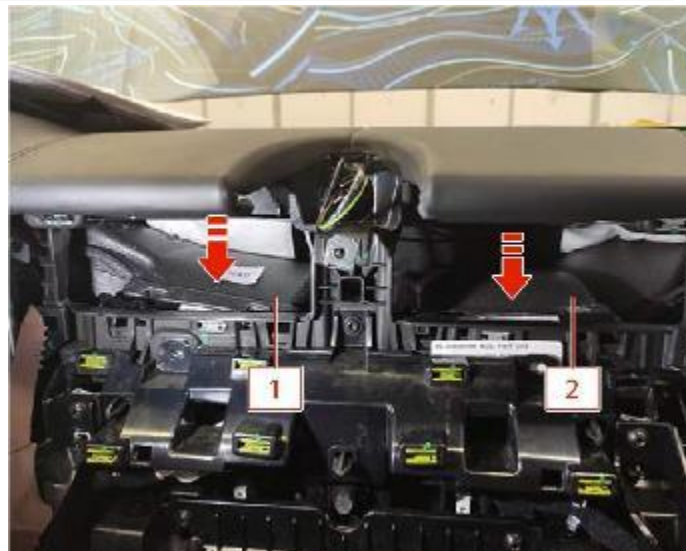
19. Lower the duct at the left dashboard air opening (1) and the duct at the right dashboard air opening (2) as shown.

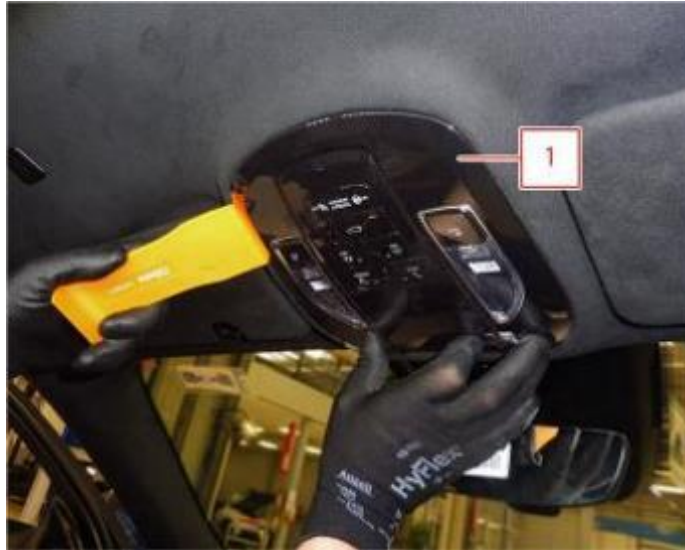
20. Pull out the front ceiling light (1) using a plastic interior trim removal tool

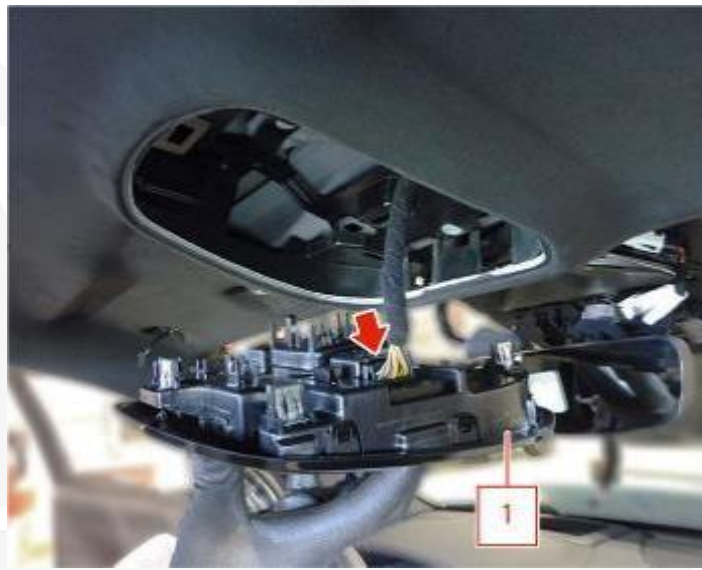
21. Disconnect the connector and remove the front ceiling light (1).

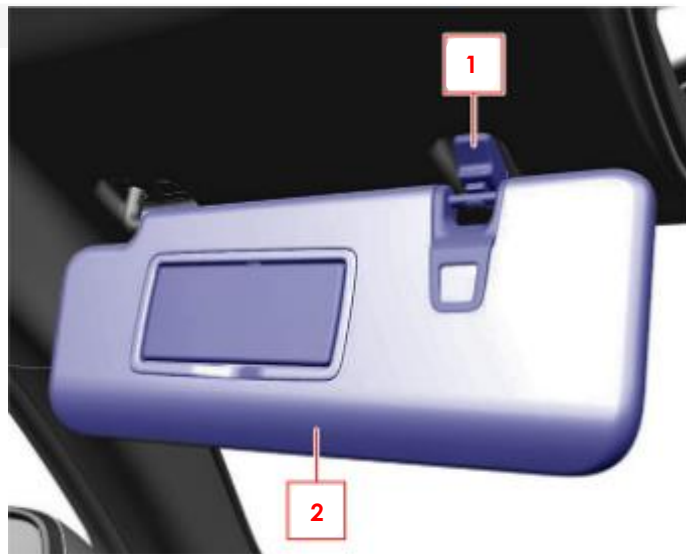
22. Release the sun visor (2) from its support (1).

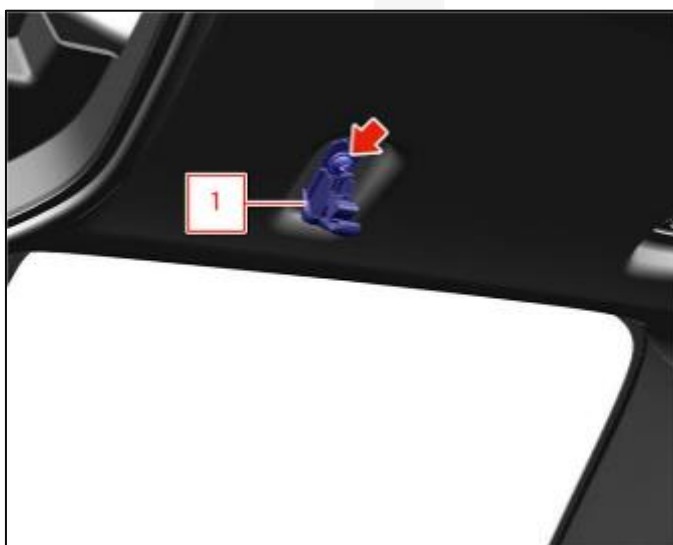
24. Undo the screw and remove the sun visor support (1).

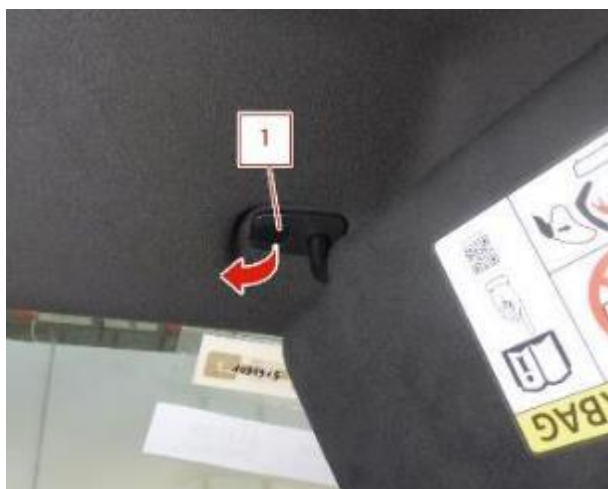
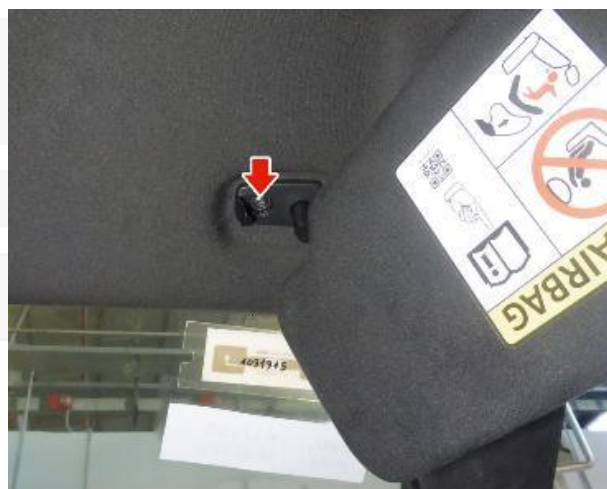
26. Open the cover (1) and remove the screws shown below.

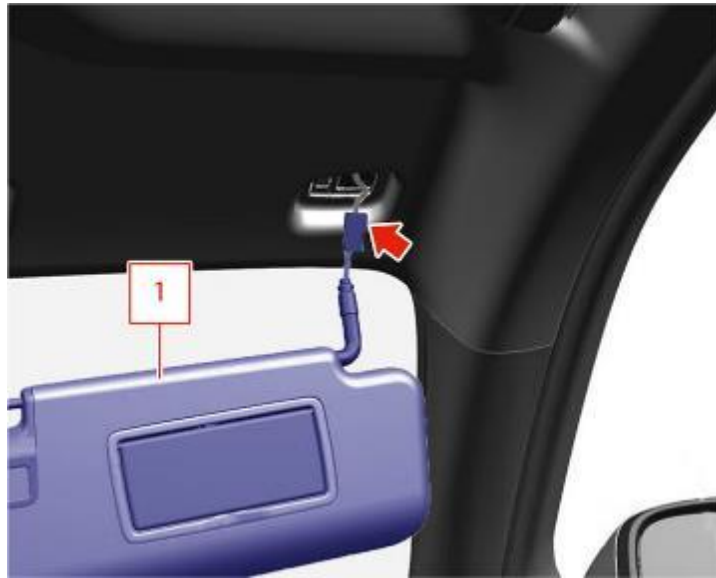
27. Disconnect the connector and remove the sun visor (1).

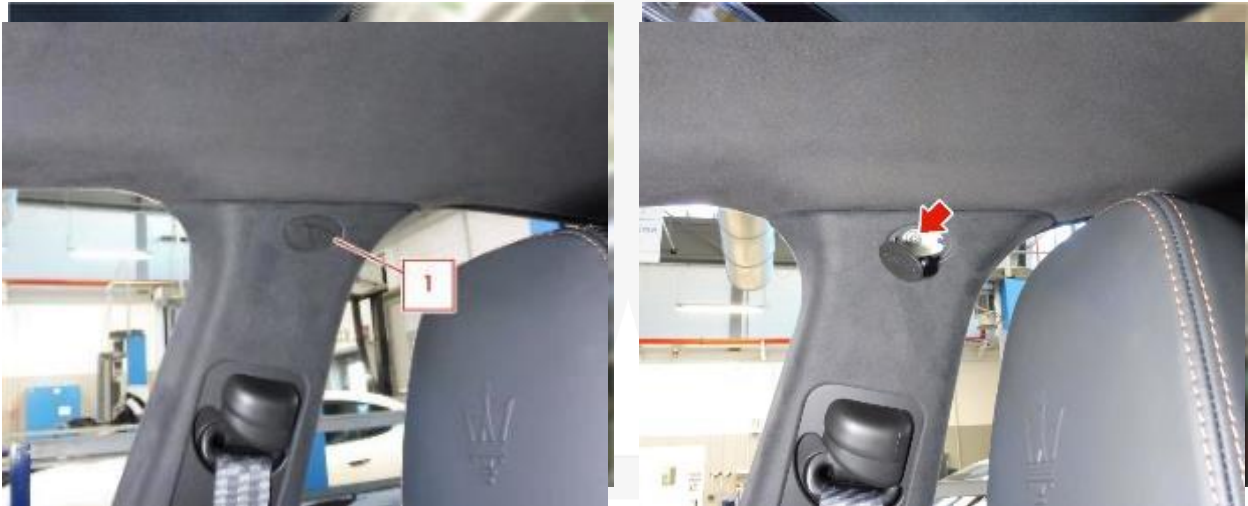
- 33. Repeat the procedure for the front left and rear handles, both right and left.
- 34. Remove the cable trim panel of the interior rear-view mirror (1) using the Teflon tool.
- 35. Remove and open the cover (1) and remove the screw shown below.

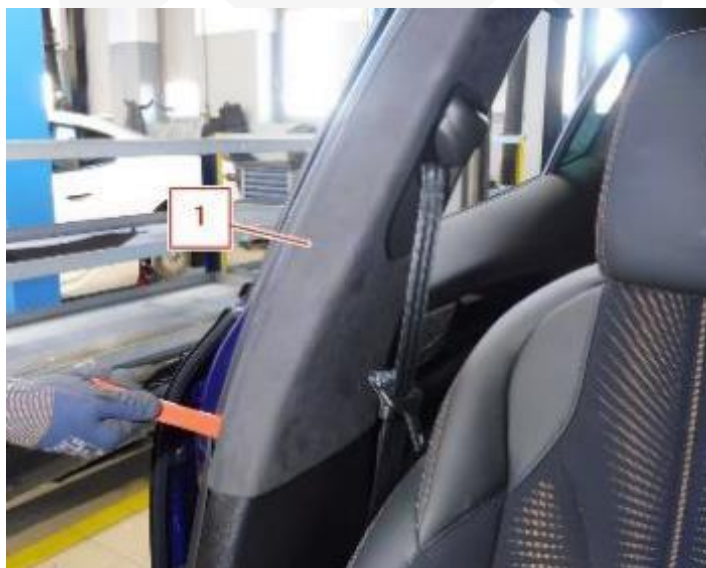
36. Carefully disengage and remove the right upper B-pillar cover (1).

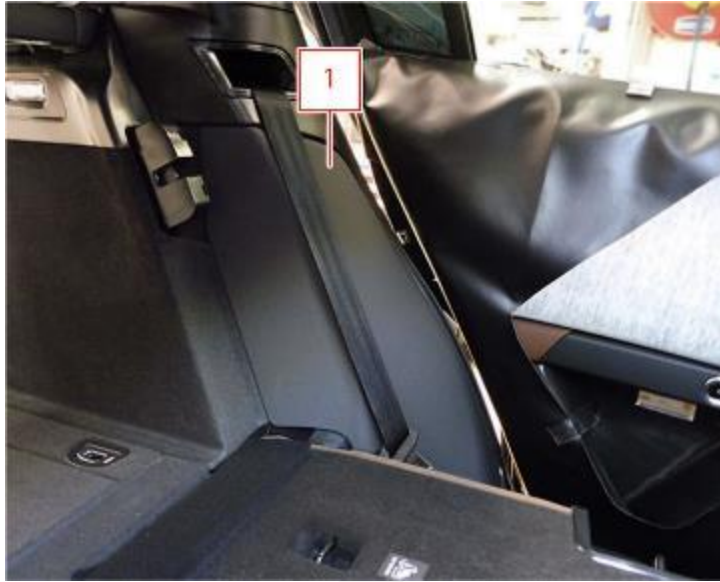
38. Lower the left rear seat and pull out the trim (1).

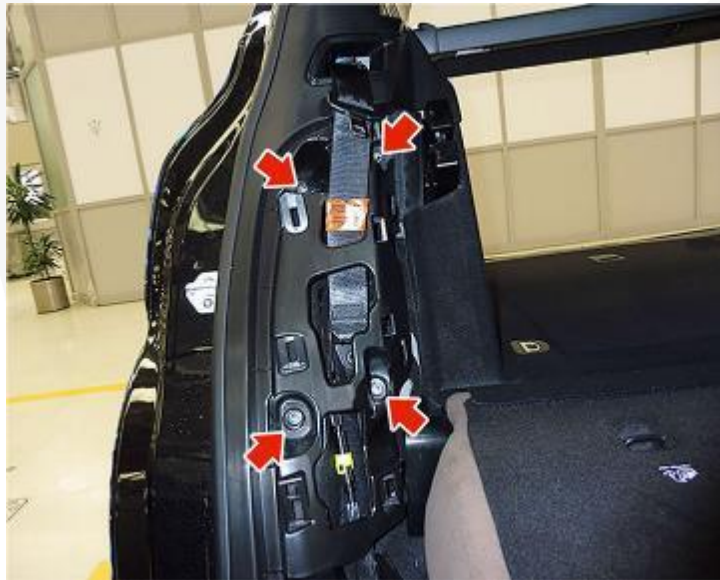
39. remove the screws shown

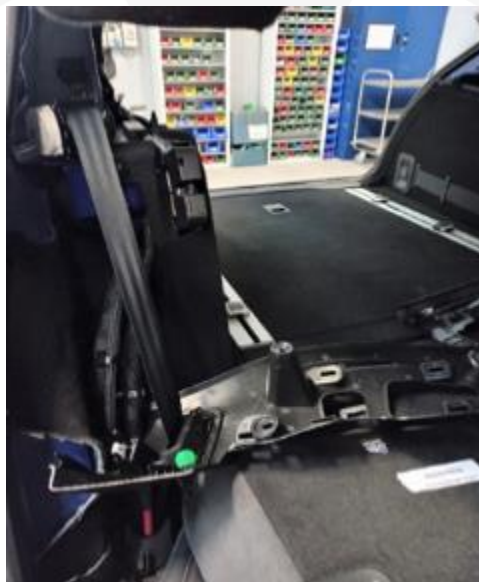
40. Do not remove the lower right C-pillar cover completely

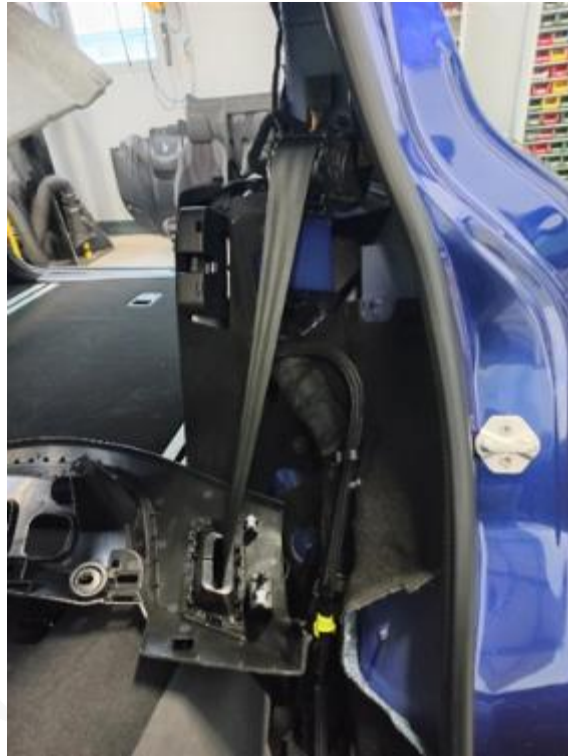
41. Repeat the procedure for the lower left C-pillar cover

Note: Do not remove the lower left C-pillar cover completely

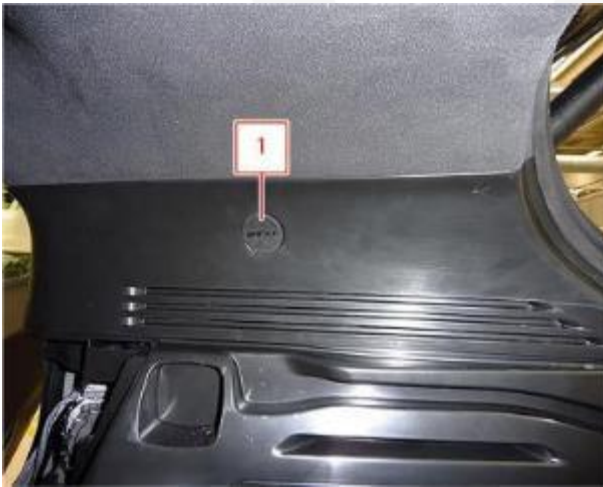
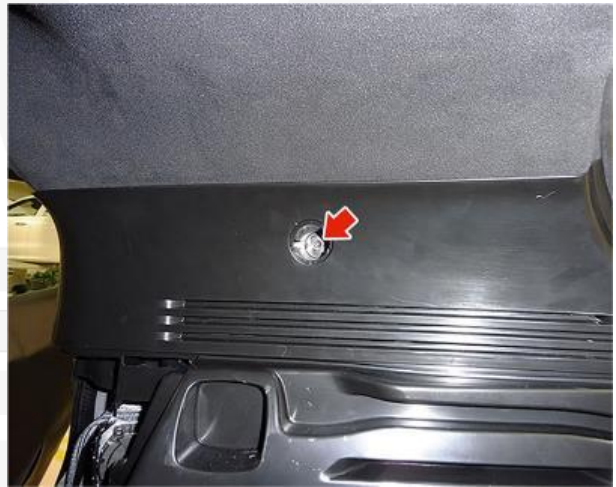
42. Remove the cover (1) and remove the screw shown below.

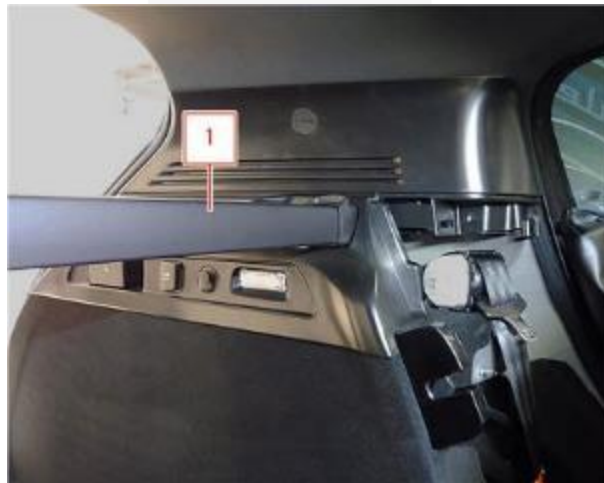
43. Remove the rear luggage shelf (1).

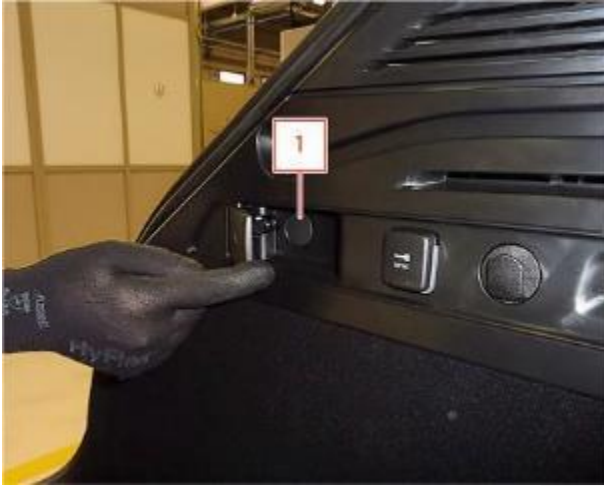
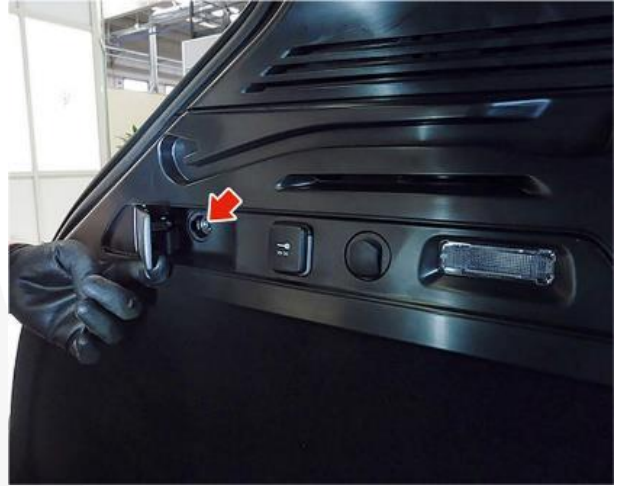
44. Remove the cover (1) and remove the screw shown below.

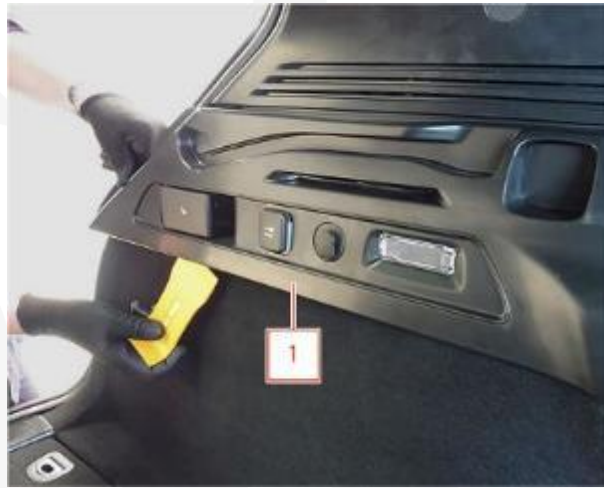
45. Using a plastic interior trim removal tool, remove the cover (1).

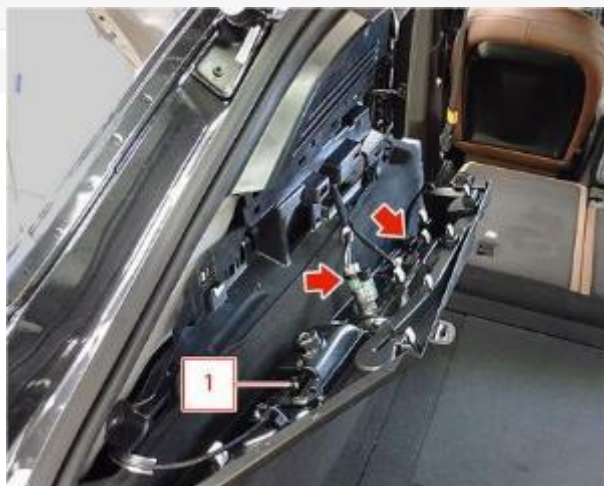
46. Disconnect the 2 connectors and the seat reclining control cable (1).

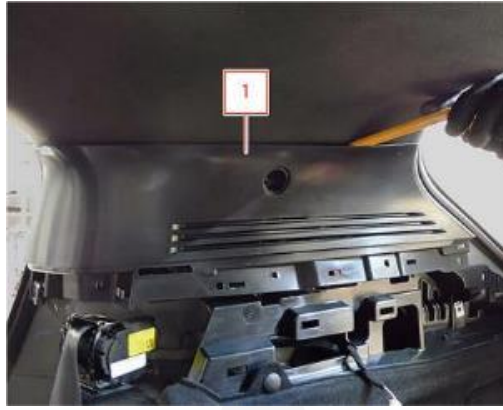
47. Remove the rear window pillar cover (1) using a plastic interior trim removal tool.

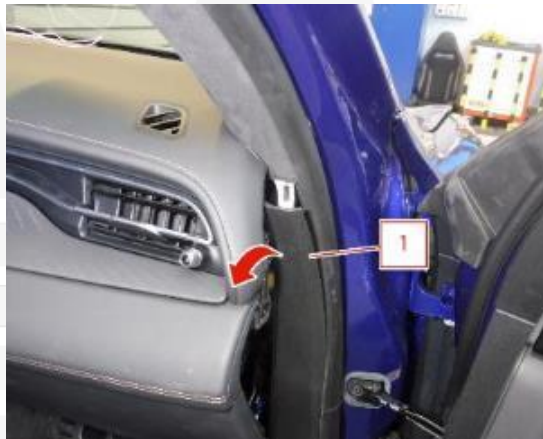
50. Release the upper section of the corner cover of the right side panel (1)

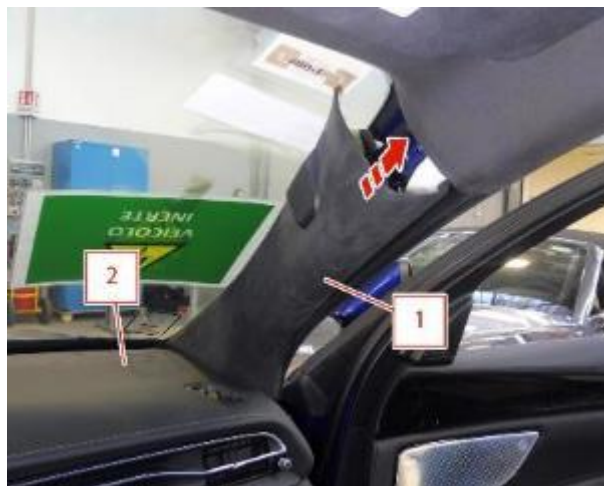
51. Very carefully, detach the right-hand windscreen pillar trim panel (1) from the dashboard (2).

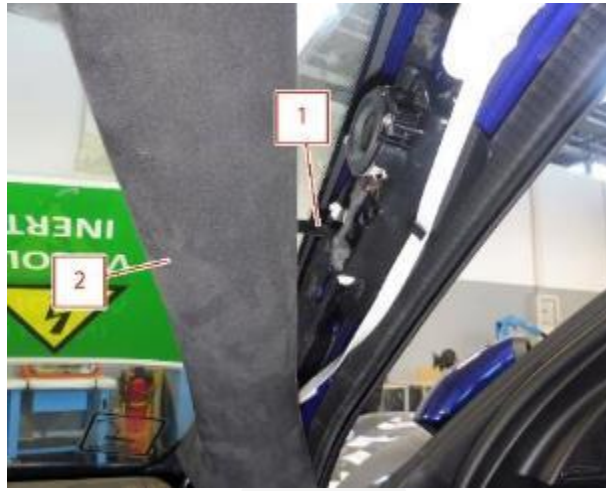
52. Disengage the safety catch (1) and remove the right-hand windscreen pillar cover (1).

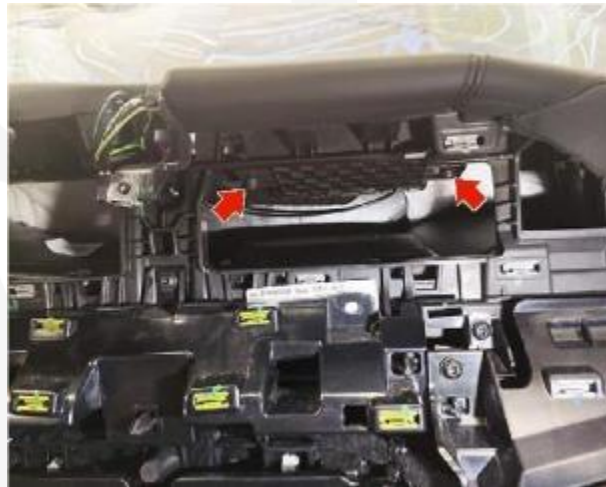
54. Remove the screw shown below.

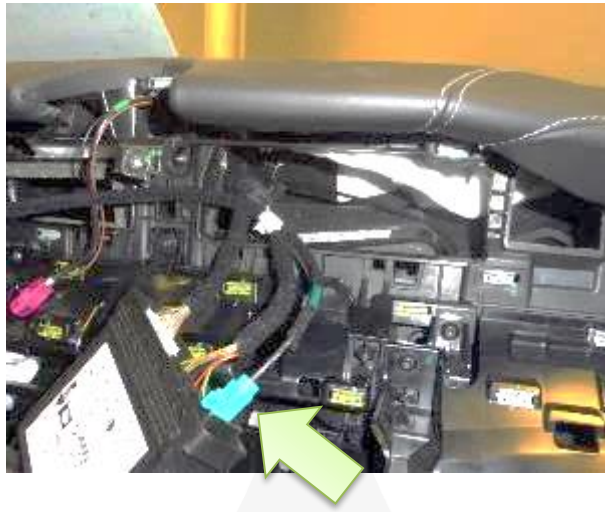
57. Disconnect the pink antenna connector and connect the green antenna cable 1 to RFHM. Connect the green antenna cable 1 to RFHM. **Note:** Clips are pre-installed on the wiring harnesses to be used for repair.

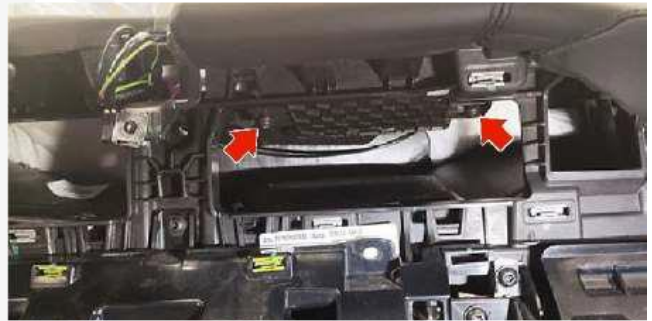
58. Plug the green antenna cable into the dashboard and reinstall the RFHM control unit

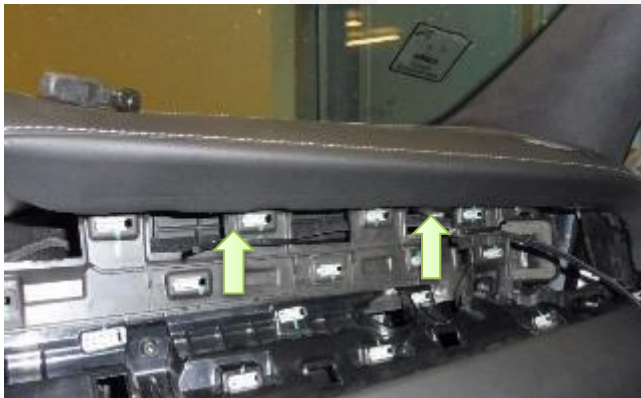
59. Fix the green antenna cable with cable ties and insert it through the duct, pointing towards the air vent opening on the right.

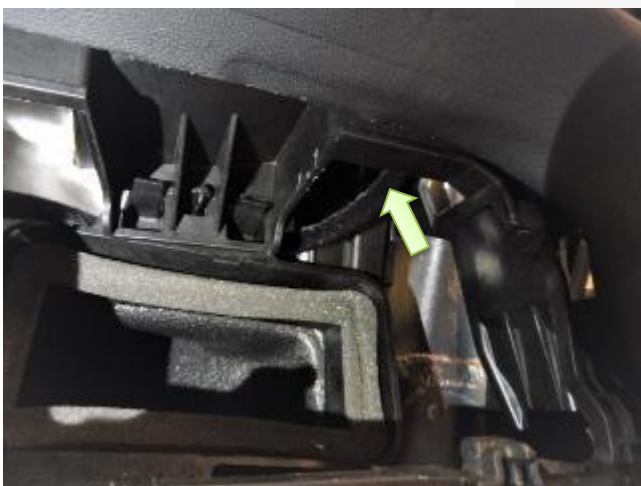
60. Pull the antenna cable through the access indicated by the arrow on the side of the A-pillar, until it exits at dashboard level.

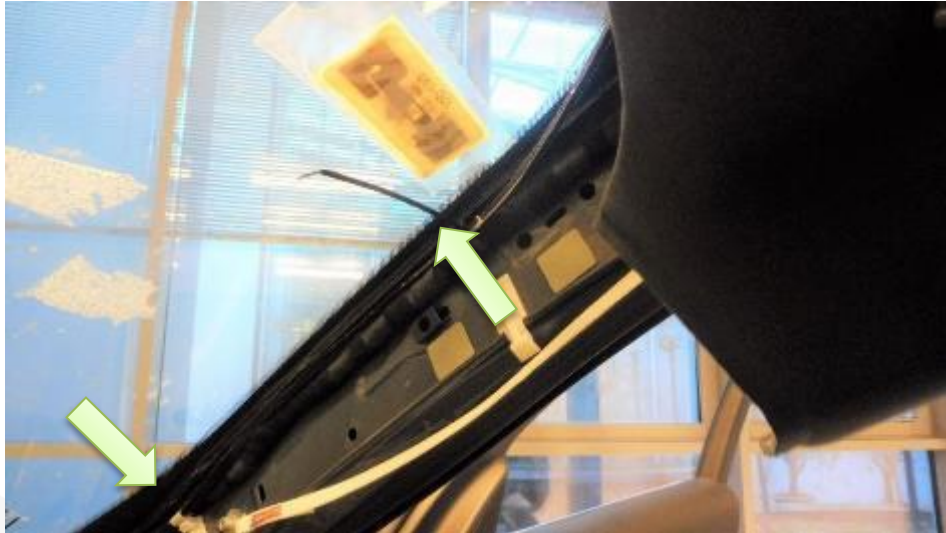
61. Now, going up the pillar, secure the entire green antenna cable with cable ties, as shown in the figure. Leave the end connector disconnected for the moment.

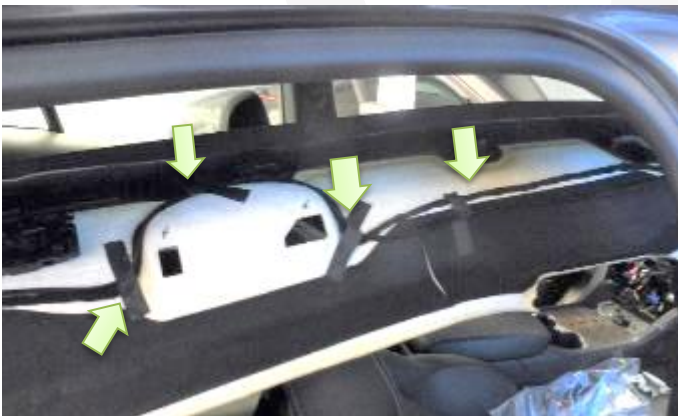
62. At this point, retrieve the "blue" antenna cable and, using an acrylic polyester tape at least 40 mm wide, fasten the cable by following the wiring already present and running along the roof, continuing around the perimeter until it reaches the rear of the roof.

Note: The two connectors, the "green" antenna, and the "blue" antenna must **ONLY** be connected afterward. Therefore, check that they are close but do not connect them at this time.

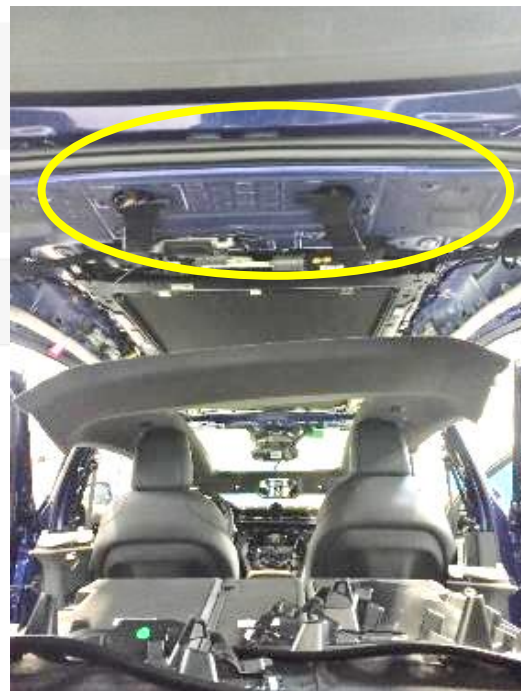
63. At this point, move the roof panel to clear the area of the rear cross member.

Warning: Make sure that all wiring are disconnected

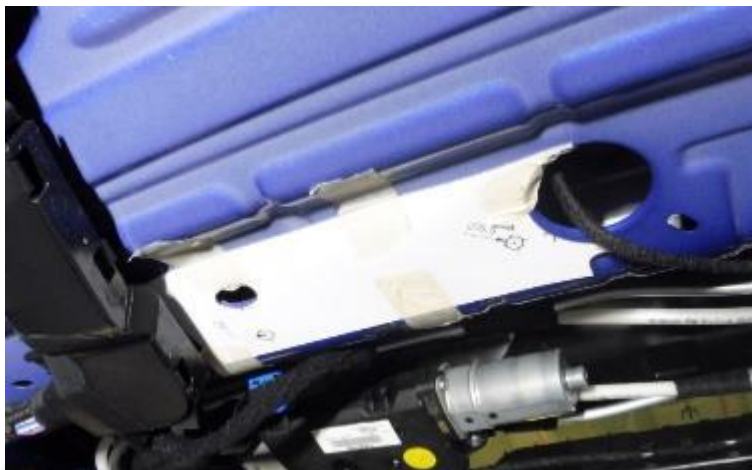
64. **TPMS ANTENNA RETROFIT BRACKET INSTALL:** To mount and secure the TPMS bracket, it is necessary to drill holes. Use the "TPMS bracket" TEMPLATE included with this bulletin, Position it and secure it as illustrated below using Painter's tape.

**Use protective eyewear when drilling!**

Protect the interior of the vehicle from metal shaving using a cover!

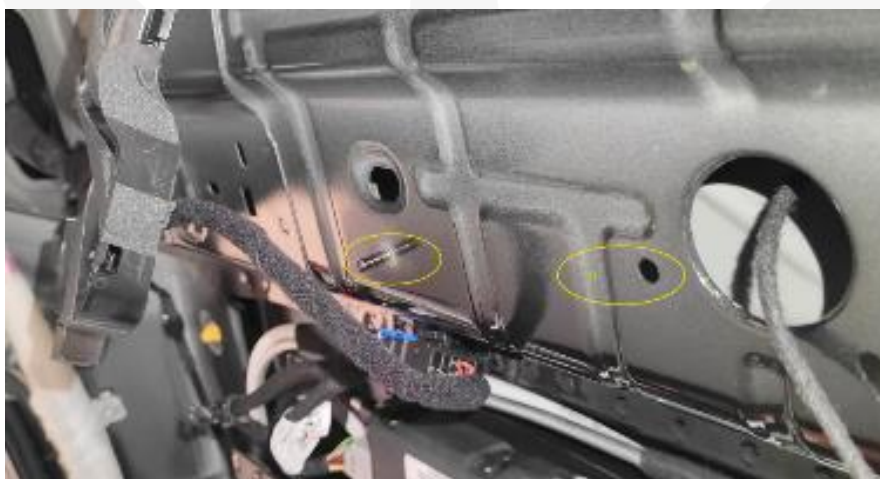
65. Following the pattern, drill holes in the sheet metal using **5 mm** and **6.5 mm diameter drill bits**, at the positions indicated on the template. **Caution:** Use drill bits with a **maximum length of 50 mm**.

Note: Some vehicles may not need holes to be drilled. The bodywork has already been updated at the Plant. In this case, simply fit the new bracket directly and use the nut **675000324 on the stud present** instead of the rivet. Then continue to follow the instructions from step 68.

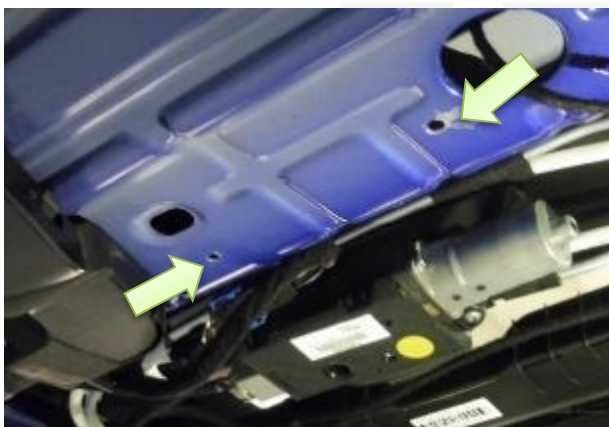
66. **AFTER DRILLING THE HOLES:** It is recommended to **treat the perforated area** with the appropriate protective compounds (anti-corrosion primer) before proceeding further.

Refer to the instructions in the workshop manual.

- **09.AA.008 SEALANT AND CONSUMABLES** in the **ANTICORROSION PROTECTION** section

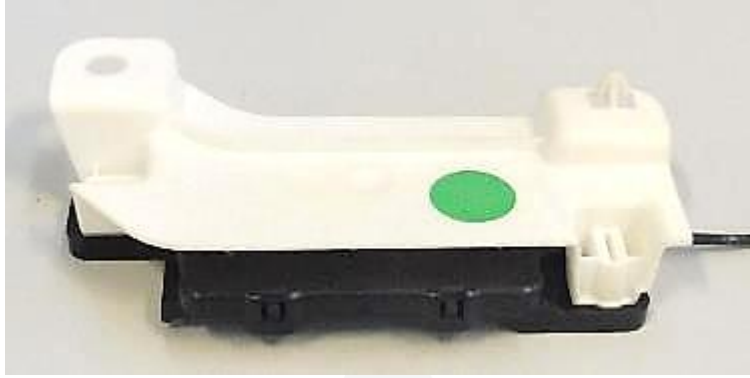
67. Now, **first**, fit the antenna with the new bracket using the screws and **then** fit the **bracket + antenna** assembly on the car in the previously prepared area.

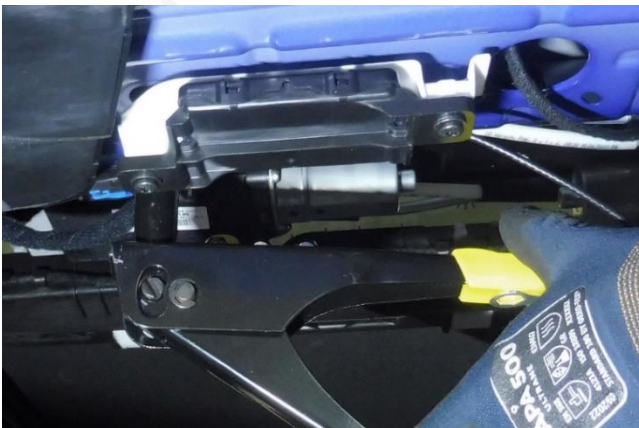
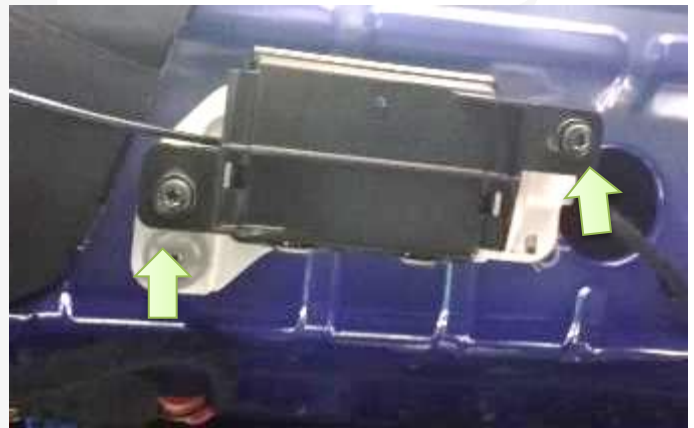
68. Secure the bracket by inserting the bracket clip into the 6.5 mm hole and use a **rivet with a washer** in the 5-mm hole

Warning: For **RIGHT-HAND DRIVE** cars, fit the **antenna** to the bracket by rotating the component by 180°.

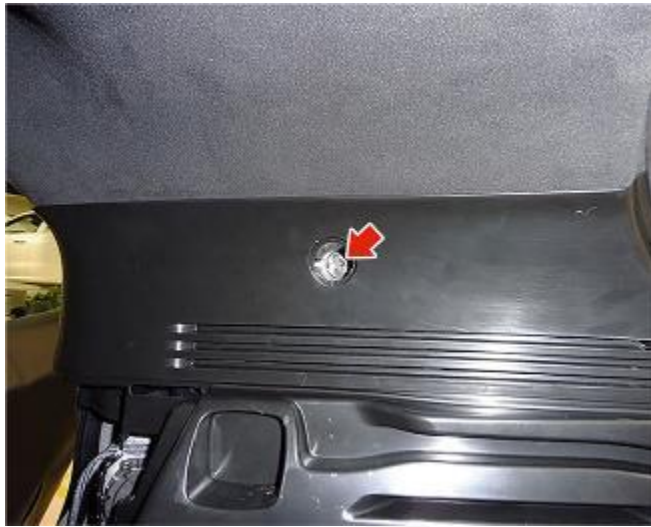
71. Tighten the indicated screw to a torque of:

Screw connection

Tightening cover screw

9 N·m
(6.6 ft·lb_f)

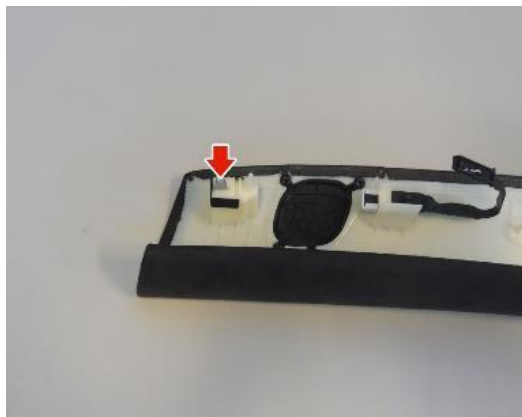
74. Check the fastener before installation
