SIB 12 06 25

SERVICE ACTION: CHECK HIGH PRESSURE PUMP ELECTRICAL CONNECTOR

G70 (7 Series Sedan)

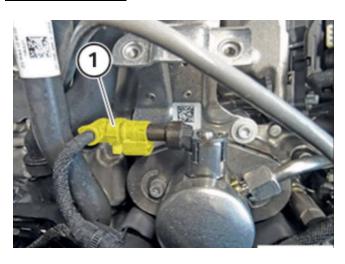
The electrical connector for the bank 1 high pressure pump may not have been locked correctly.

- 1. Remove the acoustic cover as described in Repair Instruction 11 12 070 "Removing and installing/replacing the acoustic cover".
- 2. Check and if necessary, lock the electrical connector on the bank 1 high pressure pump (1).
- 3. Reassemble the vehicle.
