HYUNDAI Technical Service Bulletin

| GROUP BODY ELECTRICAL | NUMBER 25-BE-010H |
| DATE MAY 2025 | MODEL(S) PALISADE (LX2) |

SUBJECT: SEAT BELT BUCKLE INSPECTION AND REPLACEMENT
(WARRANTY EXTENSION Z06)

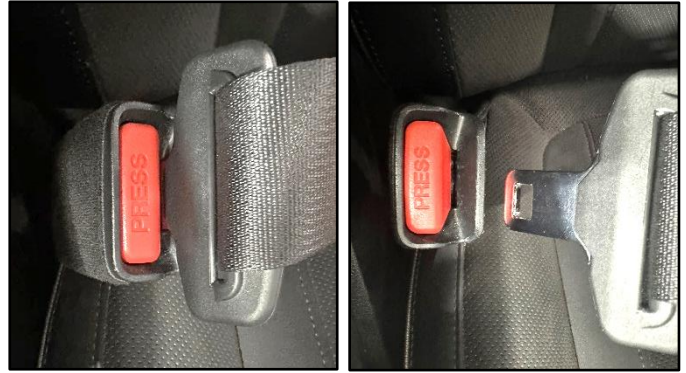
1. Inspect the seat belt buckle of concern by buckling and unbuckling it three times.

Perform the same buckling/unbuckling procedure to another seat belt buckle from the same row.

Compare the seat belt buckle of concern with the other seat belt buckle and inspect for:

- Abnormal buckle insertion
- Abnormal buckle ejection feeling
- Abnormal sound
- Potential debris that influences operation

If any of the above symptoms are found, replace the seat belt buckle(s).

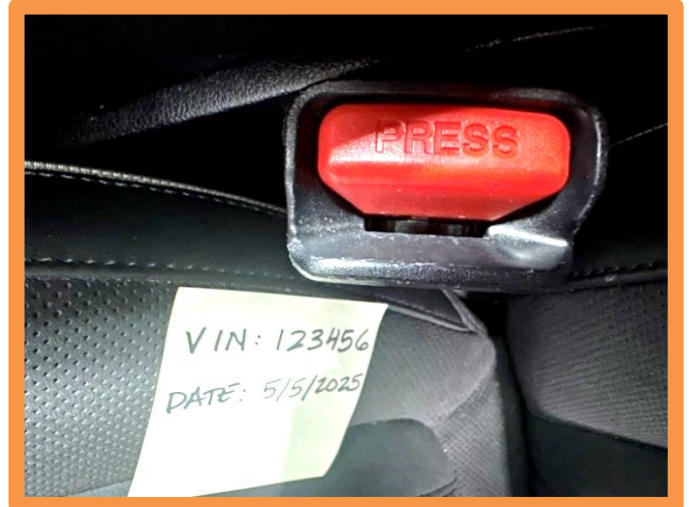
Using STUI, take a photo of the seat belt buckle cavity with the last 6 digits of the VIN and the date of repair on a piece of paper.

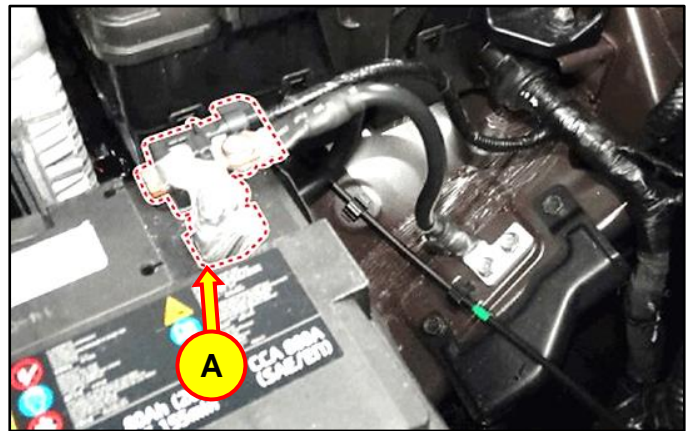
1. Disconnect the negative (-) battery terminal (A).

Tightening Torque:

| lb-ft | 6.5 |
| lb-in | 78 |
| N.m | 8.8 |

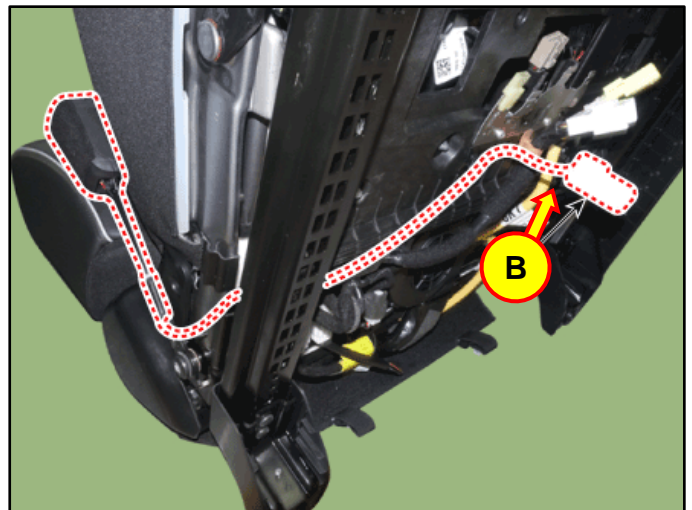
3. Disconnect the front seat belt buckle wiring (B).

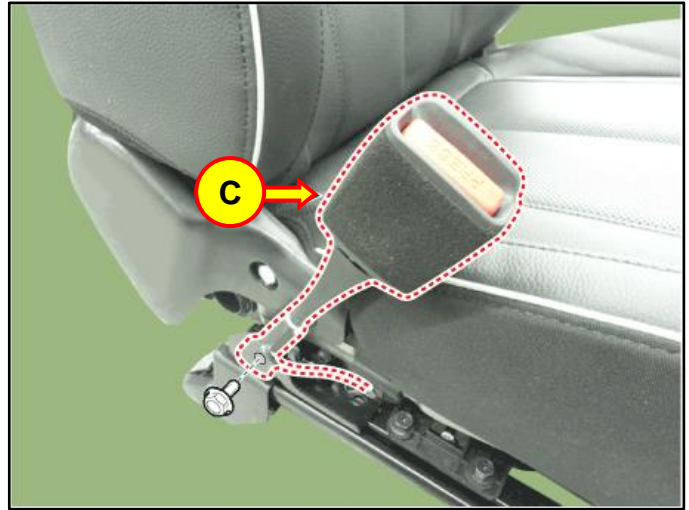
4. Loosen the mounting bolt and remove the front seat belt buckle (C).

Tightening Torque:

| lb-ft | 34 |

| N.m | 47 |

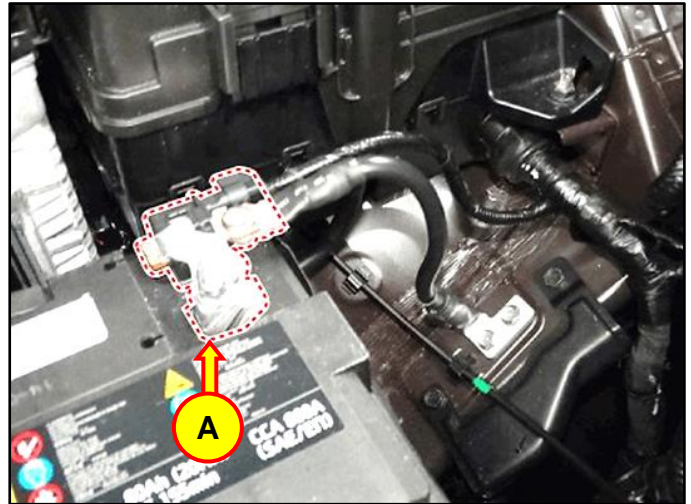
1. Disconnect the negative (-) battery terminal (A).

Tightening Torque:

| lb-ft | 6.5 |
| lb-in | 78 |
| N.m | 8.8 |

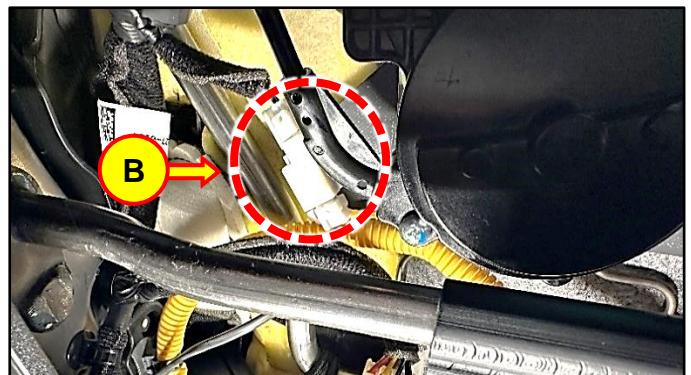
3. **Captain Chair**

Disconnect the seat belt buckle wiring (B).

The procedure for **BOTH** the left and right side captain's chair are the same.

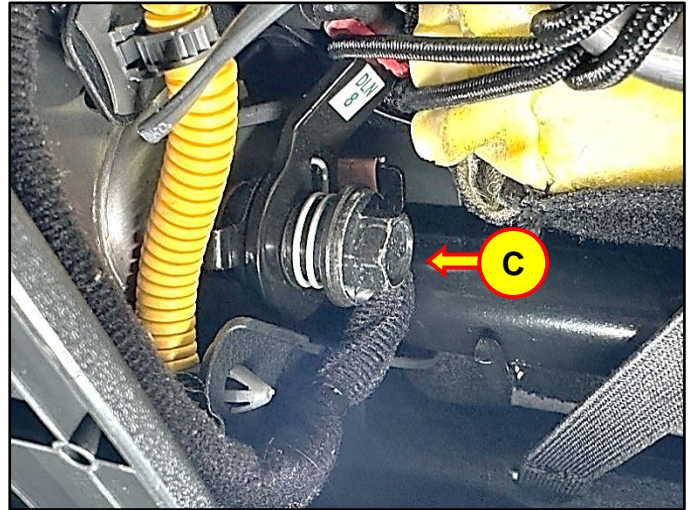
4. Remove the mounting bolt and remove the seat belt buckle (C).

Tightening Torque:

| lb-ft | 35 |
| N.m | 47 |

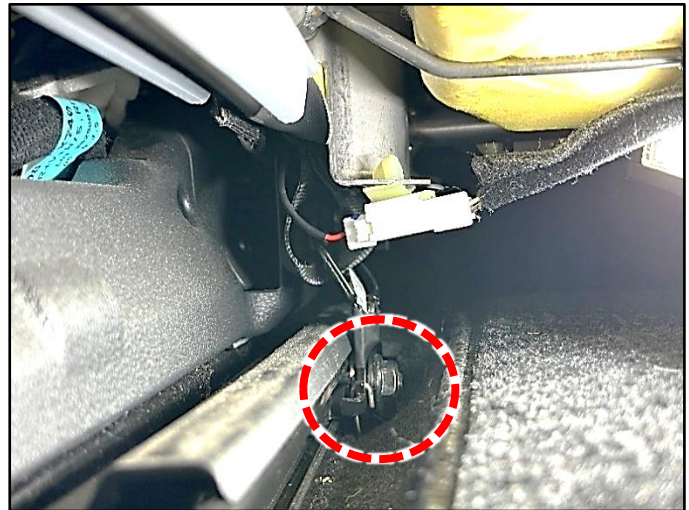
5. **Bench Chair**

The seat belt buckle for both the center and left driver side are the same. However, the right passenger side is different.

The right passenger side seat belt buckle is held in place by a **12 mm nut** instead of a **12 mm bolt**.

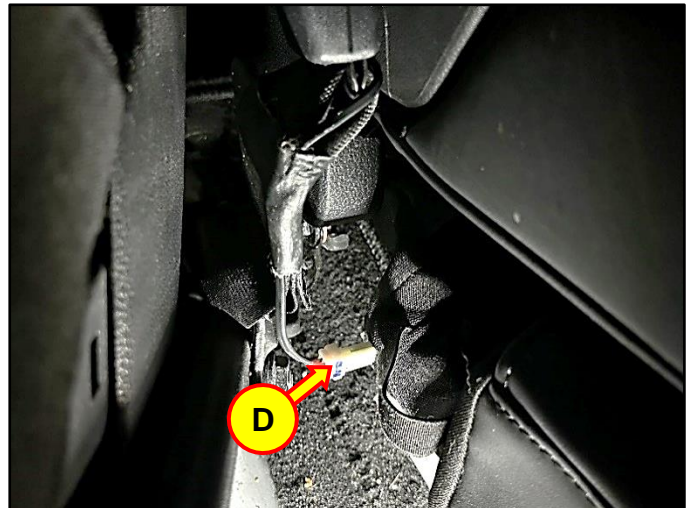
6. Lift the entire bench chair upward. Disconnect the seat belt buckle wiring (D).

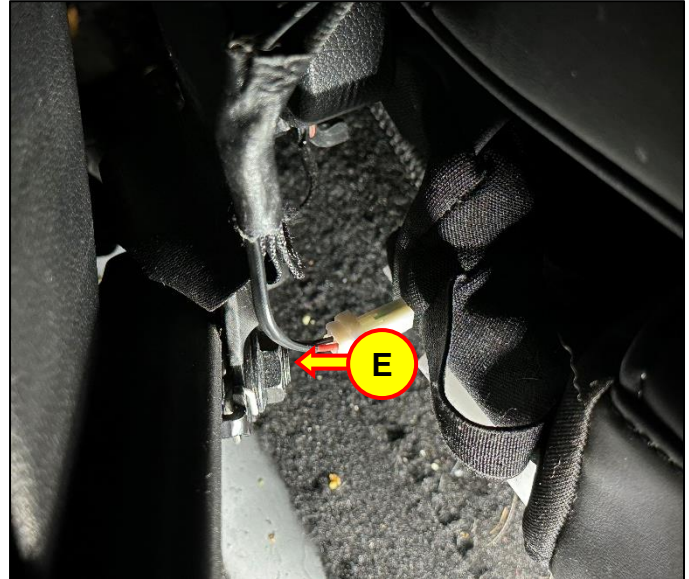
7. Remove the mounting nut and remove the seat belt buckle (E) for the second-row right passenger side.

The second-row center and left driver side seat belt buckle are held in place by a **12 mm bolt** which is the same as the captain's chair.

- **Second-Row Right Passenger Side
12 mm Nut**

| lb-ft | 35 |

| N.m | 47 |

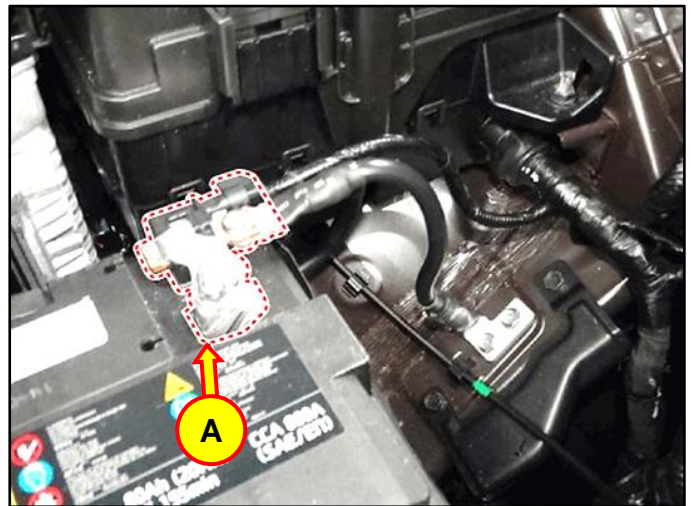
1. Disconnect the negative (-) battery terminal (A).

Tightening Torque:

| lb-ft | 6.5 |
| lb-in | 78 |
| N.m | 8.8 |

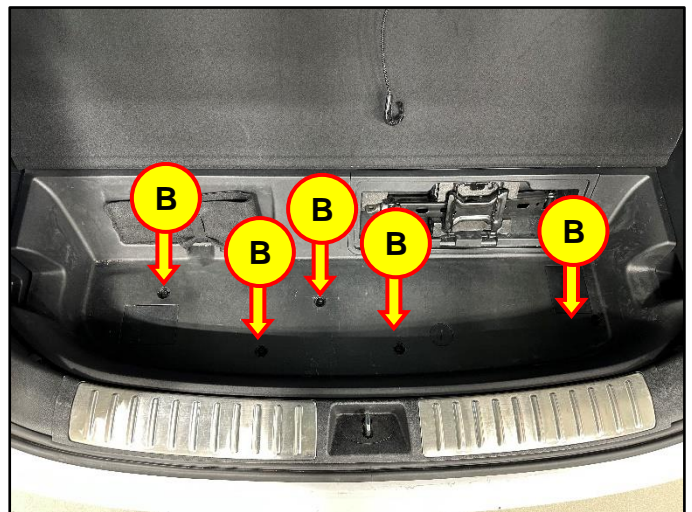
2. Remove the rear cargo tray.

Use a small flathead screwdriver to remove the round black caps to access the **10 mm bolts**. Remove the **five 10 mm bolts (B)**.

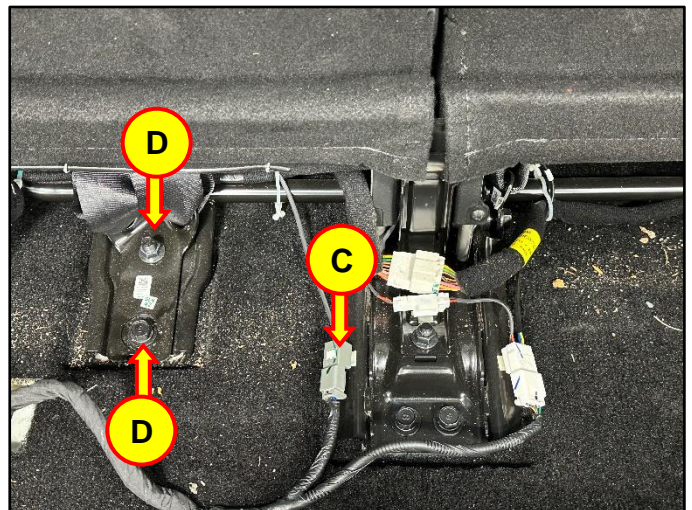
3. **Left Driver and Center Buckle:**

Disconnect the seat belt buckle wiring (C), and then loosen the mounting bolt and nut (D) to remove the seat belt buckle.

Tightening Torque:

| lb-ft | 38 |
| N.m | 52 |

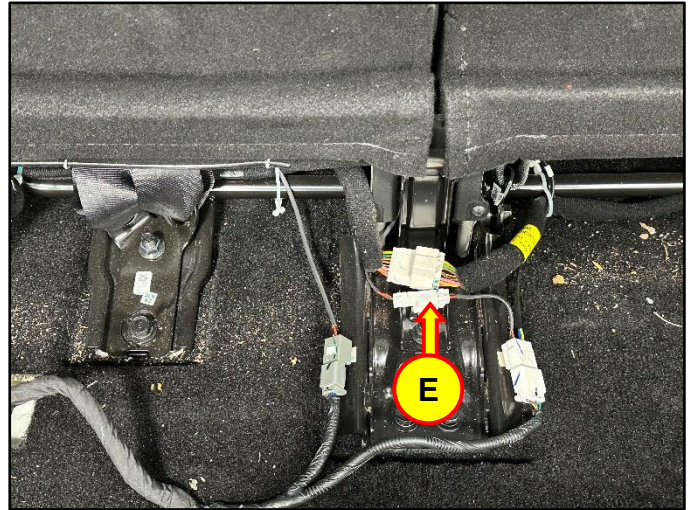
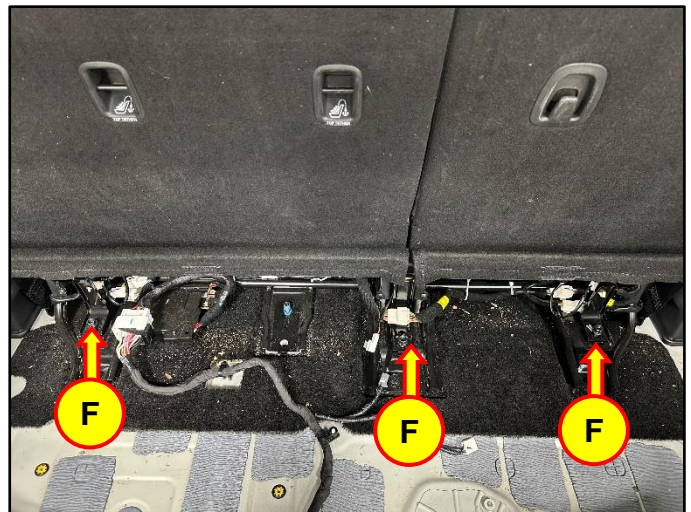
4. Right Passenger Buckle:

Disconnect the seat belt buckle wiring (E), and then loosen the seat bracket by removing the **three 12 mm nuts (F)**.

The third-row seat bracket must be loosened to access the right passenger buckle harness clip.

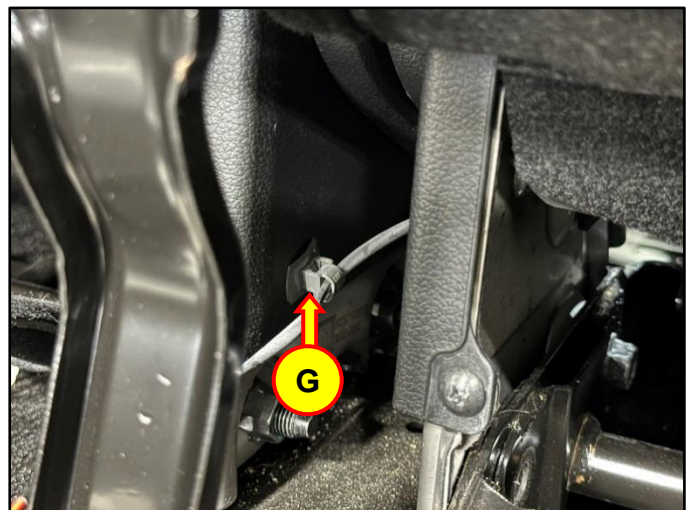
5. Remove the buckle connector clip (G).

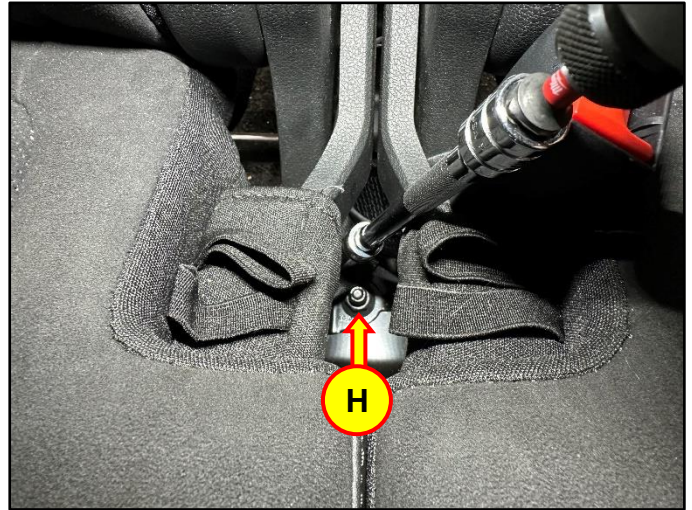
6. Remove the third-row right passenger buckle **12 mm nut** from inside the vehicle in between the seats.

Tightening Torque:

| lb-ft | 35 |
| N.m | 47 |
