Technical Service Bulletin

GROUP	NUMBER
BODY	25-BD-006G
DATE	MODEL(S)
MAY 2025	GV60 (JW1 EV)

SUBJECT: ACCESSORY CARGO MAT, UP SEATBACK REPLACEMENT

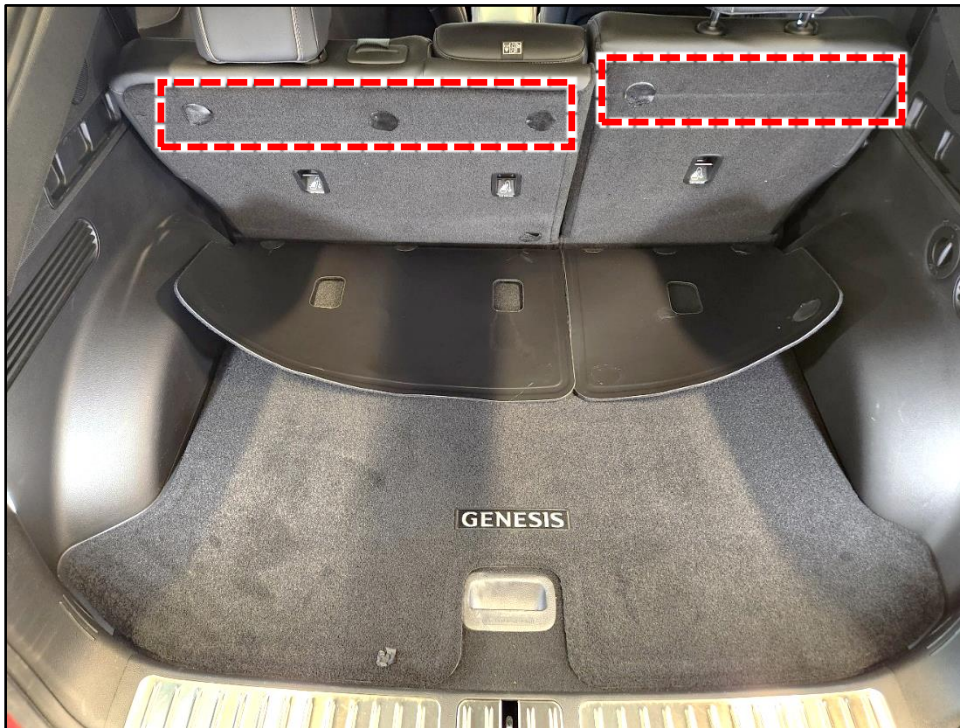
Description: Certain GV60 (JW1 EV) vehicles equipped with the accessory cargo mat, may exhibit separation from the mat's adhesive securing pads on the back of the rear seat. This bulletin provides instructions to replace the cargo mat with a new part.

Example of Cargo Mat, Up Seatback Separated at Adhesive Patches

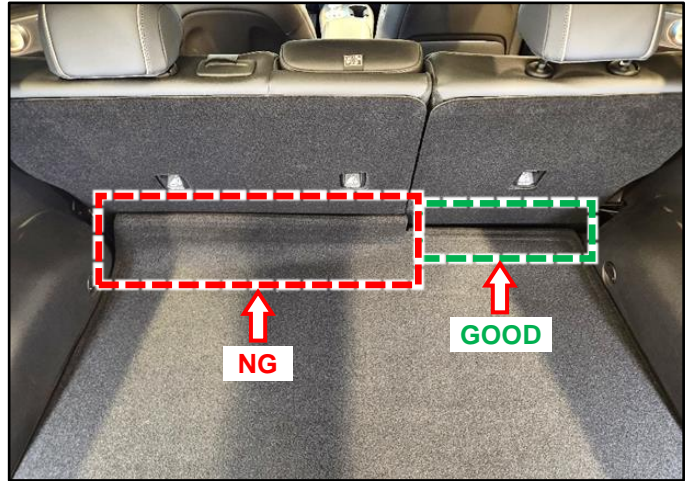
- **GOOD:** Cargo mat hinge aligned correctly.
- **NG:** Cargo mat hinge **NOT** aligned correctly.

8. Return the rear seatbacks to the upright position, ensuring the cargo mat hinge settles on the cargo floor correctly as shown in the **GOOD** example at right.
