TECHNICAL SERVICE BULLETIN

Turbocharger Wastegate Rattle Noise

25-2215

Ford 2024 F-150	Engine: 2.7L EcoBoost Built On Or Before 04-Oct-2024
---------------------------	---

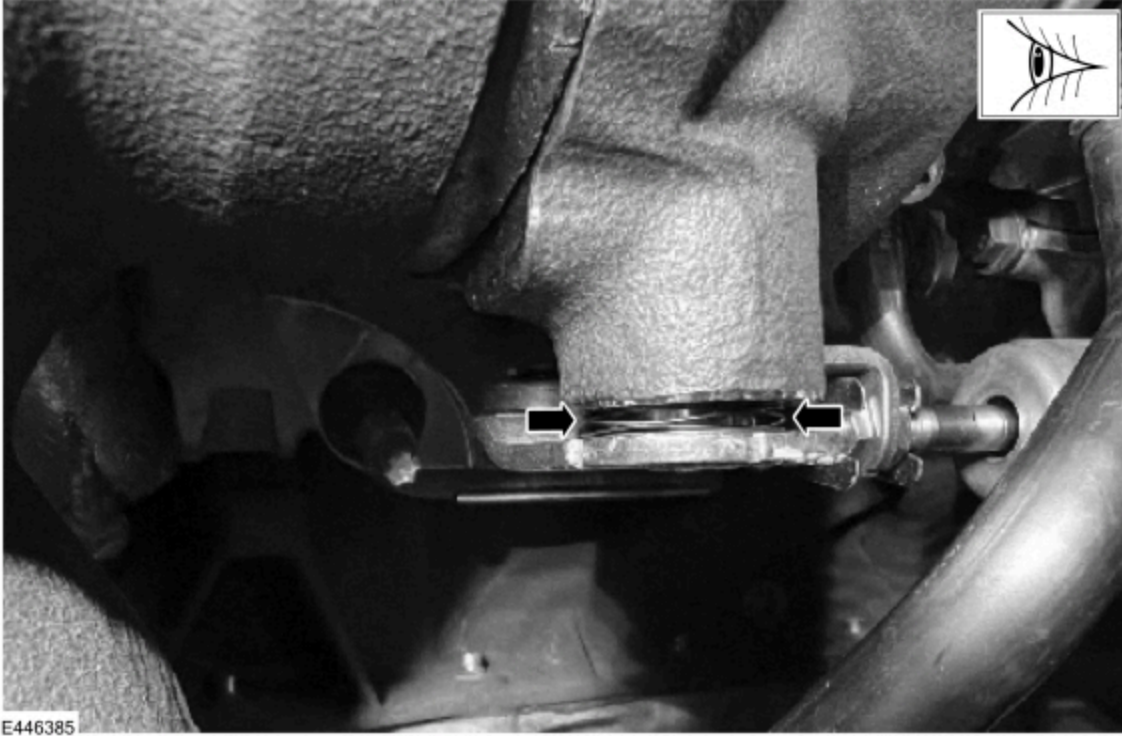
Figure 1

1. Remove both front wheels. Refer to WSM, Section 204-04A > Wheels and Tires > Removal and Installation > Wheel and Tires.
2. Remove both front inner splash shields. Refer to WSM, Section 501-02 Front End Body Panels > Removal and Installation > Fender Splash Shield.
3. Is a wave spring installed between the wastegate actuator lever arm and the turbine housing on both the left and right turbochargers? (Figure 1)

- (1). Yes - this article does not apply. Refer to WSM, Section 303-04 for normal diagnostics.
 - (2). No - proceed to Step 4 to install a wave spring on both the left and/or right turbochargers.
4. Using a paint pen, mark the position of a wastegate. (Figure 2)
