Subject: TS45 Brake Sensor Corrosion

Bulletin No: TS45-FC-2514

Vehicle Model: TS45

To prevent corrosion caused by road conditions (such as the salting of roads) on the brake sensors of TS45 vehicles, a design modification was implemented to shield the sensors from external environmental exposure.

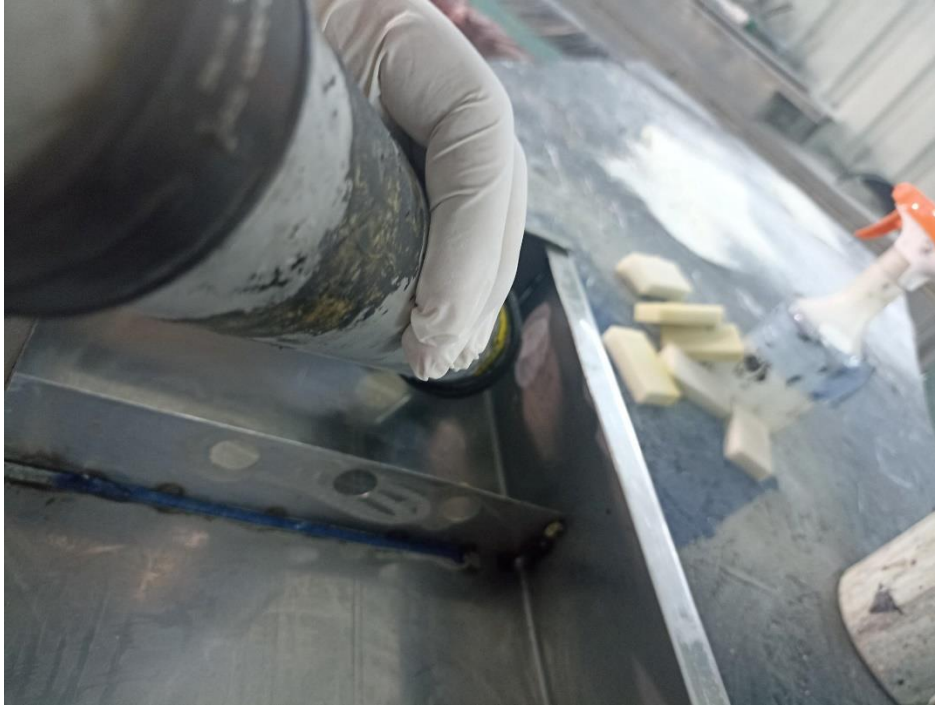
*Figure 1 – Application of Sealing Compound*

Sealing should be applied to close gaps caused by bends after the material has been produced.

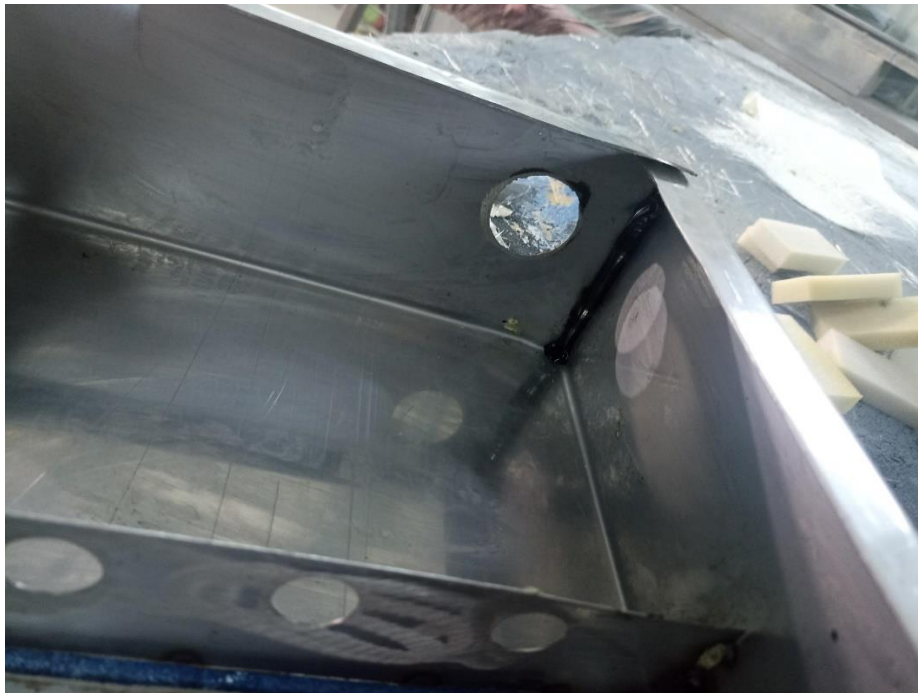
*Figure 2 – Application of Sealing Compound*

After the sealing compound process, product should be paint, color specified in the technical drawing.

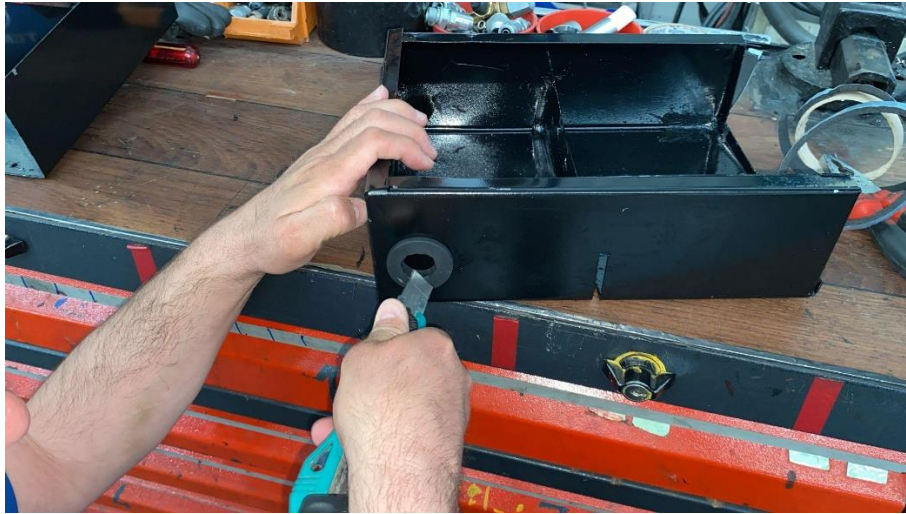
*Figure 4- Application of Grommet*

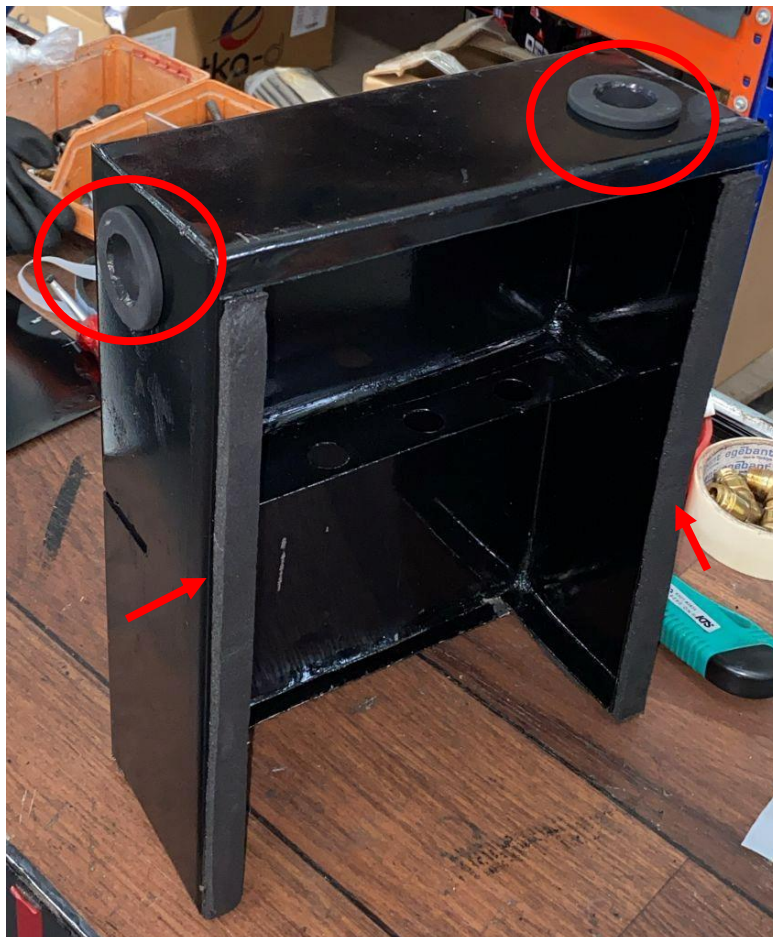
*Figure 5- Application of Grommet to Cable and Hose Holes*

Grommet must be applied to the holes indicated in the visual above, and foam edge tape must be applied to the specified surfaces.

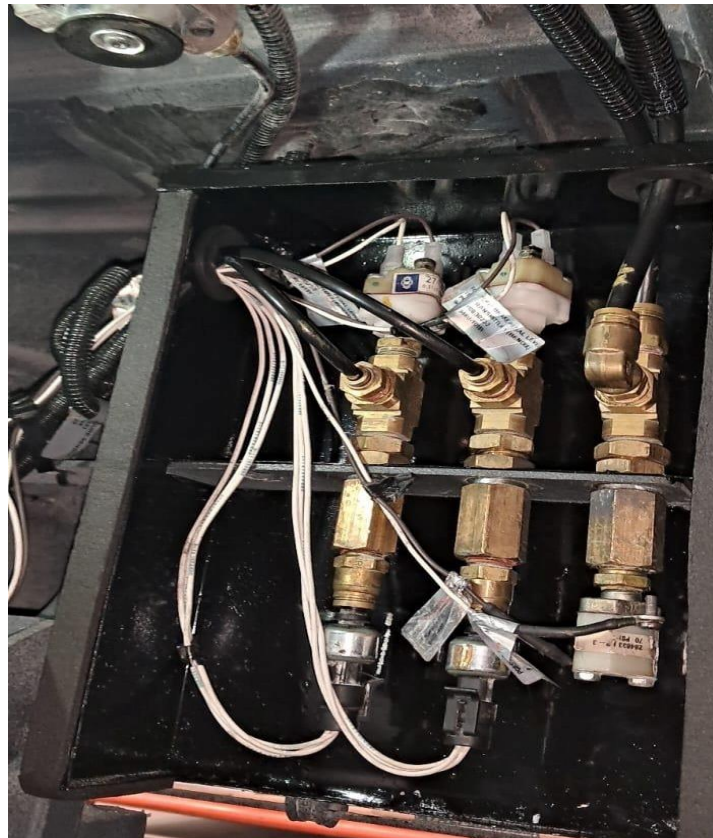
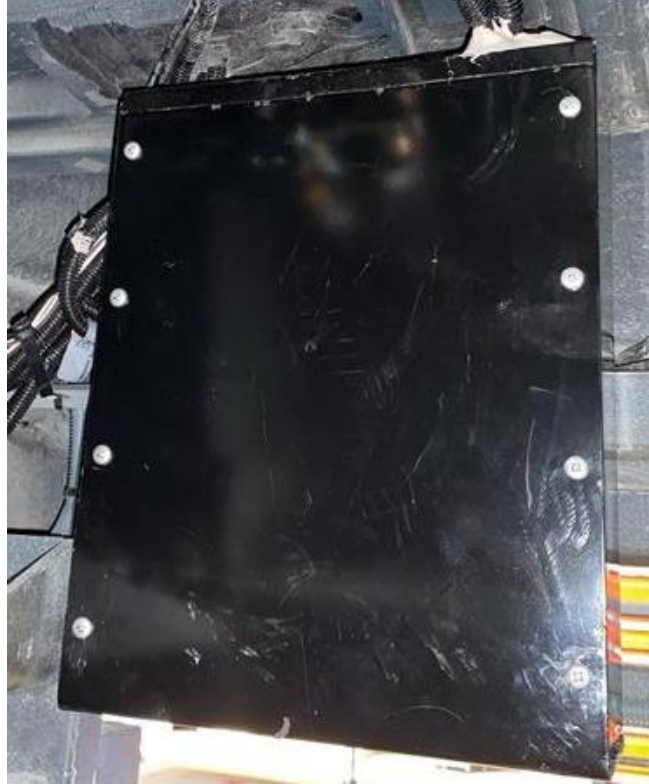
Figure 6 – Assembled View of the Part on the Vehicle

Figure 7- Assembled View of the Part on the Vehicle

Figure 8 - Assembled View of the Part on the Vehicle

Figure 9 - Assembled View of the Part on the Vehicle

*Figure 10 - Assembled View of the Part on the Vehicle*

After part number 9325-8289 is mounted onto the vehicle, CRC SP400 Corrosion Inhibitor must be applied to the brake sensors. Following this application, part number 9325-8290 must be mounted and secured using 8 screws.
