Subject: TS45 Air Tank strings replacement      Bulletin Type: FC

Bulletin No: TS45-FC-2512

Vehicle Model: TS45

Due to the freezing issue observed in the cable of the air tank drainage system in TS45 model vehicles, a revision has been implemented.

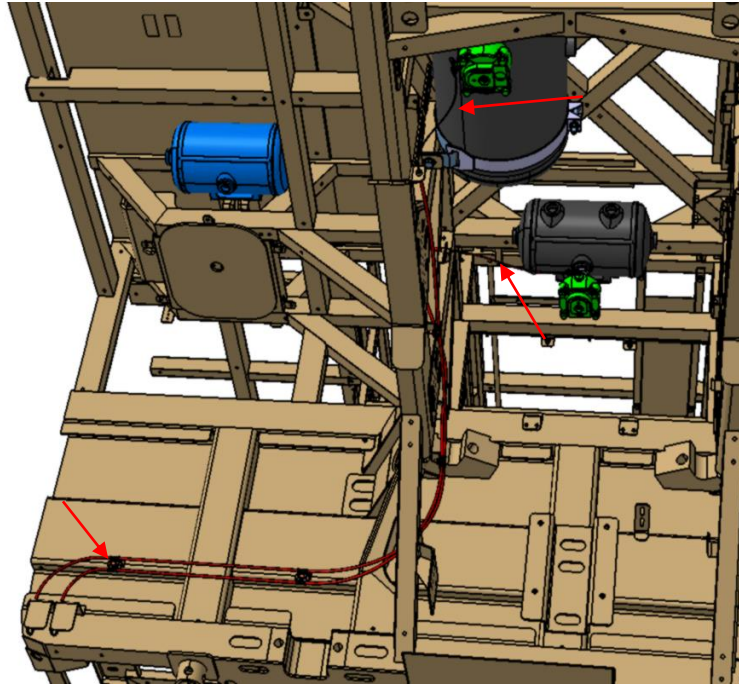
*Figure 1 - Old Rear Air Tank Drain systems must be demounted.*

The bus must first be moved to the maintenance bay to facilitate operations on the rear air tanks. Once relocated, the old systems are to be dismantled and removed from the vehicle.

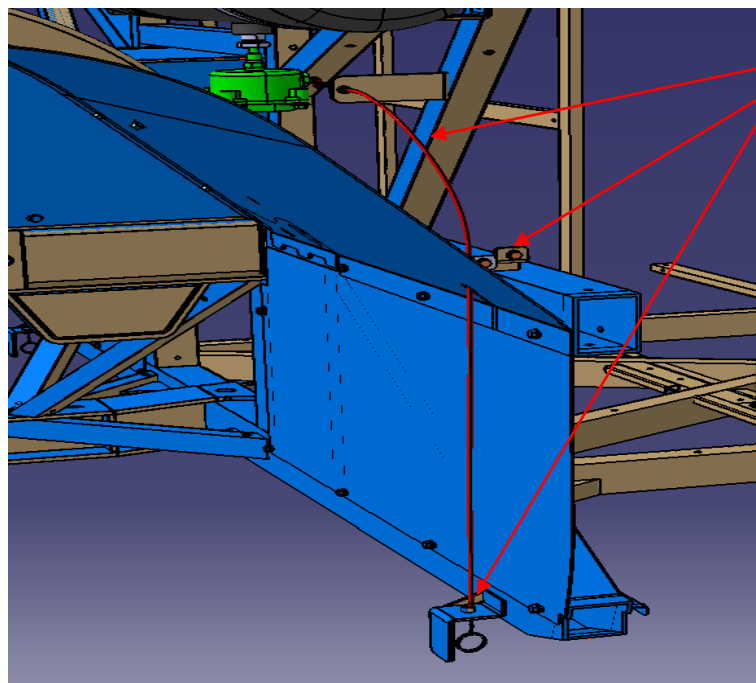
These parts must be dismantled

*Figure 2 - Front Brake Air Tank Drain System on Left Side*

The old systems were removed from the bus. It is recommended to cut and remove the brackets located at the bottom. To facilitate the process, the steering system should be turned to the right while cutting and removing the bracket positioned on the lower left side.

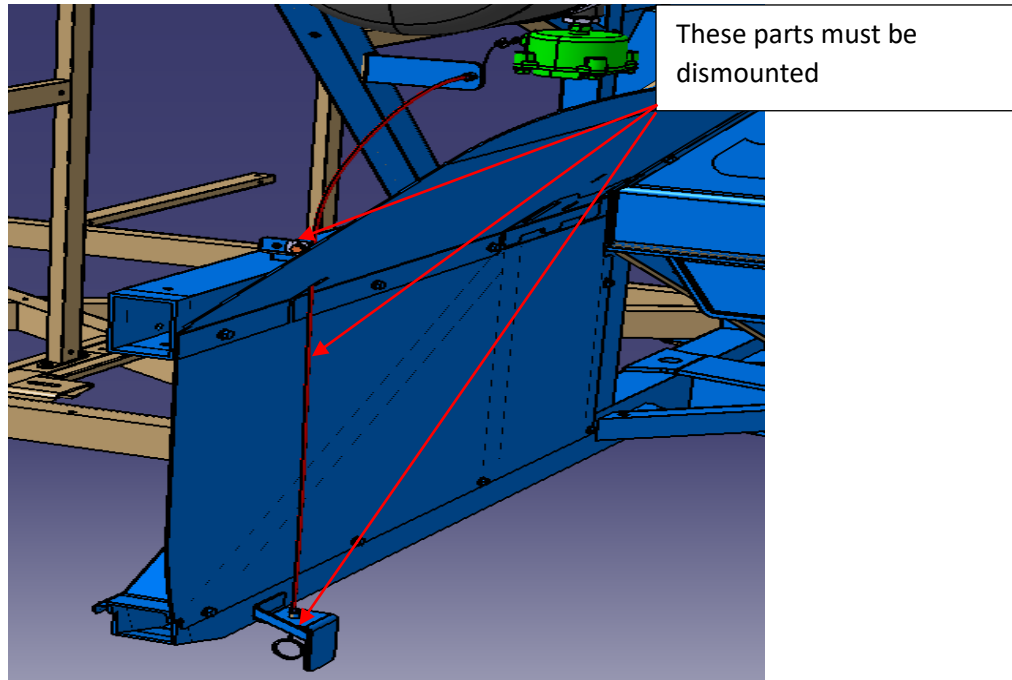
*Figure 3 - Front Brake Air Tank Drain System on Right Side*

The old systems were removed from the bus. It is recommended to cut and remove the brackets located at the bottom. To facilitate the process, the steering system should be turned to the left while cutting and removing the bracket positioned on the lower right side.

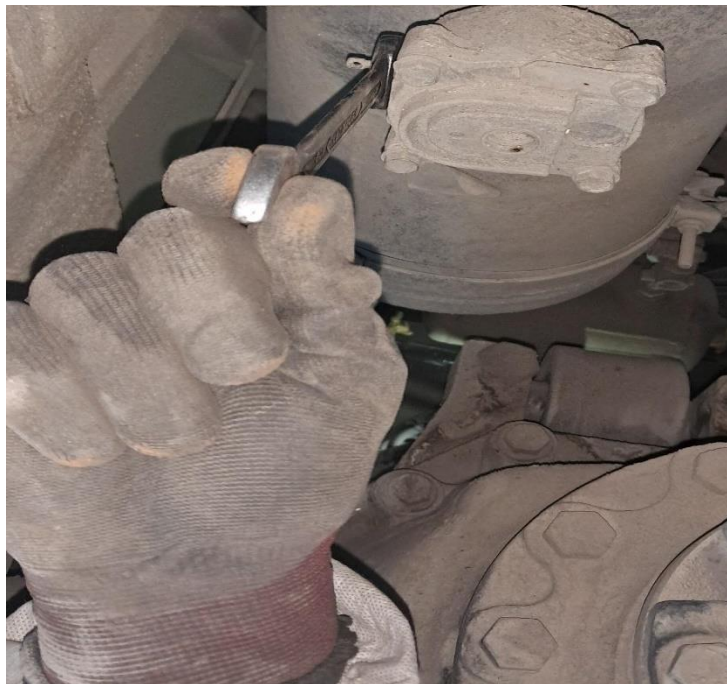
*Figure 4- Drain Plugs on the Rear Side must be dismantled with suitable wrench.*

The drain plugs on the Brake and Distributor air tanks should be removed using an appropriate wrench. Prior to this process, the air in the tanks must be fully released.

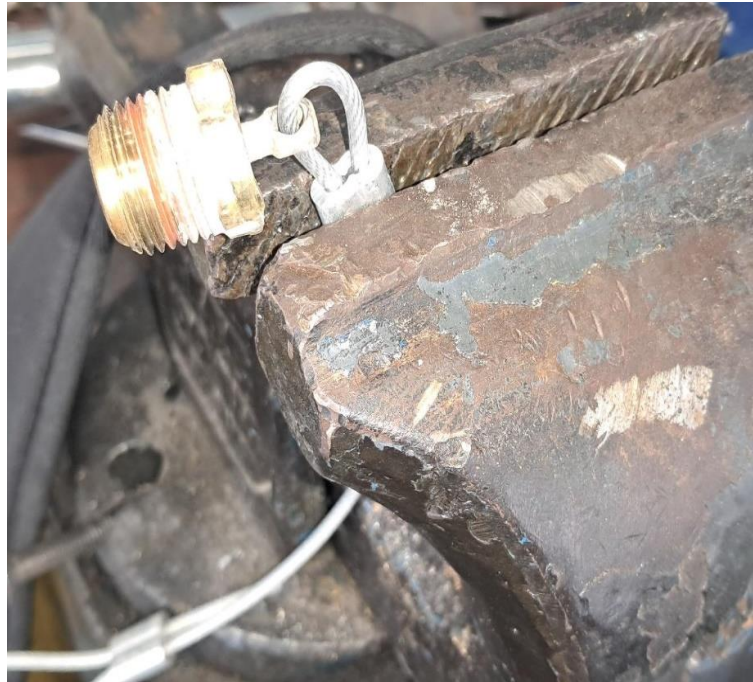
*Figure 5- String assembly to the Drain Plug.*

The strings should be cut to lengths of 20 cm for the Brake Air Tank and 35 cm for the Distributor Air Tank. They must then be formed into rings, attached to the nut, and secured with an aluminum clamp.

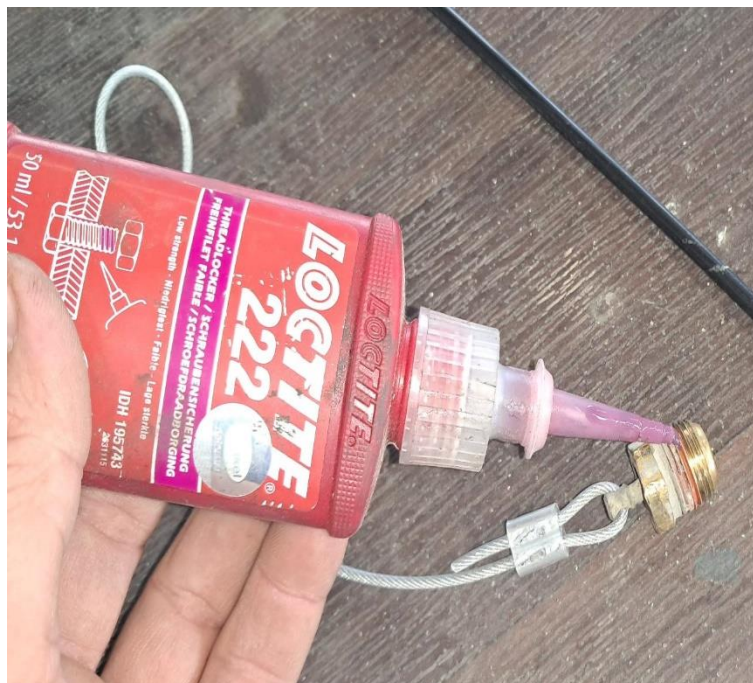
*Figure 6 – Before Drain Plugs mounted, must apply Loctite 222*

Following this process, drain nuts must be reinstalled and secured using Loctite 222.

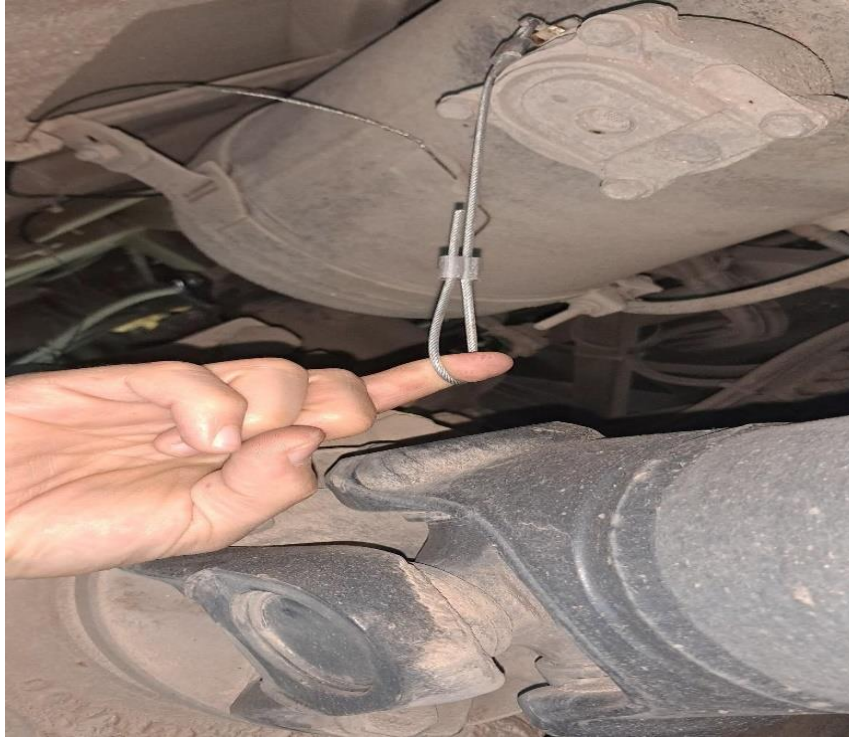
*Figure 7- Brake Air Tank's string assembly. Attention! The string must not contact the shaft*

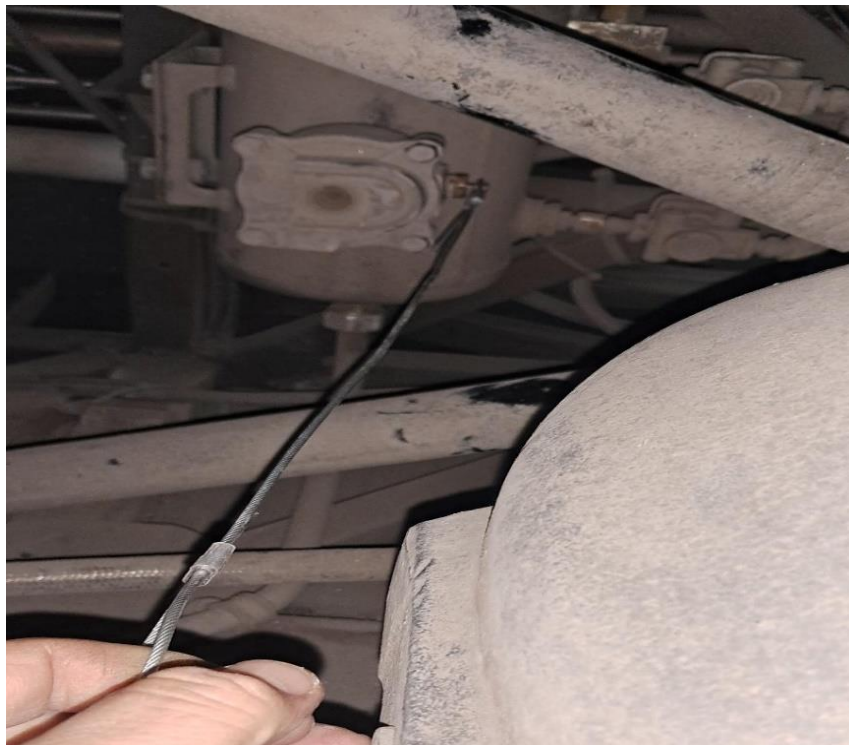
*Figure 8- Distributor Air Tank's string assembly.*

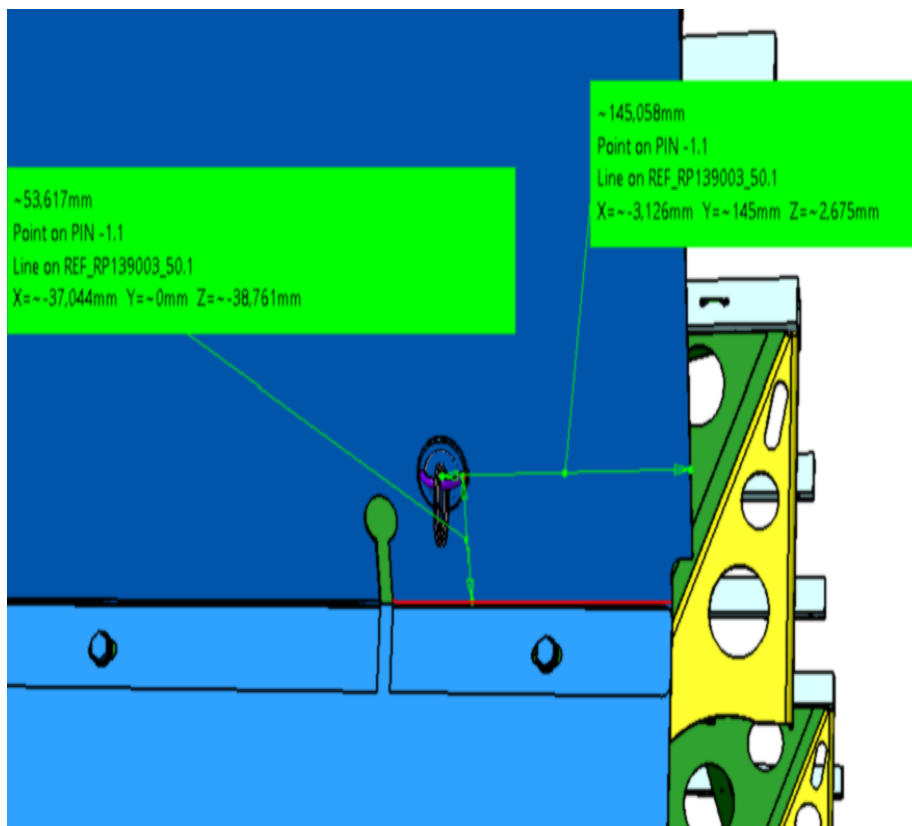
*Figure 9 – Left Side Hole Dimensions for Pin in New System*

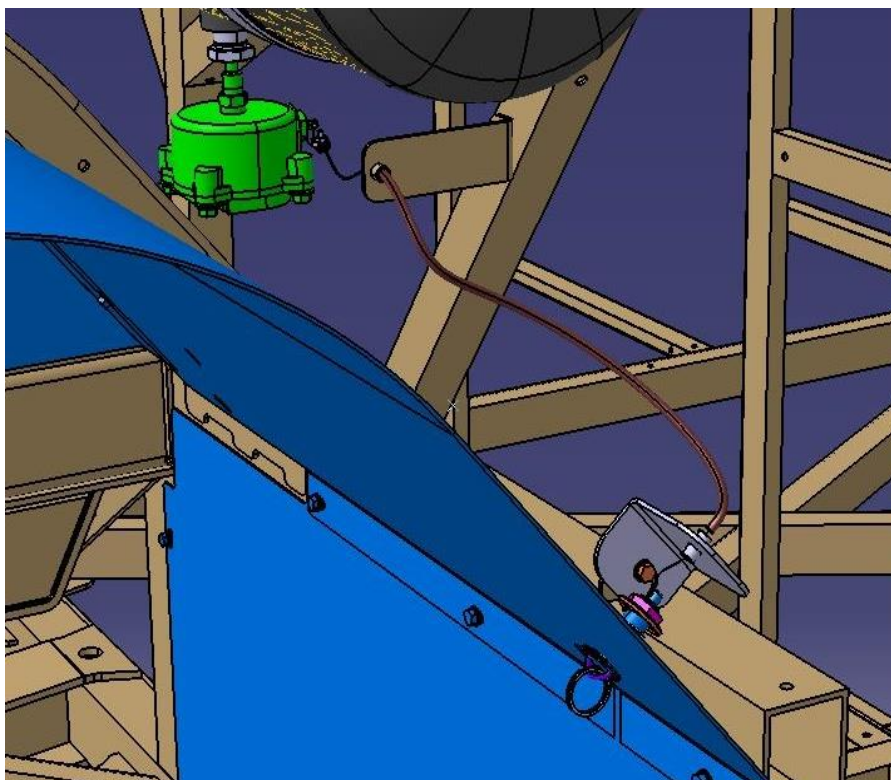
*Figure 10- Front Brake Air Tank Drain New System on Left Side*

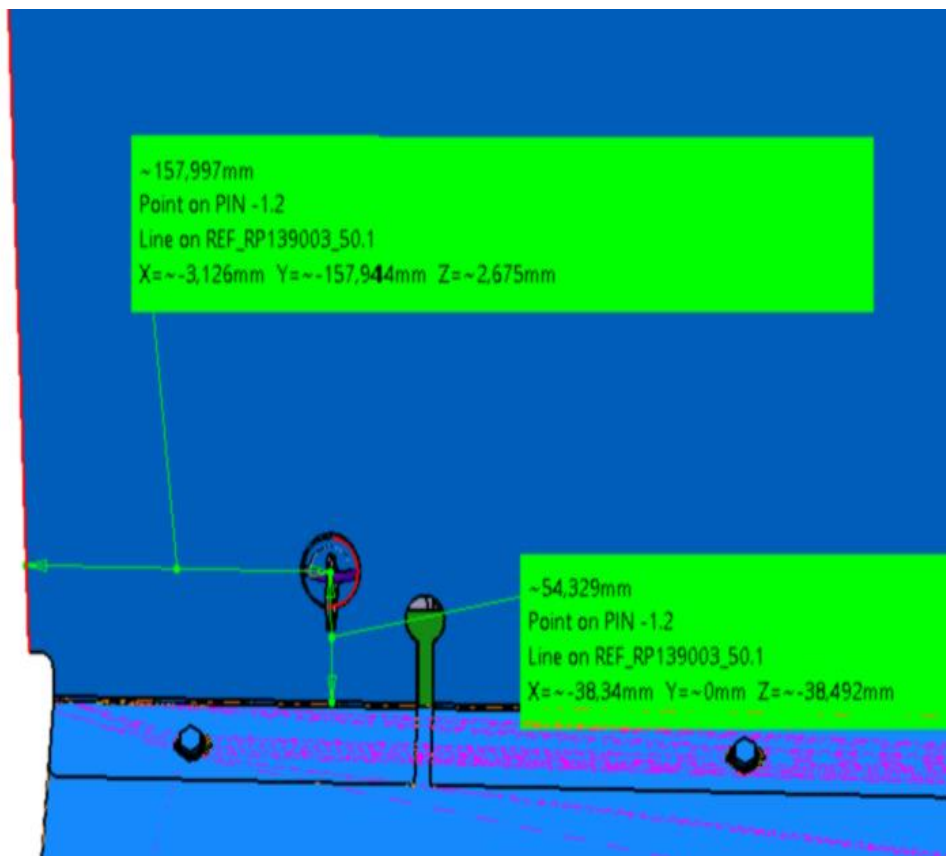
Figure 11 - Right Side Hole Dimensions for Pin in New System

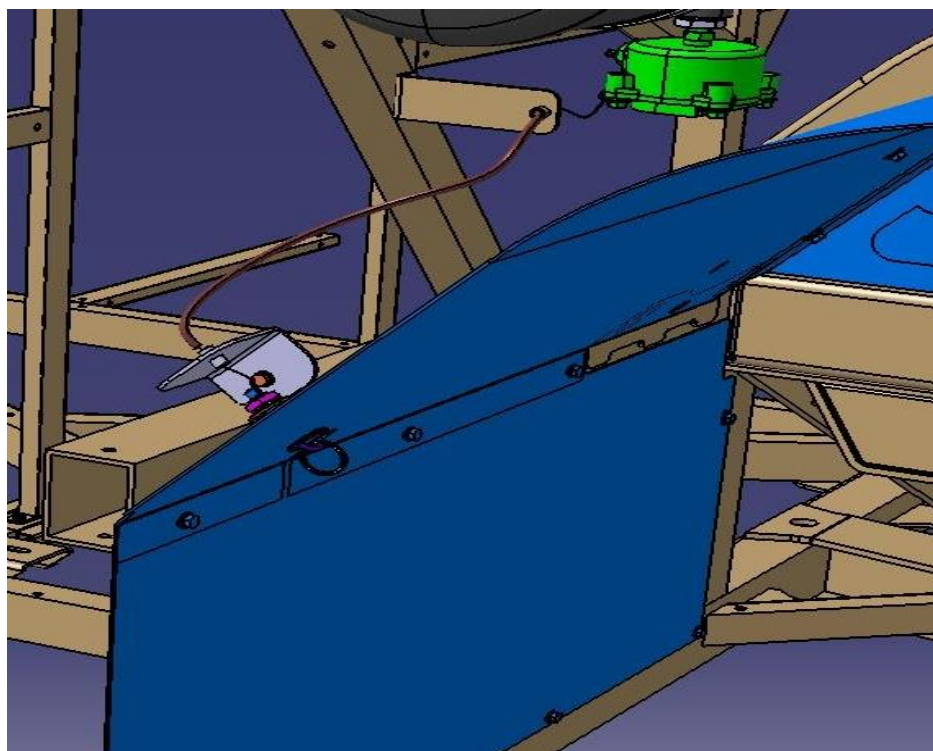
Figure 12- Front Brake Air Tank Drain New System on Right Side

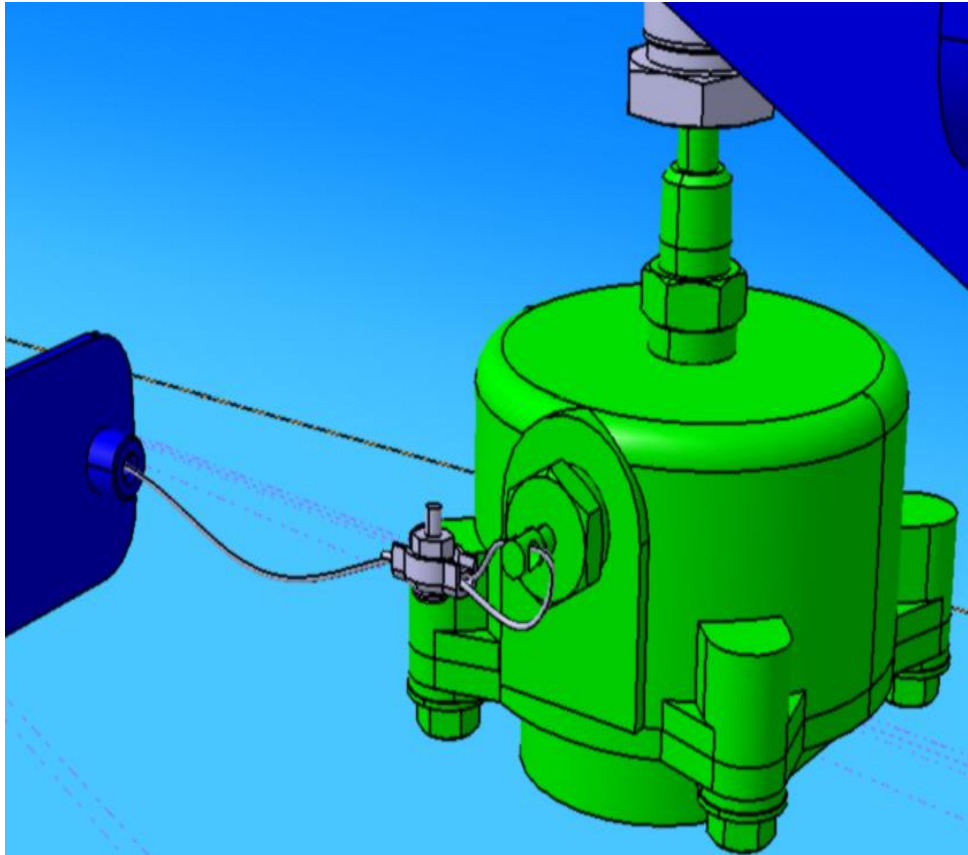
*Figure 13 – String Connection to Air Tank Detail on New System in Front Side*

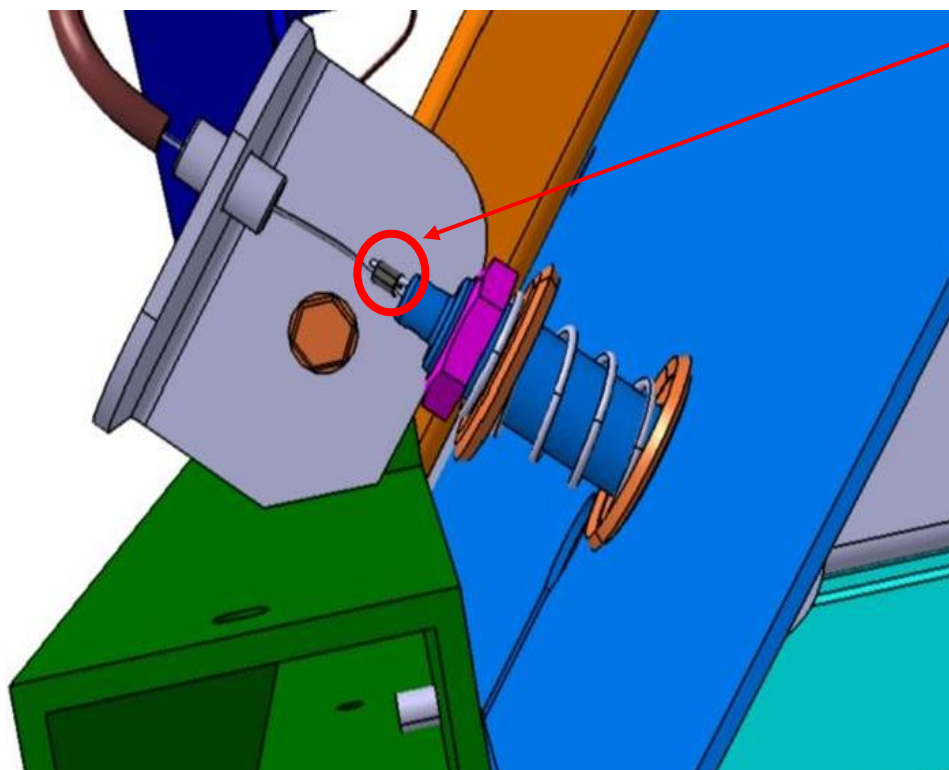
*Figure 14 – String Connection to Pin Detail on New System in Front Side*

This copper clamp must be tighten after the string is adjustment
