SIB 01 08 25

LWR ACTIVE AIR FLAP ASSY VEH-SPECIFIC CUSTOMER SATISFACTION INITIATIVE 15/150

Front Lower Active Air Flap Assembly Vehicle-Specific Customer Satisfaction Initiative 15/150

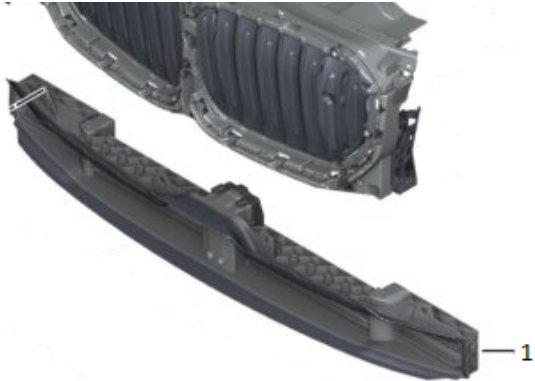
After carrying out the vehicle test, one or more of the stored faults indicate that the operation of the front bottom active air flap is obstructed or blocked.

Thoroughly inspect the front bottom air flap, when applicable, remove any contamination that is found caught in and between the bottom air flaps (aka “blinds”) and/or the housing.

<p>For the eligible listed vehicles that qualify, and for the issue described in the photo (item # 1 shown):</p> <p>With the release of this Service Information Bulletin under this Customer Satisfaction Initiative, only for applicable repairs going forward on the models listed above, BMW of North America, LLC (BMW NA) will cover for the first 15 Years / 150,000-miles, from the vehicle's original first in-service / delivery date.</p> <ul style="list-style-type: none"> When the Procedure outlined below is used to identify and remove contamination that is found obstructing or blocking normal operation of the front lower/bottom active air flap assembly
--	--

1. When contamination is found to be the reason why the bottom active air flap (blind) operation is restricted, provide a photo document what is found in the WarrantyAPP, and carefully remove the contamination (Removal of the front bumper cover is not necessary).
2. Delete the fault memory, carry out the test module’s functional check again to verify the repair, or if physically damaged** Front Active Flaps and/or Assembly are found during “Step 3,” this Service Information Bulletin no longer applies.
