Title:	Inspection and Protection of PACCAR Engine Harness

Number:	SB_743	Release Date:	5/27/2025	
Revision Number:	Not Applicable	Revision Date:	Not Applicable	
Chassis Type:	Custom Chassis with PACCAR Engines			
Component Description:	PACCAR Engine Harness

SERVICE BULLETIN #743

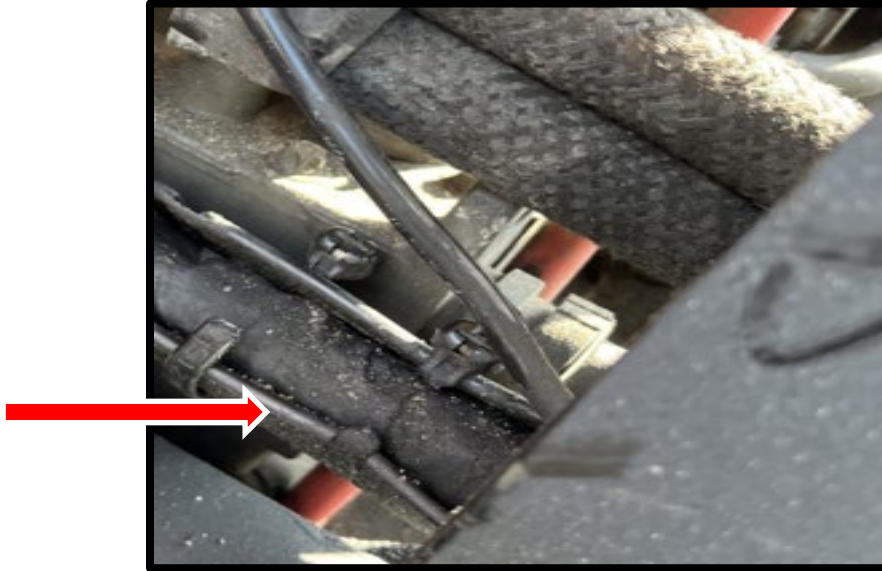
Wire harness is within a PVC hose guard to prevent abrasions and rubbing through the wire harness.

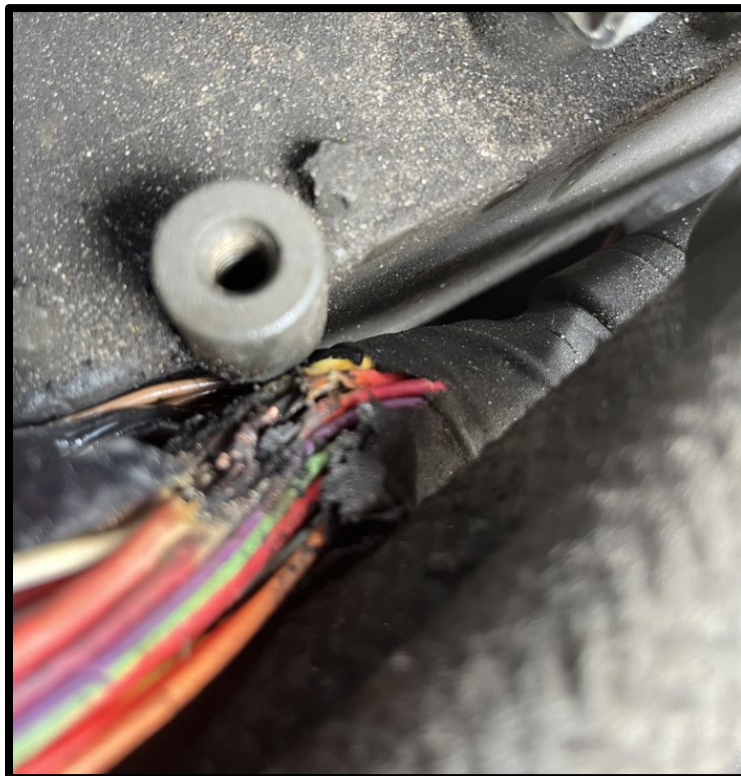
Wire harness was not protected by plastic protective sheath. Exposed wires can lead to electrical shorts, fault codes, and placing the vehicle out-of-service.

- Ensure all engine harnesses are either encased in a durable protective loom or shielded using a PVC hose guard wherever they are routed near potentially abrasive or sharp surfaces.
- Reposition or secure the harness using proper clamps or fasteners to prevent contact with brackets, mounts, or frame edges.
- If signs of wear, rub-through, or exposed wire are found, replace or repair the affected section immediately using OEM-approved materials.

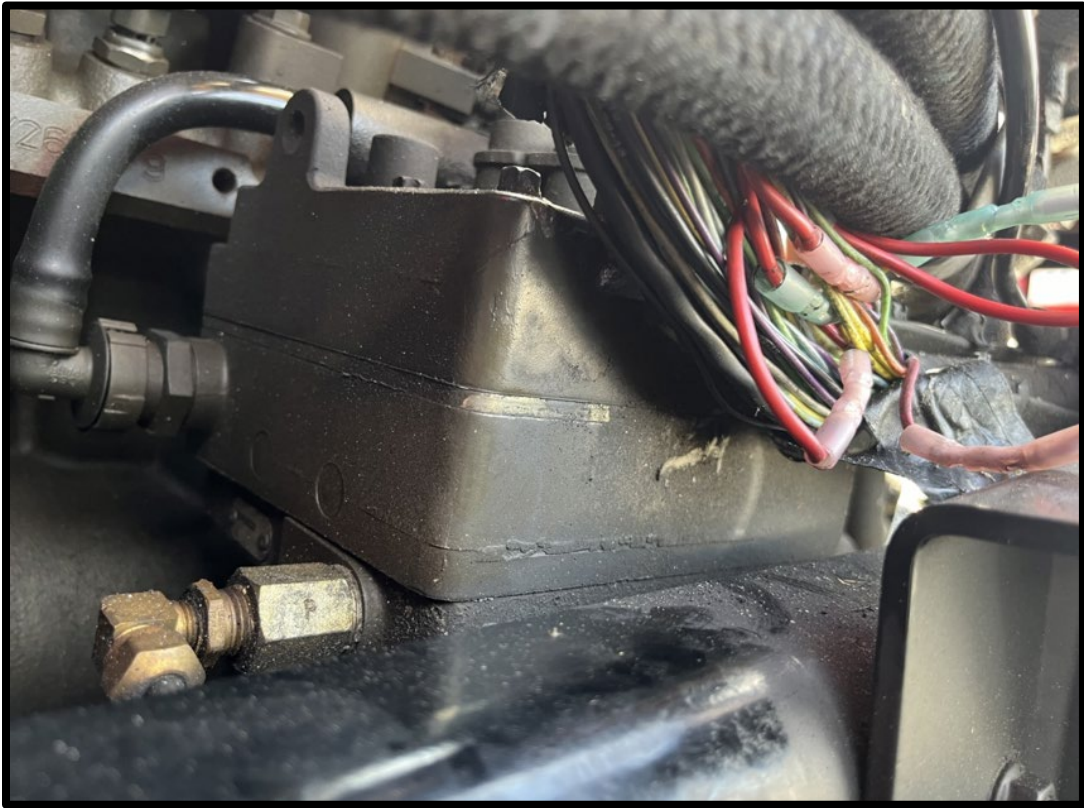
Exposed wiring is inviting to moisture and corrosive elements.

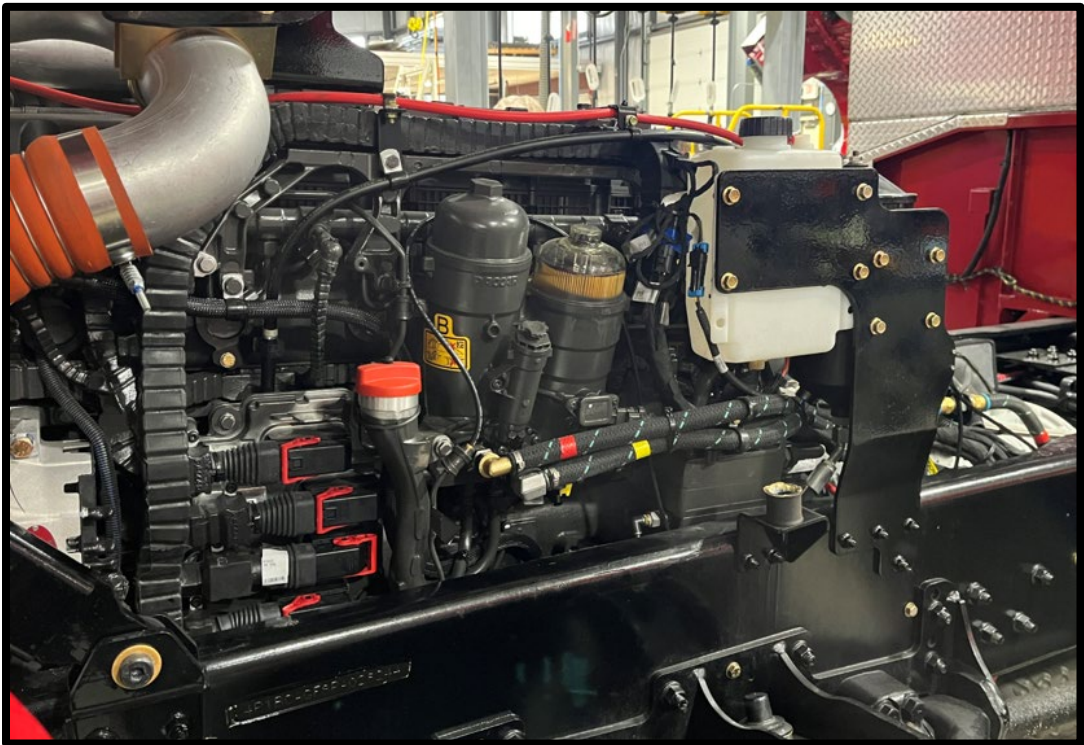
Clean and well-routed wire harnesses last longer and with greater efficacy than ill-routed wire harnesses.
