SERVICE BULLETIN

APPLICABILITY: 2020-24MY Legacy & Outback

NUMBER: 12-266-25

SUBJECT: Washer Tank Design Change

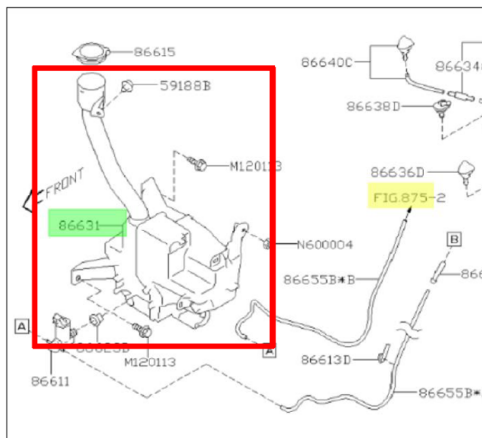
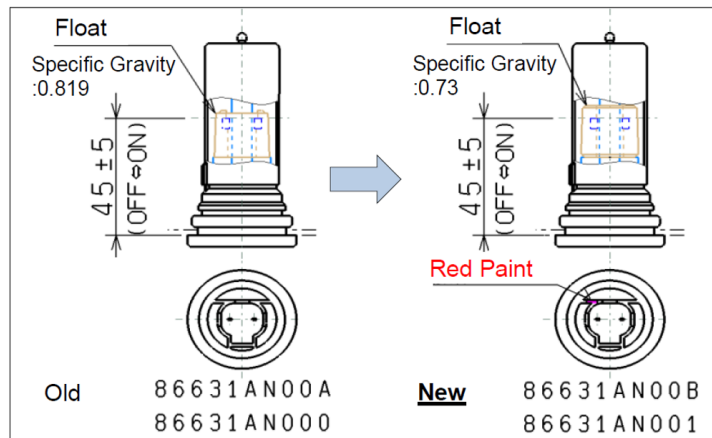
This bulletin announces the design change made to the Washer Tank. The updated washer tank now features an enhanced level sensor. Previously, the low washer fluid warning light on the instrument cluster would occasionally illuminate despite the fluid level being adequate. The new level sensor's float is designed to resist fluid immersion resulting in more accurate readings.

Part Description	Part Number
Tank-Washer Front	86631AN00B
