SERVICE BULLETIN

APPLICABILITY: 2019-24MY Ascent **NUMBER:** 06-92-24R

SUBJECT: Front Brake Pulsation/Squeal Diagnosis & Repair Front Brake Warranty Extension **DATE:** 07/31/24

REVISED: 05/19/25

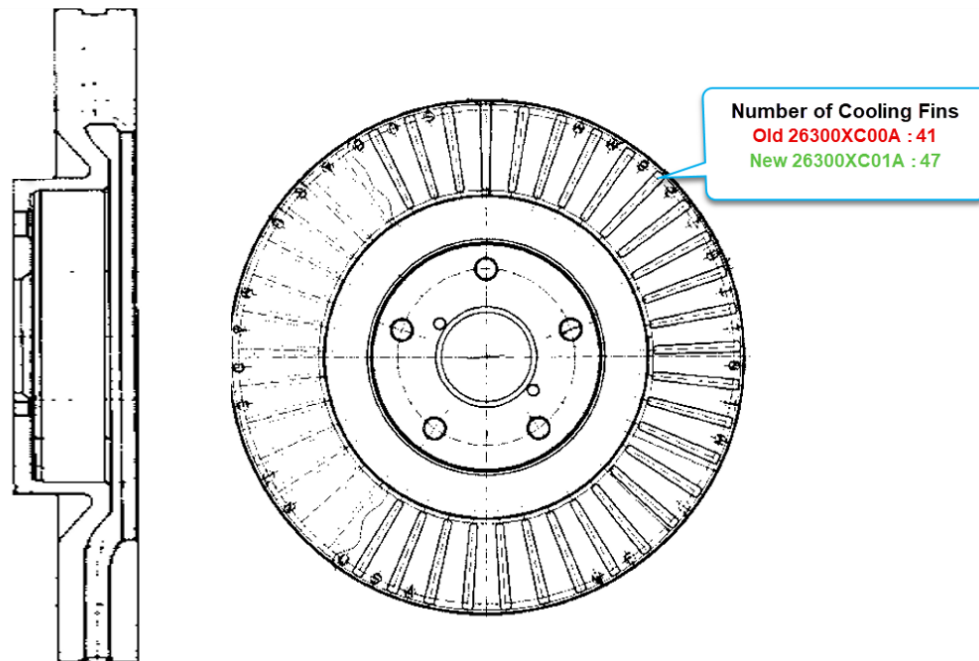
STEP 2: Raise the vehicle using the lift manufacturer's specified procedures. Remove both front wheels. Inspect the brake disc part numbers to confirm the brake disc version currently installed on the vehicle. See the images below for part number location.

NOTE: The new parts have 47 cooling fins, and the old parts have 41 cooling fins.

YES: Resurface the brake discs using a Subaru approved brake lathe. Perform a road test and confirm there is no front brake squeal/pulsation. Record and note the before and after brake thickness. **IMPORTANT: ALWAYS** use an approved brake lathe. A list of approved equipment can be found on the Subaru tools and equipment site: <https://subaruretailersolutions.com/equipment/category/601>

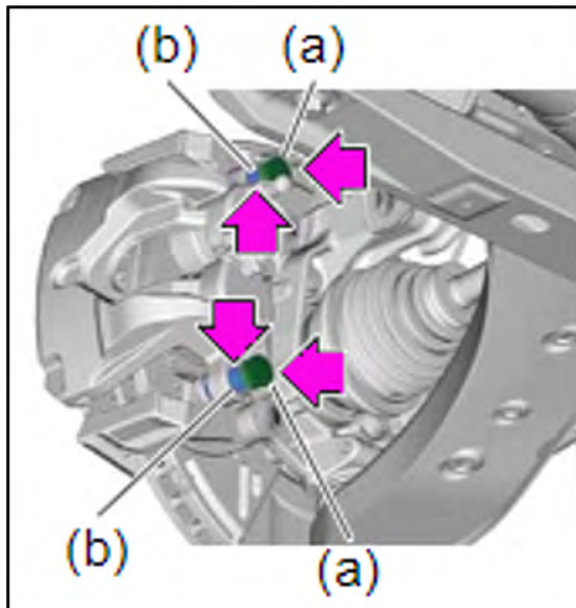
STEP 4: Remove both dust caps (a). Using an 11 mm allen key, remove both guide pins (b). The caliper body can then be removed.

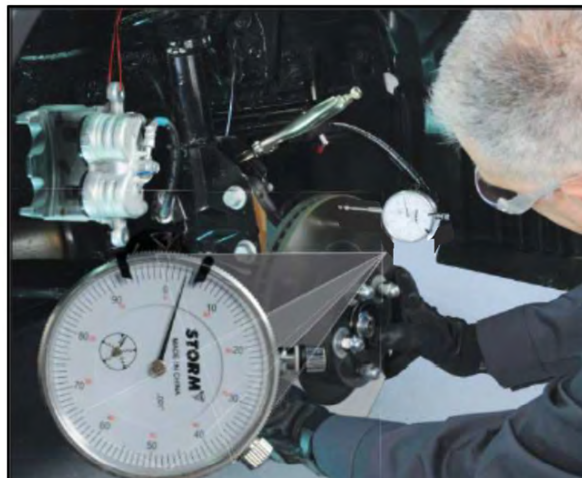
STEP 8: Install the new brake disc. Secure the disc to the hub using the five lug nuts in conjunction with matching suitable washers. Torque the lug nuts in a star pattern to **120 Nm (88.5ft-lb)**. Using a dial gauge, inspect the outer brake disc runout. Confirm the observed measurement does not exceed 0.05 mm (0.002 inch). If the measurement exceeds the specified value, remove the brake disc from the hub. Using the wheel studs as a guide, rotate the disc clockwise one wheel stud position and reinstall the brake disc. Inspect the runout using the procedures described above. The brake disc position can be rotated up to 4 more times to confirm the position with the least amount of runout. Install the brake disc at this position. In rare cases of the measurement not reading within specification after the five position inspection, exchange the brake disc with the other side of the vehicle and repeat the measurement. If the measurement continues to produce results out of specifications, replace the brake disc. Record and note all measurements.

IMPORTANT: For best accuracy, the runout measurement should be taken 10mm from the outer circumference of the brake disc. See the example image below.
