Technical Service Bulletin

| Topic | 66 Front radiator grille incorrect and front license plate holder missing from vehicle |
| Transaction No. | 2078020/1 |

Q5

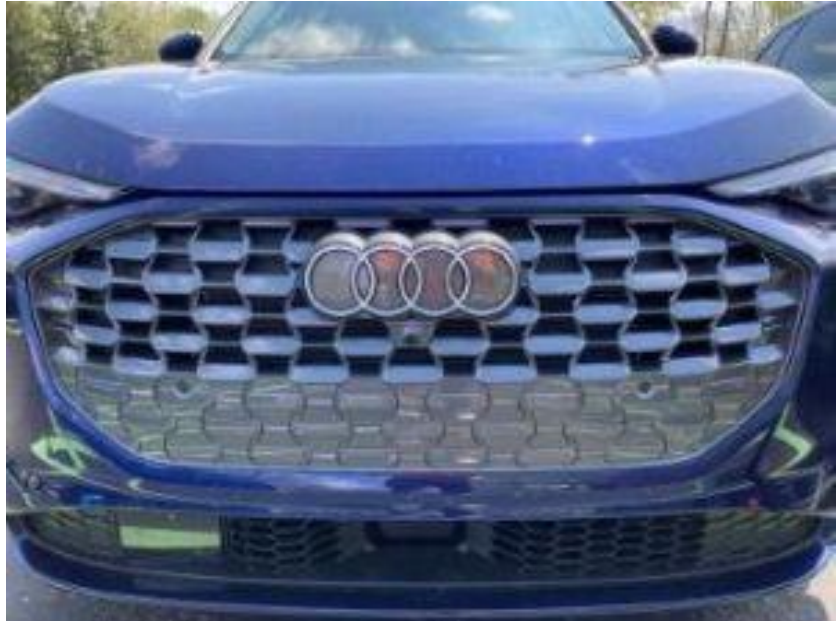
The front license plate bracket is missing from the vehicle. It is not present in the bei-pack, trunk area or in any other area of the vehicle.

Figure 1. Incorrect grille on the Q5 with Advanced Line trim.

1. To avoid having to replace the front grille a new front license plate bracket and 4 screws will need to be ordered and installed. The front license plate bracket will need to be modified in order to be mounted to the grille.

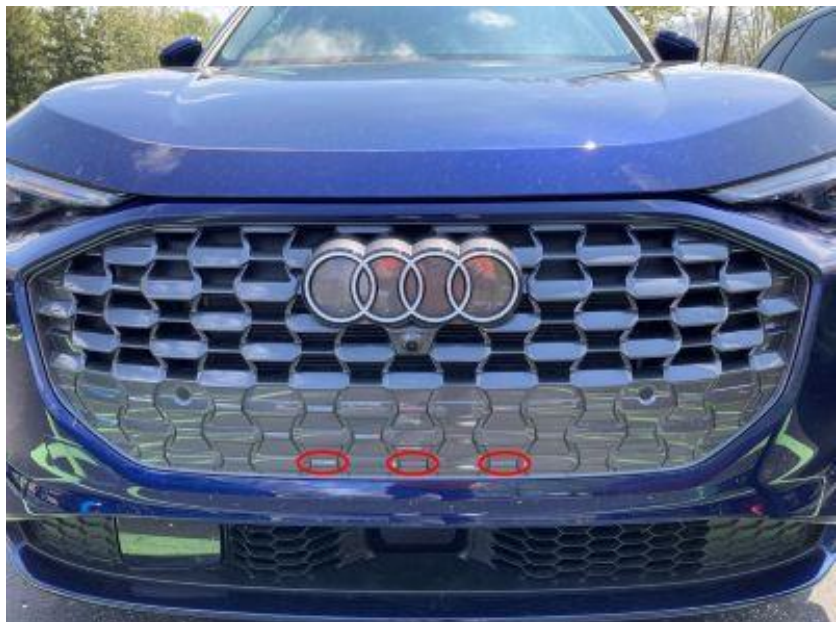
The missing front license plate bracket is confirmed. Furthermore, the rectangular openings in the lower portion of the front radiator grille intended to receive the lower tabs of the license plate bracket are also not present.

Figure 2. Normal location of grille openings. Openings missing.

Due to a production error an incorrect front radiator grille was installed on the vehicle. This error also led to the omission of the front license plate bracket.

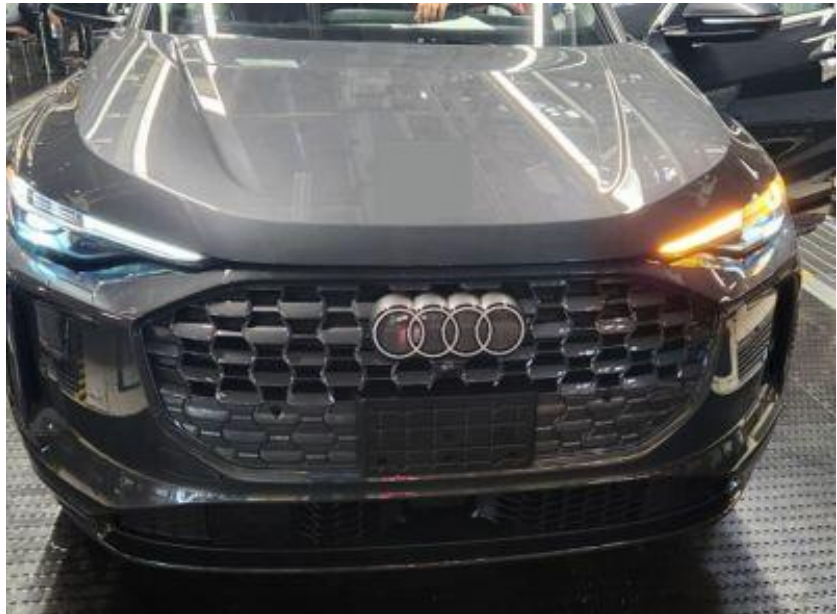
This error has been corrected in production where the front license plate bracket can be simply clipped to the radiator grille.

Figure 3. Correct vehicle configuration.

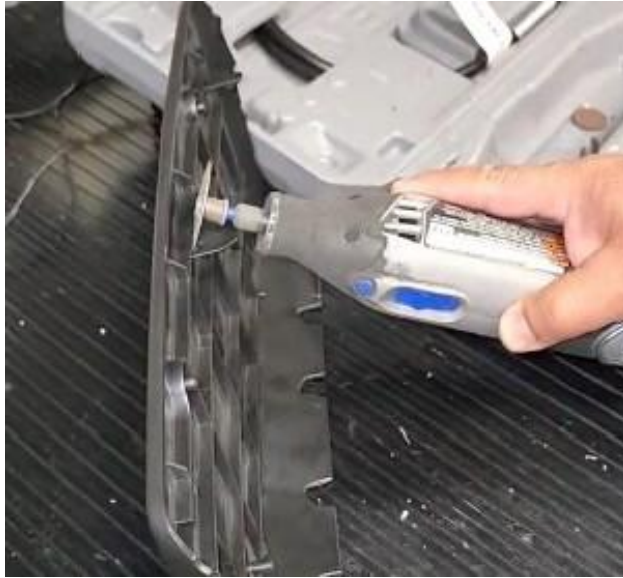
Figure 5. Lower tab removal.

- Using a rotary cut-off tool remove the three lower tabs from the bracket. Cut enough of the tabs so that the bracket can sit flush to the radiator grille.

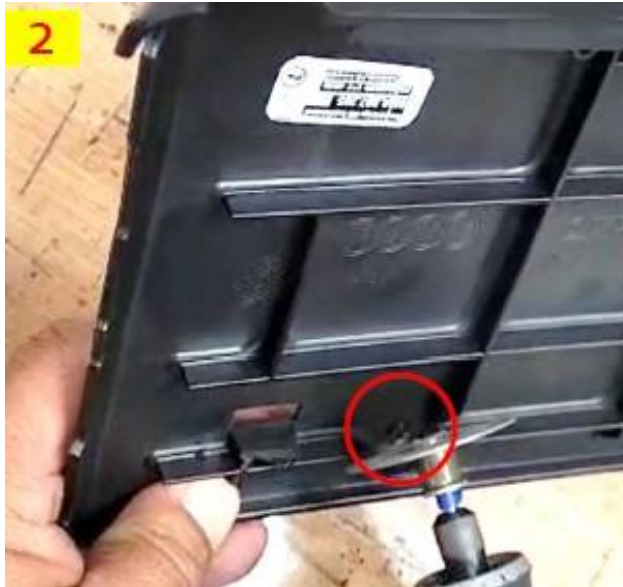
Figure 6. Screw barrel removal.

- There are two screw barrels cast into the bracket that will also need to be cut off. Cut enough of the barrels so that the bracket can sit flush to the radiator grille.

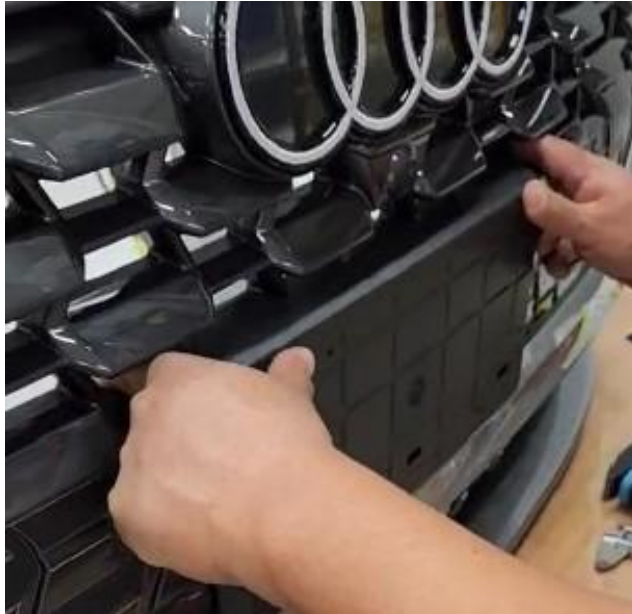
Figure 7. Test fit the license plate bracket to the grille.

- Engage the upper tabs to the grille as shown in figure 7 and test fit the bracket to the radiator grille to ensure that enough of the tab and screw barrel material has been sufficiently removed such that the bracket will lay flush to the grille.

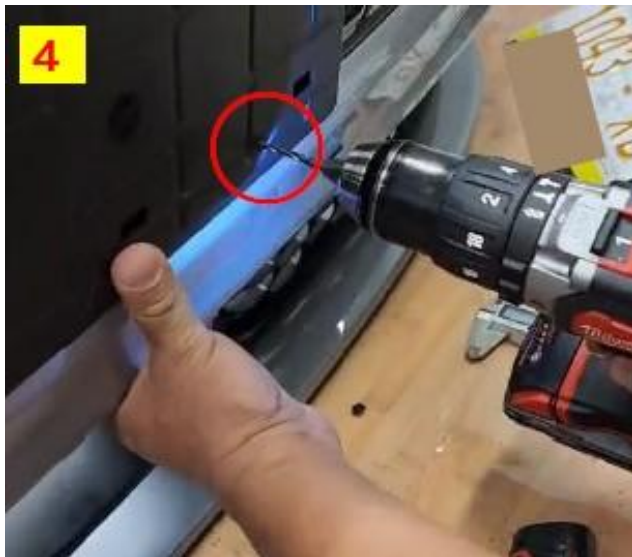
Figure 8. Drilling through the right lower hole.

- With the bracket in the correct position and flush to the grille drill two 3.5mm diameter holes in each of the lower holes and into the grille material. Only drill deep enough to penetrate the grille material. A deeper plunge of the bit could cause damage.

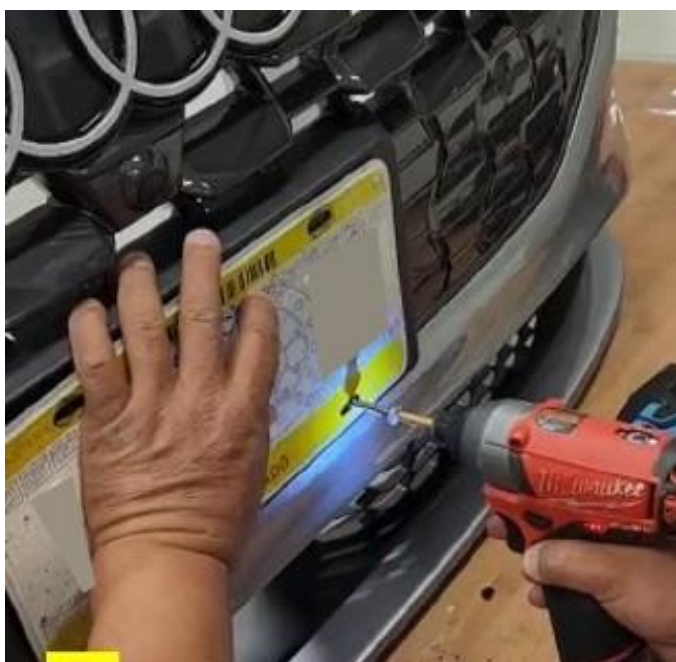
Figure 10. Screwing the right lower license plate and bracket into the grille.

6. Using two N 10547902 self-tapping screws position the license plate to the bracket and insert the screws first through the license plate then through the bracket and finally into the radiator grille.

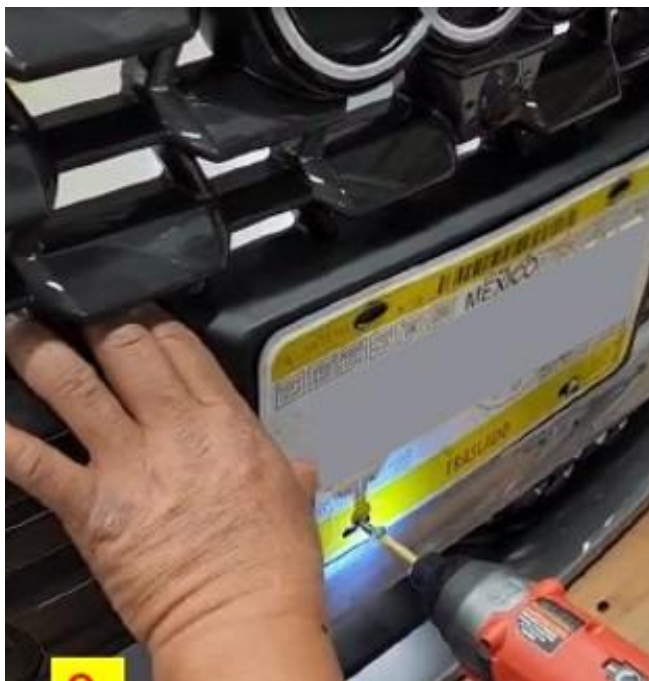
Figure 11. Screwing the left lower license plate and bracket into the grille.

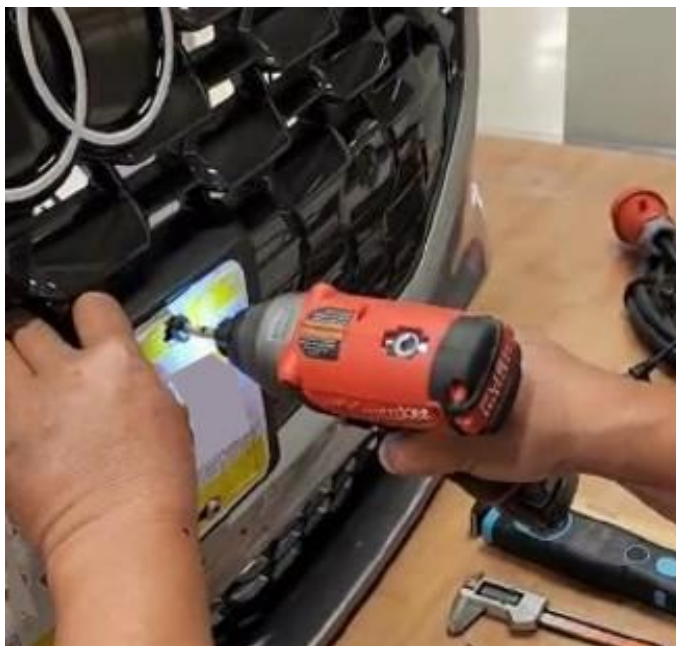
Figure 12. Installing right upper screw through the license plate and into the bracket.

7. Install two N 90915901 self-tapping screws into each of the upper license plate holes just into the license plate bracket.

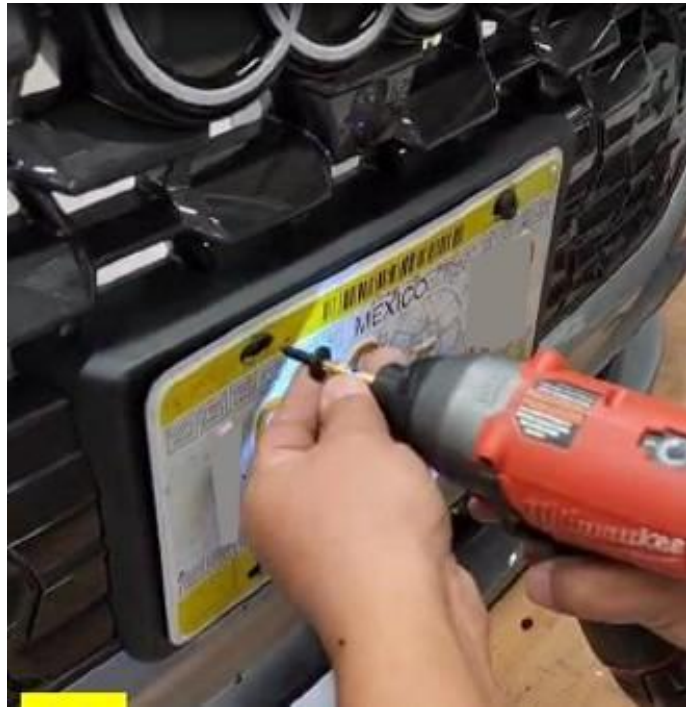
Figure 13. Installing left upper screw through the license plate and into the bracket.

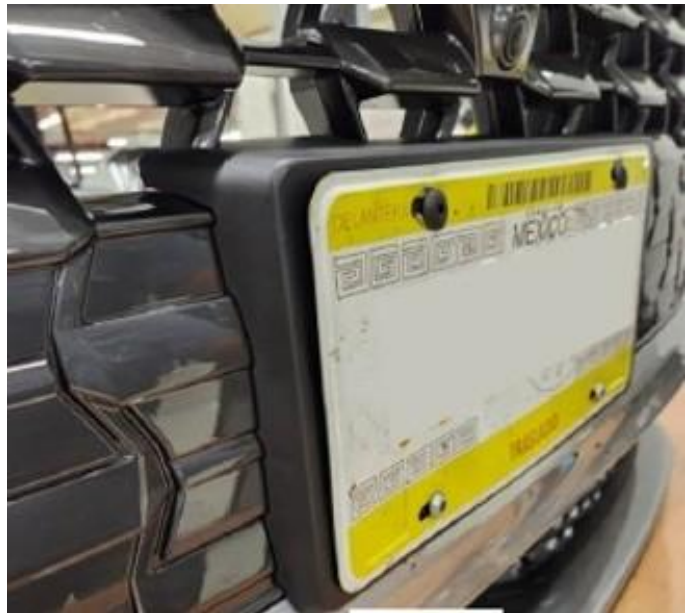
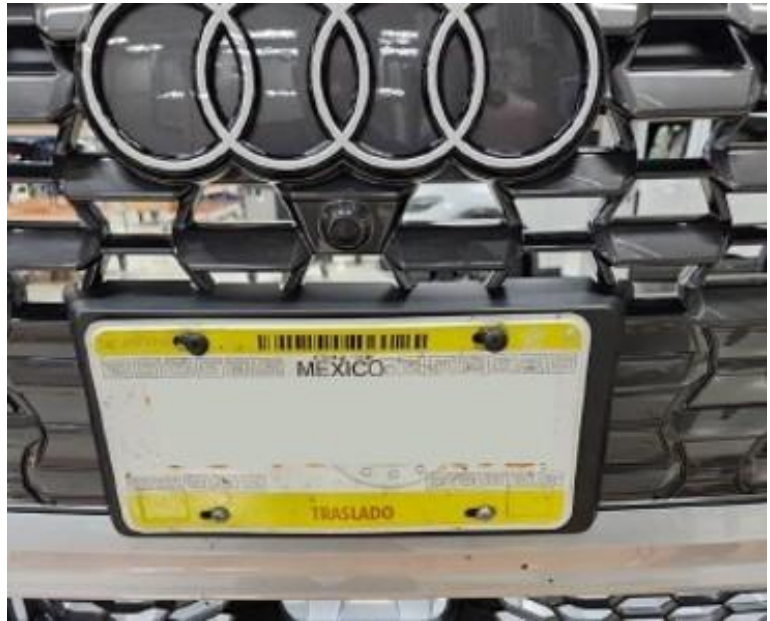
Figure 14. License plate bracket and license plate attachment completed.

Figure 15. License plate bracket and license plate attachment completed.

8. The front license plate bracket and license plate attachment is complete.
