Technical Service Bulletin

GROUP	NUMBER
BODY	25-BD-001G-1
DATE	MODEL(S)
MAY 2025	SEE BELOW

SUBJECT: DARK CHROME TRIM STAINED OR DISCOLORED

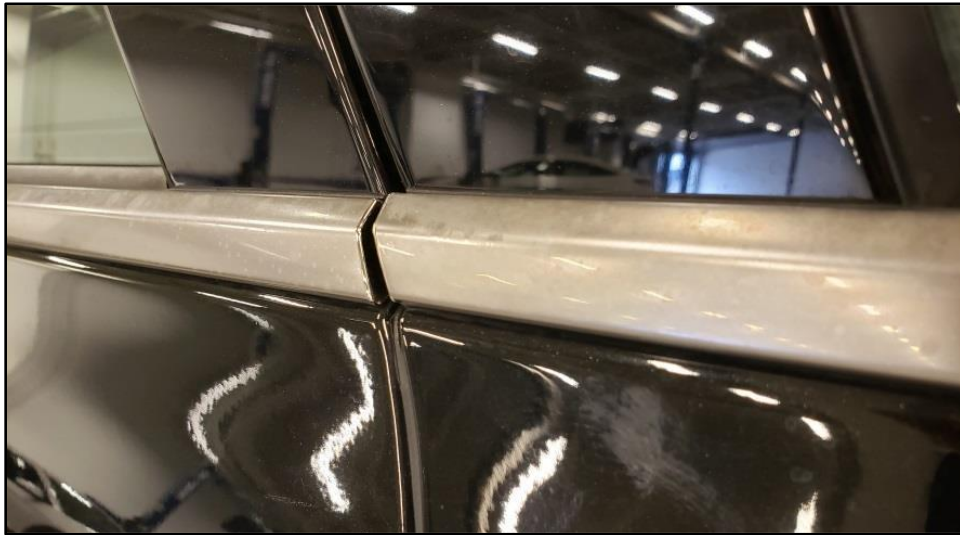
Description: This bulletin provides repair information for the dark chrome trim when stains are present. Some stains may occur from hard water or cleaning chemicals used during a car wash. Follow the procedures below to replace the affected dark chrome moldings.

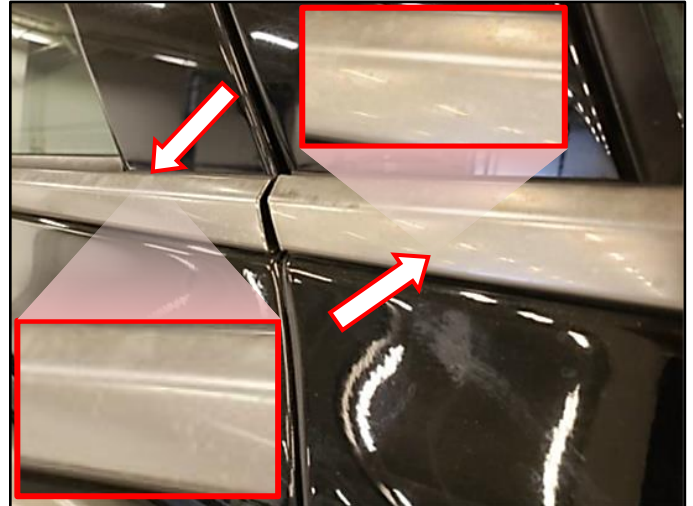
1. Inspect all exterior chrome surfaces on the vehicle to identify which areas are stained or discolored.

3. Replace each affected dark chrome trim.
Refer to the applicable shop manual procedure for each part.
4. The service procedure is now complete.

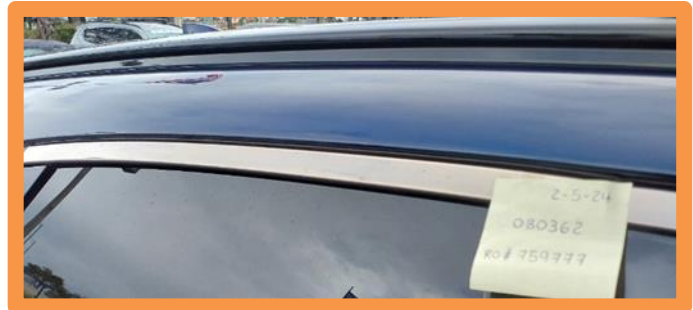
Using STUI, take photos of each stained/discolored dark chrome trim with the last 6 digits of the VIN and the date of repair on a piece of paper.

Upload the photos to STUI.
