Technical Service Bulletin	GROUP BODY	NUMBER 25-BD-007G
	DATE MAY 2025	MODEL(S) SEE BELOW
SUBJECT: 2023-2024MY G70/GV70 DARK CHROME TRIM STAINED OR DISCOLORED

Description: This bulletin provides repair information for the dark chrome trim when stains are present. Some stains may occur from hard water or cleaning chemicals used during a car wash. Follow the procedures below to replace the affected dark chrome moldings.

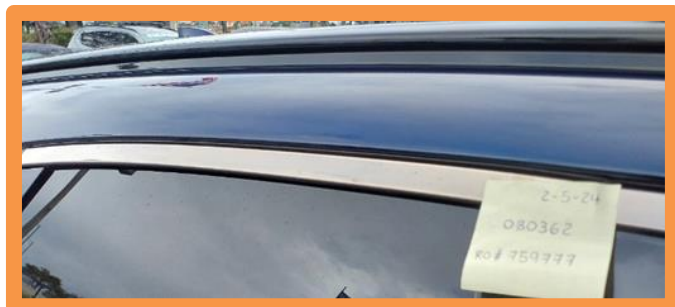
Using STUI, take photos of each stained/discolored dark chrome trim with the last 6 digits of the VIN and the date of repair on a piece of paper.

3. Replace each affected dark chrome trim.
Refer to the applicable shop manual procedure for each part.
4. The service procedure is now complete.
