Technical Service Bulletin

Subject: SUNROOF RATTLE NOISE	Bulletin No.: 09-010/25
	Last Issued : 05/29/2025

2023-2025 CX-50

2025 CX-50 Hybrid

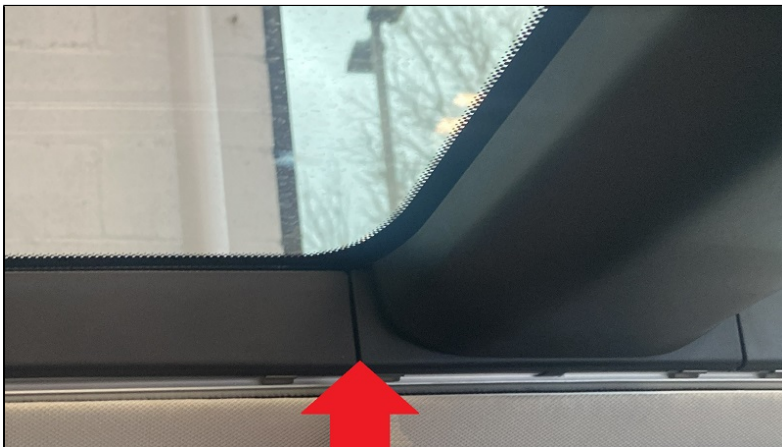
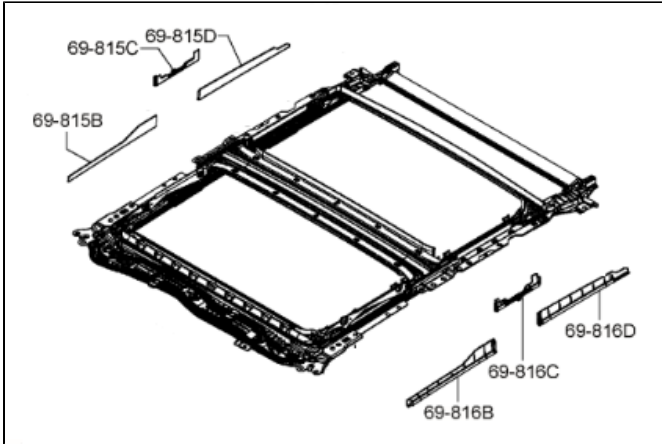
The noise comes from the side cover vibrating against the assembly at the location marked by the arrow due to poor retention of the cover clips.

1. Test drive the vehicle and if you hear the noise, press the edges of the side covers (6 total) as shown in the example below.

YES: Continue to the next step.
NO: Skip to the next section.

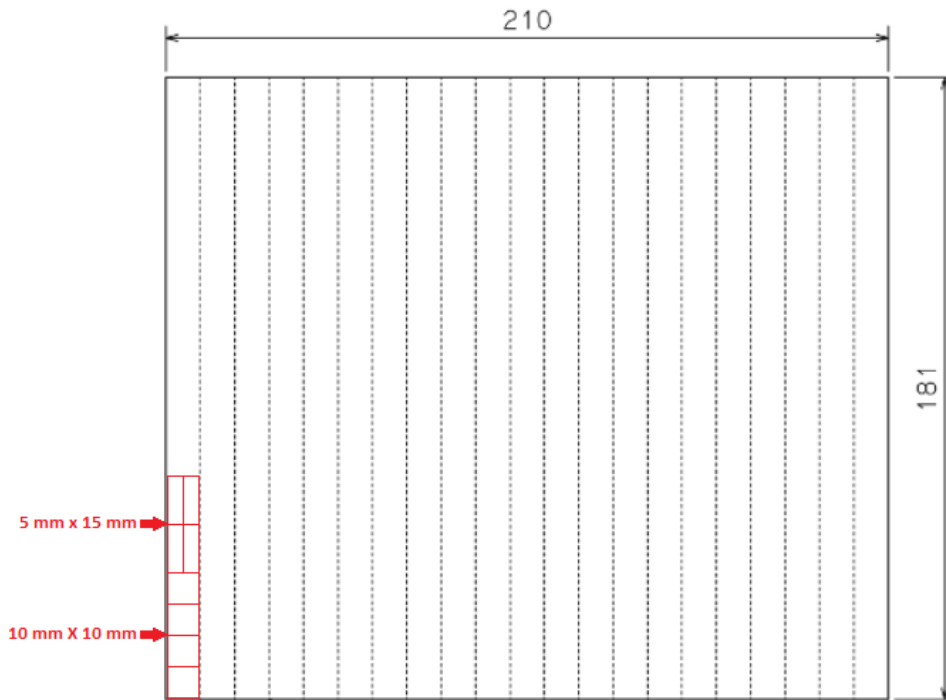
VAY1-68-2A3

FELT SHEET

SIZE : 210 x 181 x t0.5

3. Cut 4 pieces sized 5 mm x 15 mm x 0.4 mm and 4 pieces sized 10 mm x 10 mm x 0.4 mm out of the A-pillar felt (VAY1-68-2A3) and then tape the cut pieces to the new link covers as shown in the image below.

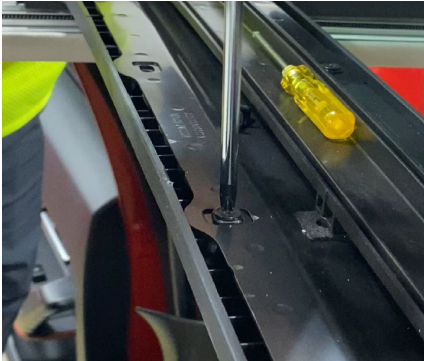
The noise comes from the cross brace cover after the vehicle has been driven and the clips loosen. Follow the instructions below to eliminate the noise.

3. Remove the pushpins and then remove the trim.

CAUTION: DO NOT damage the trim as it is only available with the sunroof assembly.

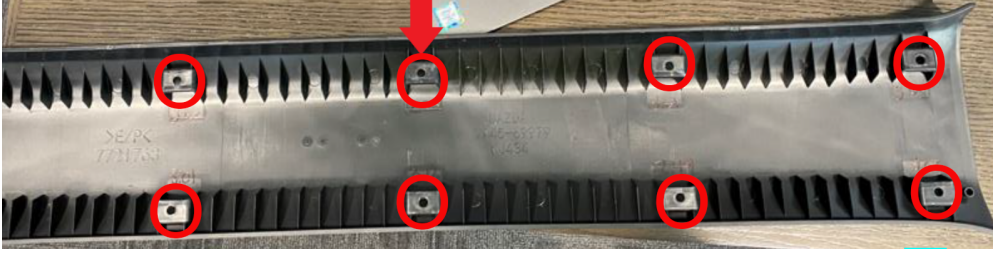
4. Add noise reduction material from the **Interior Noise Kit (see below)** anywhere the trim makes contact with the frame.

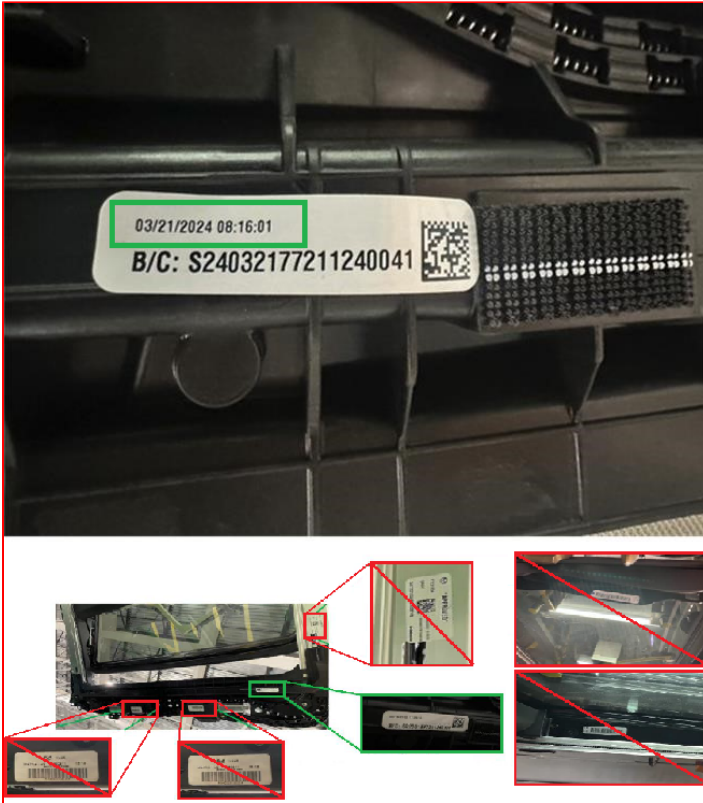
2. Check the sunroof assembly date by inspecting the label marked in green in the image below, the date is written in MM/DD/YYYY format.

Was the sunroof produced before 12/07/2022?

- **YES:** Replace the sunroof unit using the instructions in MGSS (PANORAMA SUNROOF UNIT REMOVAL and PANORAMA SUNROOF UNIT INSTALLATION).
- **NO:** Continue to the next section to check the sunroof mounting.
