Technical Service Bulletin

Topic	Seat Fans Inoperative All Models 17-25MY
Market area	Bentley: worldwide (2WBE),China 796 VW Import Comp. Ltd (Vico), Beijing (6796)
Brand	Bentley
Transaction No.	2077529/1
Level	EH
Status	Released for publishing
Release date	May 12, 2025

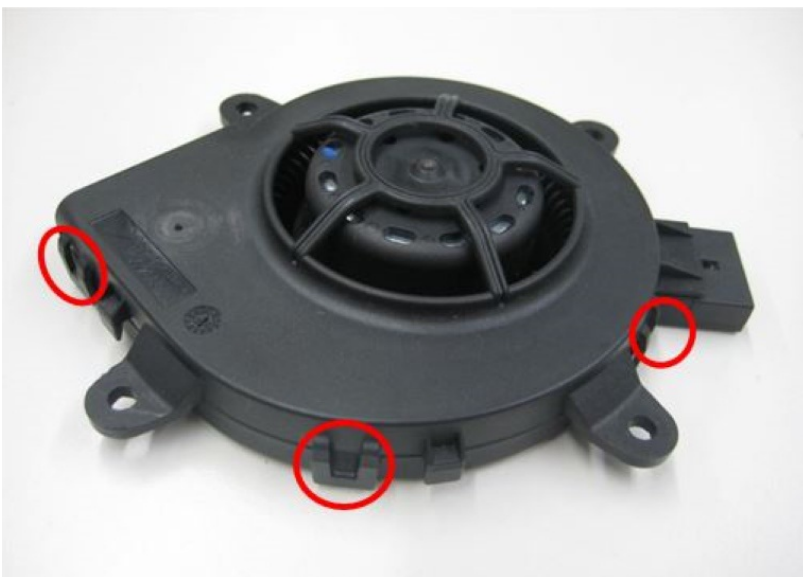
Figure 1

3. Disconnect the ventilation fan from the seat and check for any breakage of the clips on the casing.

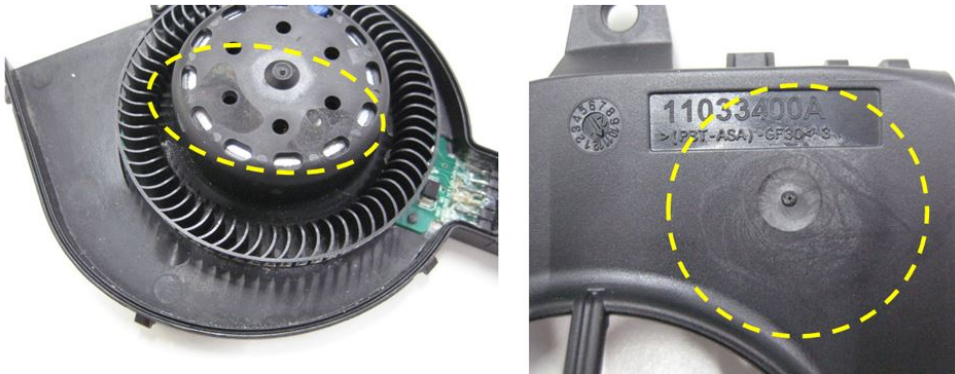
Figure 2

4. Remove the upper casing of the seat ventilation system for visual inspection of the internal components.

Plastic clips circled in red may become brittle over time. Use proper tools and techniques if disassembling the fan assembly to avoid breakage.

5. Check for any liquid ingress marks on the seat ventilation fan casing as seen on example circled in yellow in figure 2.

If there are any signs of liquid ingress, corrosion, or disconnection is observed. Document the findings with photos and attach them to a DISS ticket.

7. If a Seat ventilation fan is non-functional replace the affected unit. Refer to ElsaPro Repair Group 72 'Seat blower remove+install'.
