**SERVICE CAMPAIGN 75-07 DRIVER DOOR ASSIST HANDLE
AFFECTED MODELS: 2023-2024 SV MODELS**

Driver Door Assist Handle

Field Service Campaign

Specialty Vehicle/J-Shell

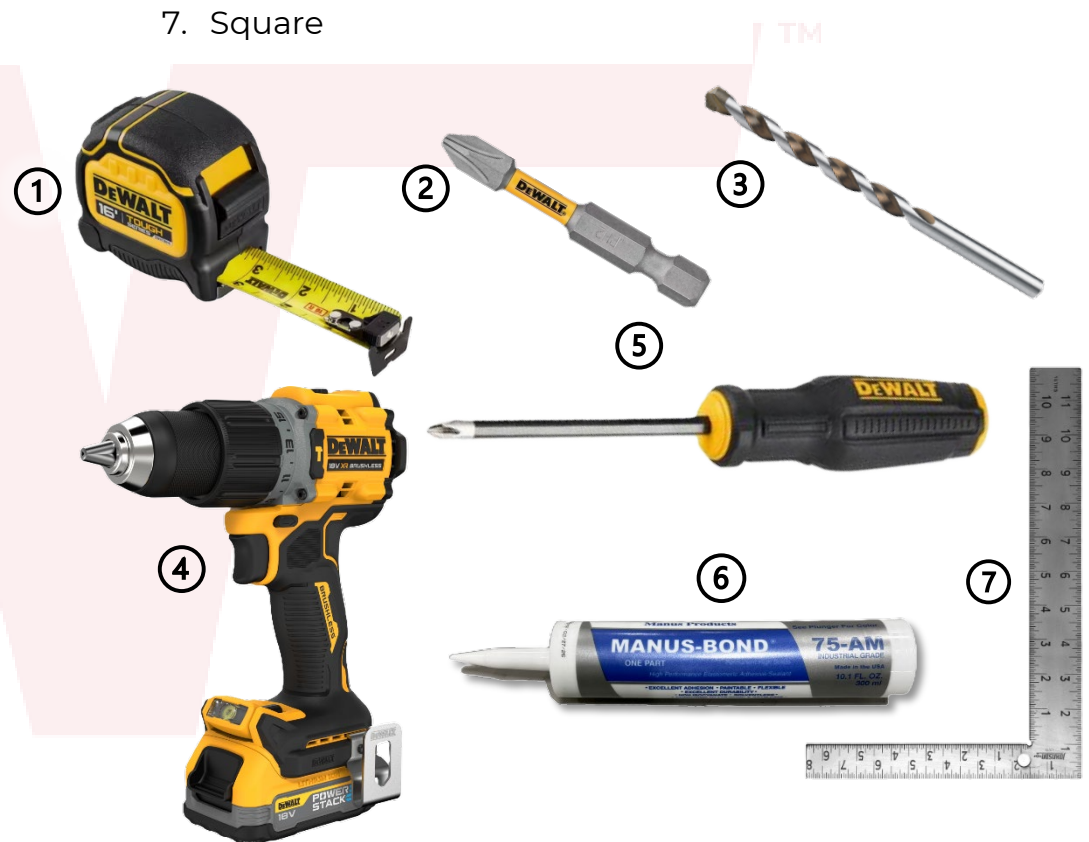
Parts/Kit Image Reference

Part Required – SC7853-25-707 ASSIST HNDL CMPGN

1. Spacers/Backing Plate, White (165309-05-700)(2)
2. 8-18 x 1.25 Screw/Self-Drilling - POH (000G60-08-20F) (8)
3. White Butyl Tape (185989-11-01A) (1 ft.)

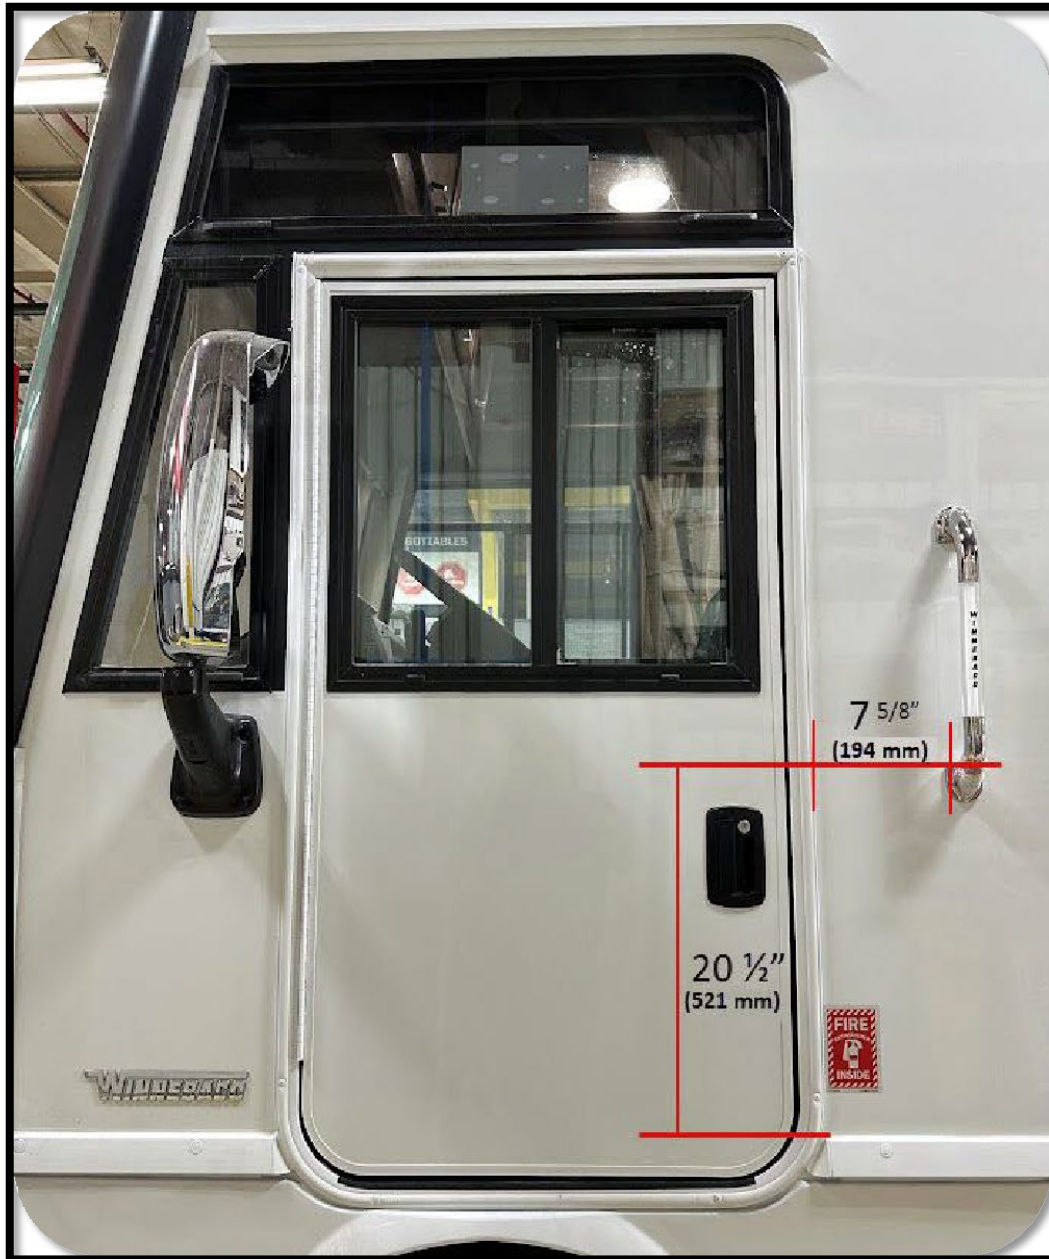
Horizontal: ↔

6" – 7 3/4", 7 5/8" nominal
(Measured from edge of door trim to handle screw)

Vertical: ↑↓

20 1/2" – 21 5/8", 20 1/2" nominal
(Measured from lower body trim to handle screw)

Objective: Use these dimensions to audit the location of your assist handle. If rework is required, please continue to the next section.

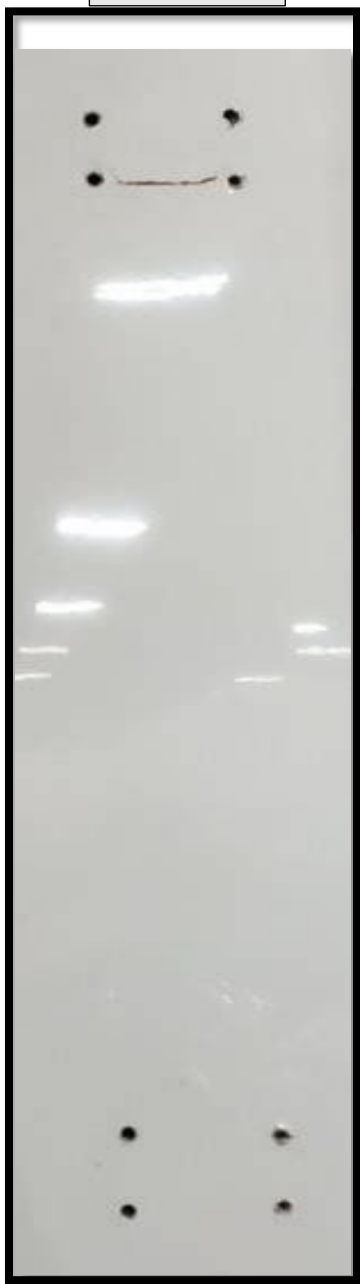
Image 1

1. Remove all the screws and take off the handle from the unit (See Image 1).
2. Fill existing holes with White Manus (185987-03-11A) (See Image 2).
3. Use tape measurer and mark the new bottom left hole location at 7 5/8" (See Image 3).

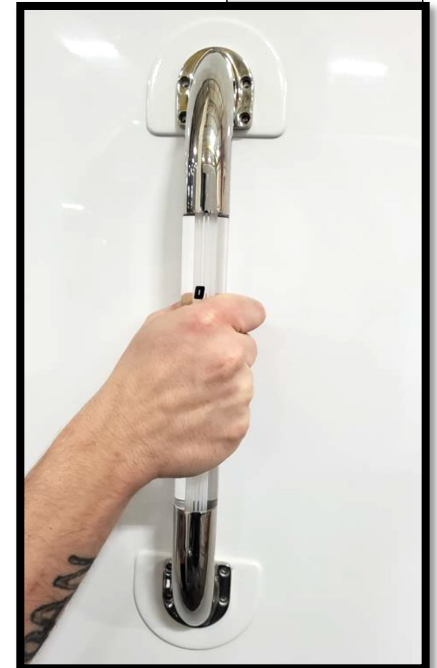
Image 9

9. Verify your installation by pulling on the handle to ensure it is secure. (See Image 9)
10. If you followed the steps carefully and installed everything according to the instructions, then the repair is now complete, and the assist handle is firmly in place and ready to use.
