GENERAL MOTORS
DCS7243
URGENT - DISTRIBUTE IMMEDIATELY

Subject: N252503850 - Special Coverage
Front Exhaust Pipe

Models: 2023 Buick Enclave
2023 Chevrolet Traverse

N252503850 Front Exhaust Pipe

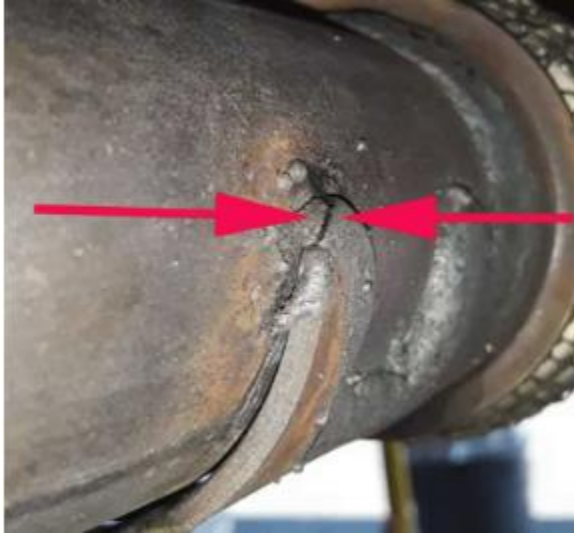
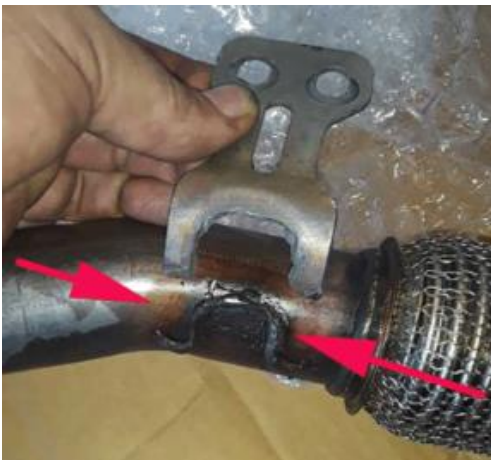
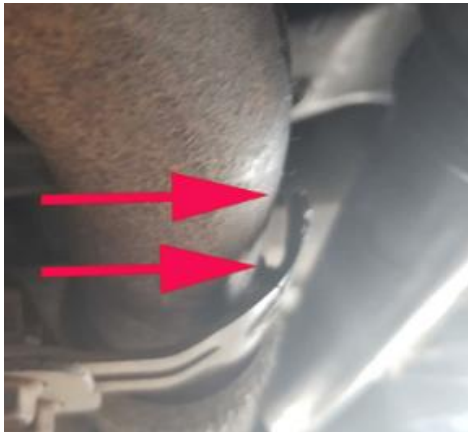
Condition	Certain vehicles listed above may have a condition that could cause the mounting bracket on the front exhaust pipe to separate from the pipe. If this condition occurs, a hole may develop in the exhaust pipe at the bracket location, and a rattling or increased exhaust noise may be heard.
Special Coverage	<p>This special coverage covers the condition described above for a period of 15 years or 150,000 miles (240,000 km), whichever occurs first, from the date the vehicle was originally placed in service, regardless of ownership.</p> <p>For vehicles covered by Vehicle Service Contracts, all eligible claims with repair orders on or after June 10, 2025, are covered by this special coverage and must be submitted using the labor operation codes provided with this bulletin. Claims with repair orders prior to June 10, 2025, must be submitted to the Service Contract provider.</p> <p>Vehicle owners or lessees who paid for repairs referenced in this Special Coverage ("Customers") are eligible for reimbursement of their reasonable and customary expenses in accordance with the procedures specified below. The conditional right to reimbursement is provided by GM solely in the interest of customer satisfaction and is personal to Customers. <i>Customers may not assign and GM does not consent to any assignment of any Customer's right to submit reimbursement claims, or to receive reimbursement, or any other rights granted by this Special Coverage to any third party, including but not limited to service contract providers, and this Special Coverage is not intended to and does not confer any third party beneficiary, subrogation or contribution rights, or any other rights to reimbursement, against GM, whether in law, equity or otherwise, on any third parties.</i></p>

2. Inspect the front exhaust pipe (the one that has the flex section built in) for damaged, cracked, or broken welds as shown in the photos above.
 - a. If no damage is found, no further action is required.
 - b. If damage is found, replace the damaged exhaust section. Refer to *Exhaust Front Pipe Replacement* in SI.

Correction	Dealers are to replace the front exhaust pipe as necessary. The repairs will be made at no charge to the customer.
