Rumbling Noise From ERAD / TVDC

REF NO: TJ 37141.3.0	ISSUING DEPARTMENT: Technical Service	CAR MARKET: United States and Canada	
PARTNER: 3 US 7515 Polestar		ISSUE DATE: 2025-04-04	STATUS DATE: 2025-04-07
FUNC GROUP: 4601	FUNC DESC: Rear axle, complete	Page 1 of 4

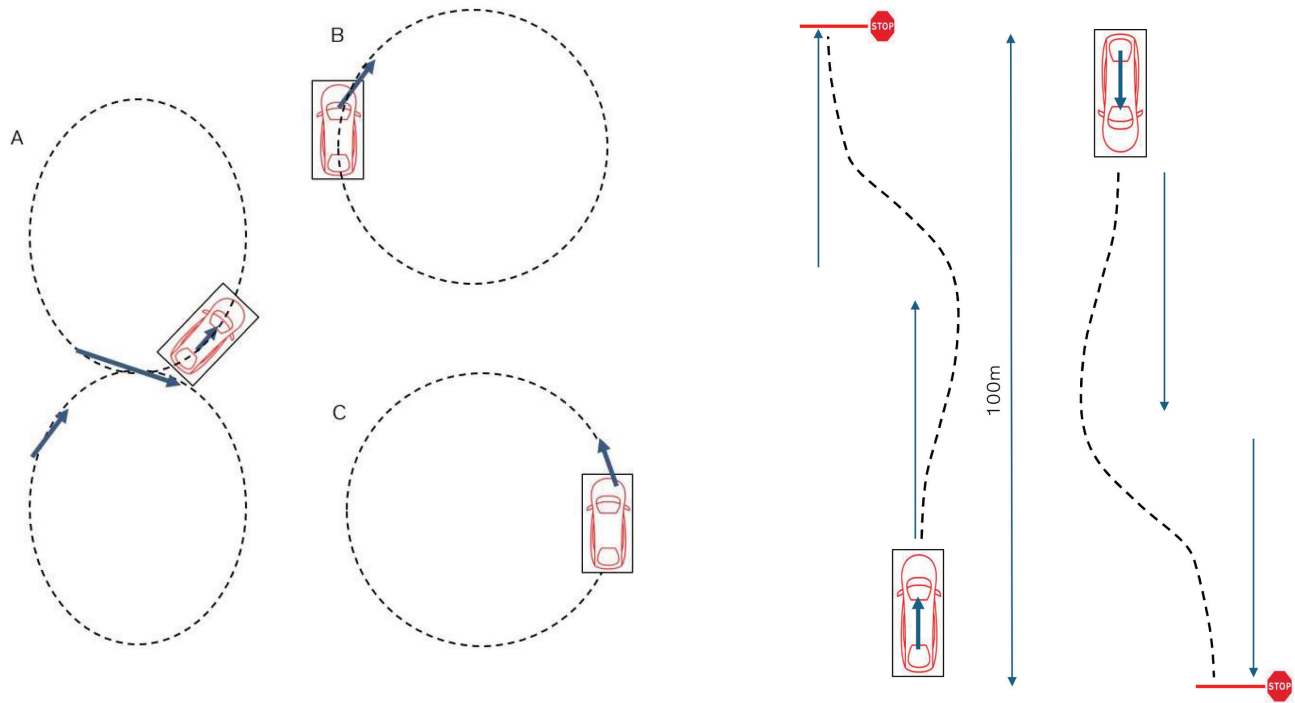
TJ 37141

1. Perform an oil change of the TVDC according to VIDA instructions. If the noise is gone afterward, release the vehicle to the customer. If the noise remains, continue to step 2.
- *2. Test drive according to the illustration in attachment TJ_37140_1.pdf and then follow steps a-e in the text below:
 - a. 1 minute 15-30 km/h (10-20 mph)
 - b. 1 minute 15 km/h (10 mph)
 - c. 1 minute 15 km/h (10 mph)
 - d. 1-time light acceleration 0-80 km/h (0-50 mph)
 - e. 1-time light acceleration 0-80 km/h (0-50 mph)
