## **Manufacturer's Communication to Dealer MCD-004 B-Van Alternator Jumper Cable**

## MCD-004 Repair Instructions

**Models Involved:** 2023 – 2024 Convoy motorhomes and 2023 – 2024 Tiffin GH1 motorhomes built between March 23, 2023, and December 13, 2023.

**Purpose:** Moving the alternator cable to the disconnect side of the battery to allow the battery to always charge from the alternator.

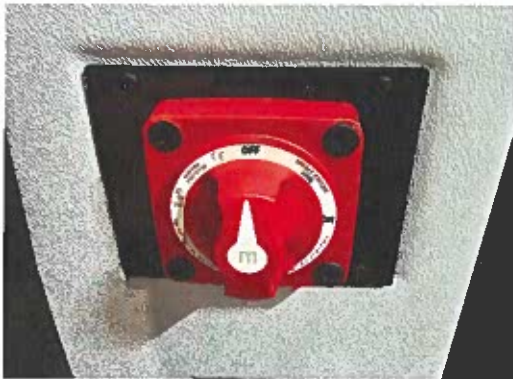
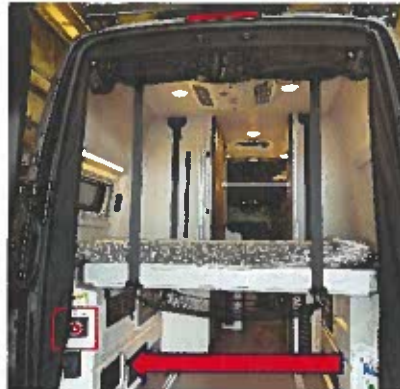
Figure 1A

1. Disconnect all power from the 30-amp shore cord.
2. Turn main battery disconnect "OFF". The disconnect is located at the rear of the coach on the driver's side. See Figures 1A & 1B below.

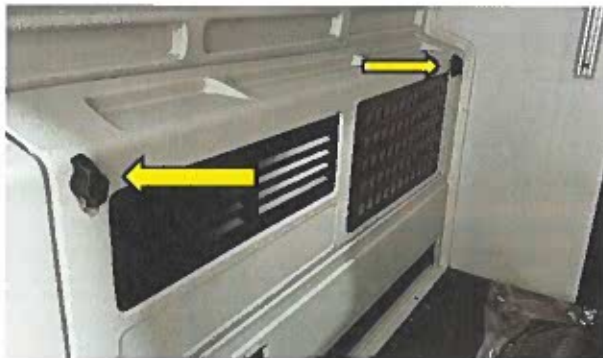
Figure 2

3. Turn the chassis engine off and remove the key from the ignition switch.
4. Remove plastic covering from battery bay by twisting release knobs and pulling up to access compartment, Figure 2.

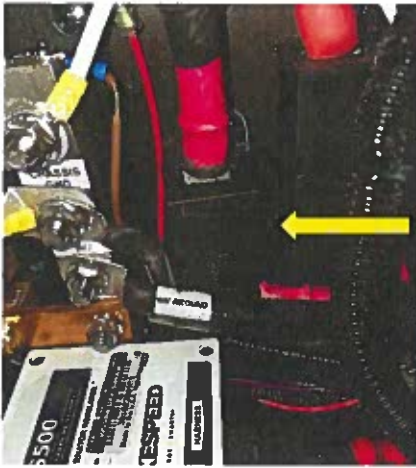
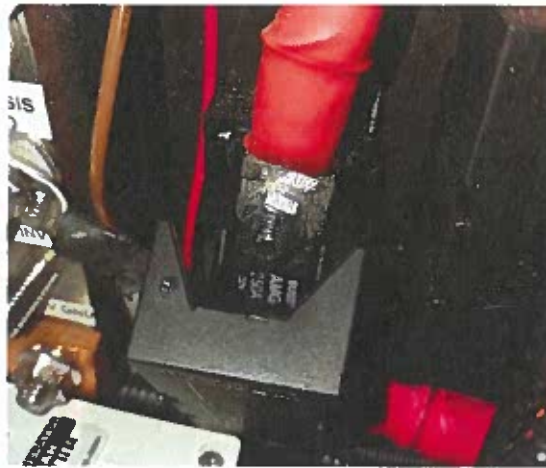
Figure 3A

5. Remove plastic cover from alternator fuse. Remove  $\frac{1}{2}$ " nut from load side of fuse to release bottom of alternator jumper cable. Keep  $\frac{1}{2}$ " nut for installation of new cable. See Figures 3A & 3B.

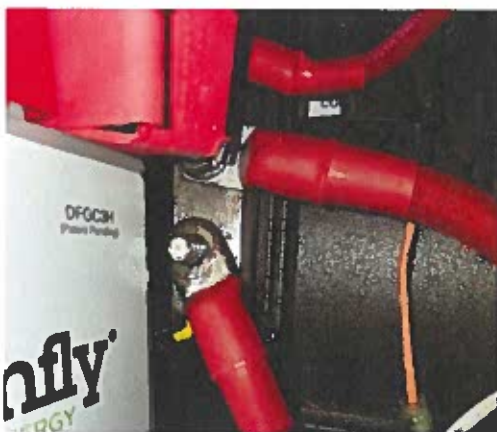
Figure 4

6. Remove  $\frac{9}{16}$ " nut from buss bar to release top of alternator jumper cable and remove cable from buss bar. See Figure 4.

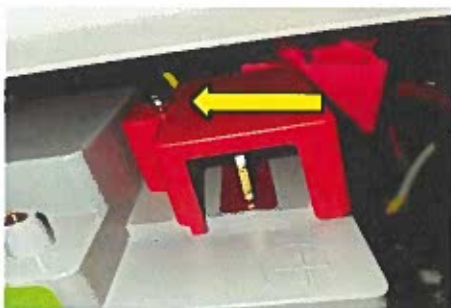
Figure 5

7. Remove cover of positive battery terminal by removing screw on top of cover. See Figure 5.

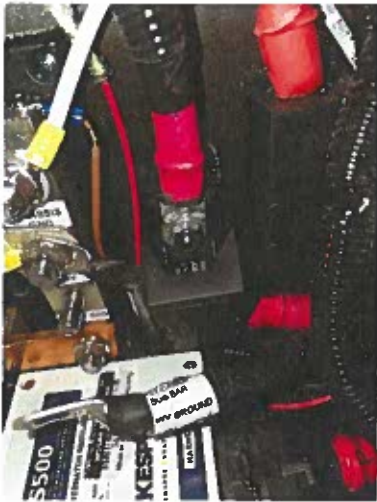
Figure 6

8. Install one terminal end of the new alternator jumper cable part 5157970 on load side of alternator fuse. Torque nut to 9 to 11 ft-lbs. See Figure 6.

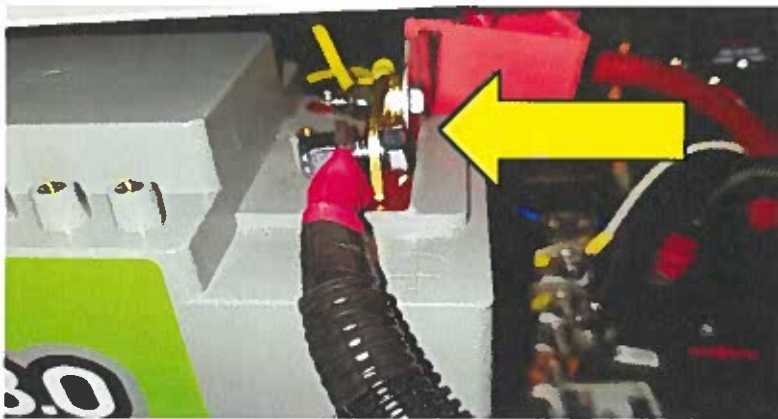
Figure 7

9. Install the remaining terminal end of the new alternator jumper cable at the positive battery terminal using the 3/8-16 x 3/4" bolt and nut as displayed below in Figure 7. Torque nut to 9 to 11 ft-lbs.

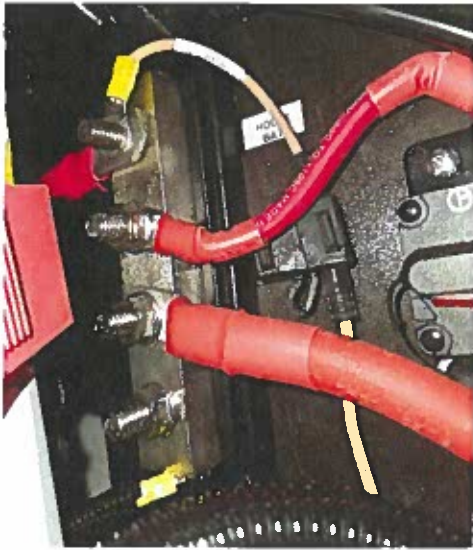
Figure 8

12. Remove the top 9/16" nut from the buss bar so that the ring terminal connected to the inline fuse can be removed from the buss bar. Reinstall the nut to the buss bar. Torque nut to 9 to 11 ft-lbs. See Figure 8.

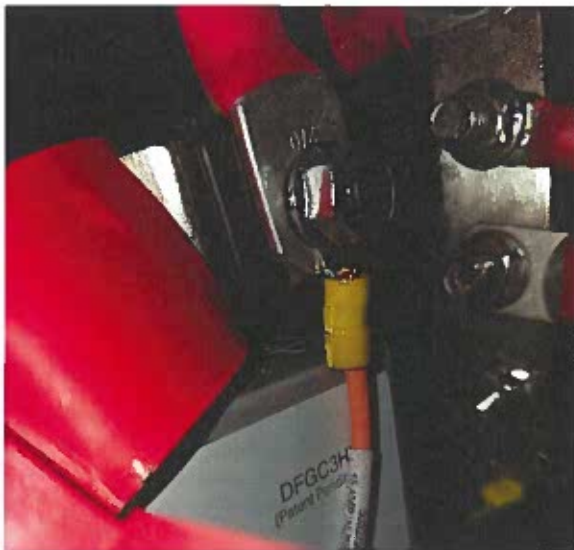
Figure 9

13. Remove the 1/2" nut from the battery terminal fuse holder. Position the ring terminal from the inline fuse on the bolt and reinstall the nut. Torque nut to 9 to 11 ft-lbs. See Figure 9.
