Service Bulletin

Bulletin No.: PI0281L

Subject: Underbody Component Corrosion

Models: 2025 and Prior GM Passenger Cars and Trucks (Excluding Medium Duty Low Cab Forward)

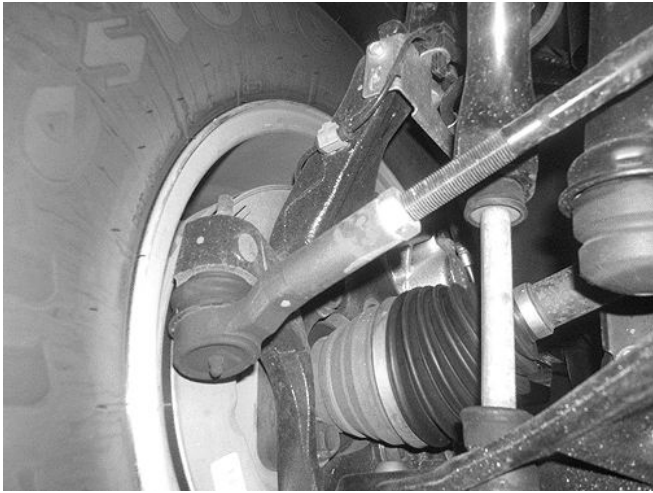
2537955

Tie rod end

No repair or consideration should be given for this condition. Surface corrosion on unprotected components will vary with age and exposure. Corrosion on these components has no detrimental impacts, either in short or long-term durability.

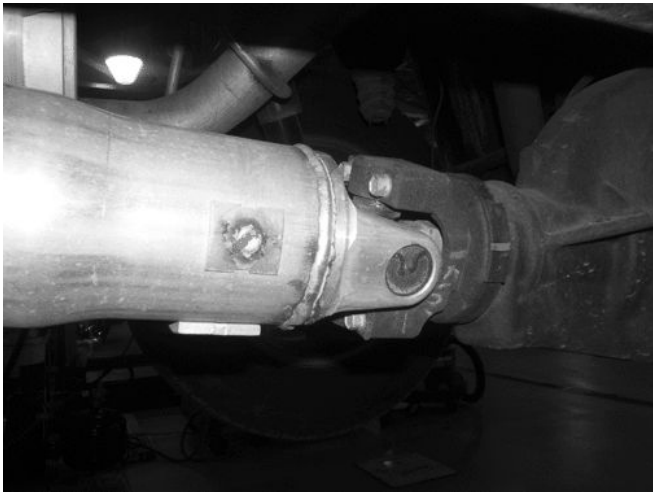
2537959

Propshaft yoke

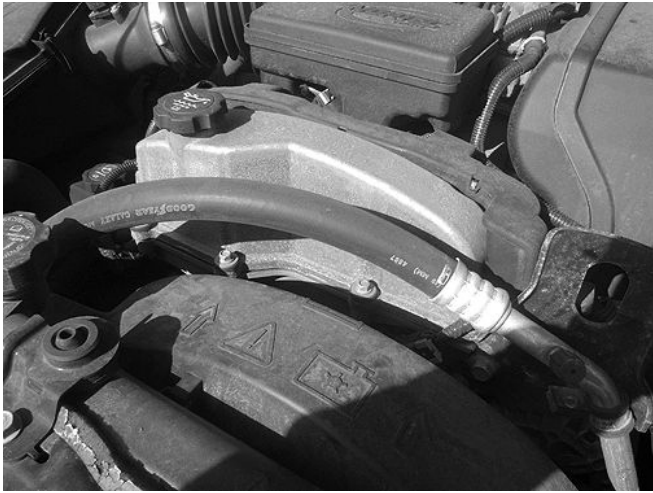
2537976

Under hood components

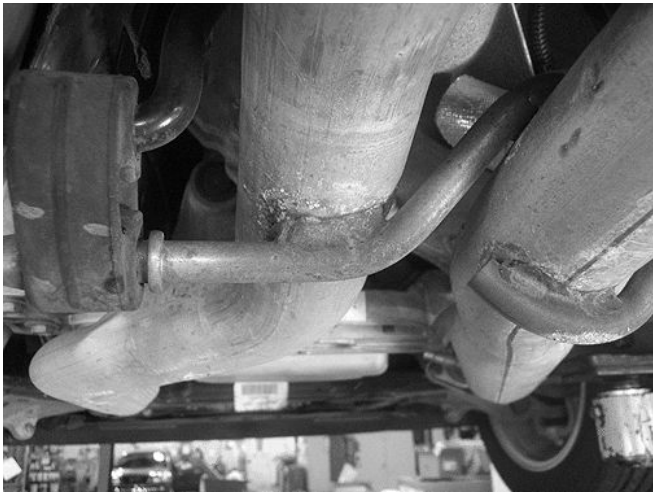
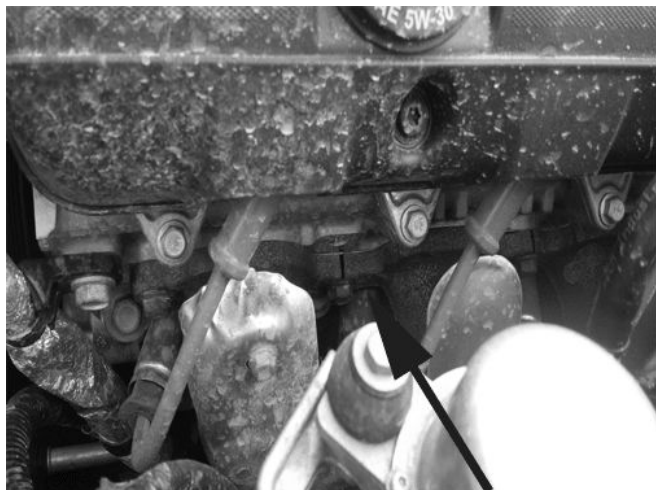
4486626

Exhaust system components

Note: During transit between the plant and the dealer, some of the exhaust system components may corrode as a result of salt exposure. These exhaust parts are made of a bare mild-grade stainless steel that will oxidize or appear rusty. Over time, these components will have a uniform rust-like discoloration, which should be considered a normal condition.
