STAR ONLINE PUBLICATION

Case Number: S2523000056

Symptom/Vehicle Issue: Gap Visible Between Instrument Panel Top Cover And A Pillar Trim.

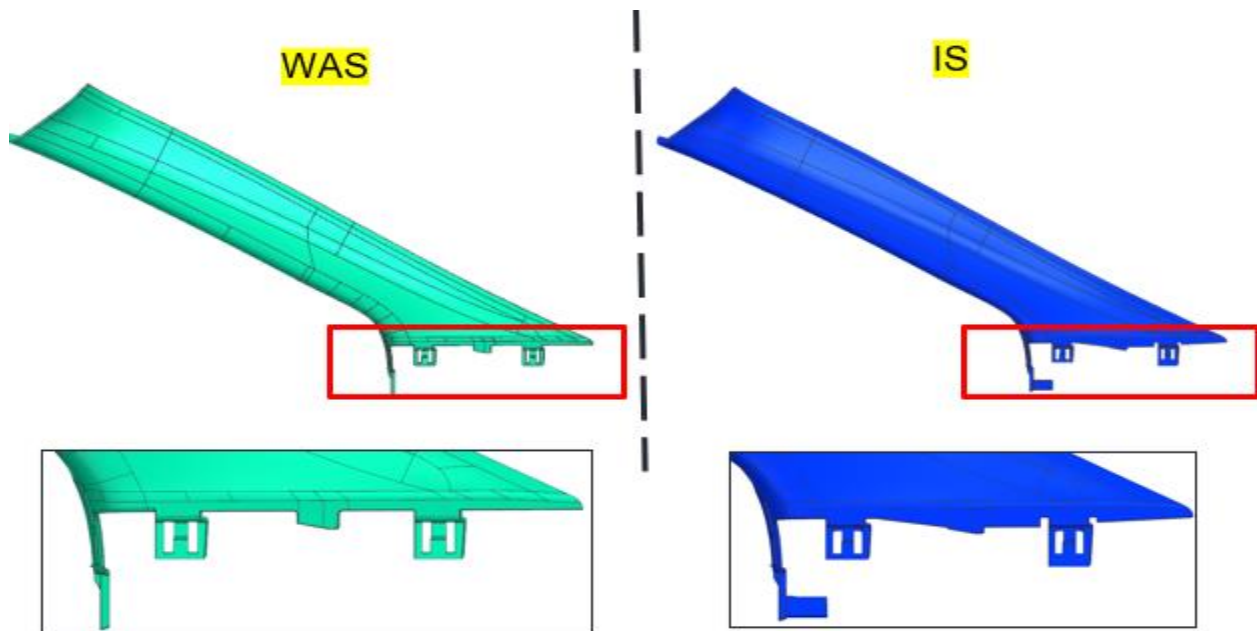
Fig 1.
AD Level Part On Right Side.

Discussion: If the customer has a visual complaint on the A-pillar trim having a noticeable gap, an update to the A-pillar trim is now available (Fig 1). Parts AD and newer will have the revised shape to resolve visual gap.
