<b>REFERENCE:</b>	<b>TSB:</b> 08-187-25 <b>GROUP:</b> 08 - Electrical	<b>Date:</b>	June 11, 2025	<b>REVISION:</b>	—
<b>VEHICLES AFFECTED:</b>	<b>2024 - 2025 (LB) Dodge Charger</b> This bulletin applies to vehicles built on or before May 05, 2025 (MDH 0505XX) equipped with Seat Parts Module (Sales Code X8Z) and Two Door (Sales Code 5ZS).			<b>MARKET APPLICABILITY:</b> <input checked="" type="checkbox"/> NA <input type="checkbox"/> MEA <input type="checkbox"/> SA <input type="checkbox"/> IAP <input type="checkbox"/> EE <input type="checkbox"/> CH <b>NOTE:</b> This bulletin applies to North America markets.	
<b>CUSTOMER SYMPTOM:</b>	<b>Customers may experience the following:</b> <ul style="list-style-type: none"> <li>One or both rear seats Easy Entry feature is inoperative.</li> </ul>				
<b>CAUSE:</b>	Loose or disconnected cable connection

This bulletin involves connecting the Easy Entry cable connector and securing that connection using a tie-strap.

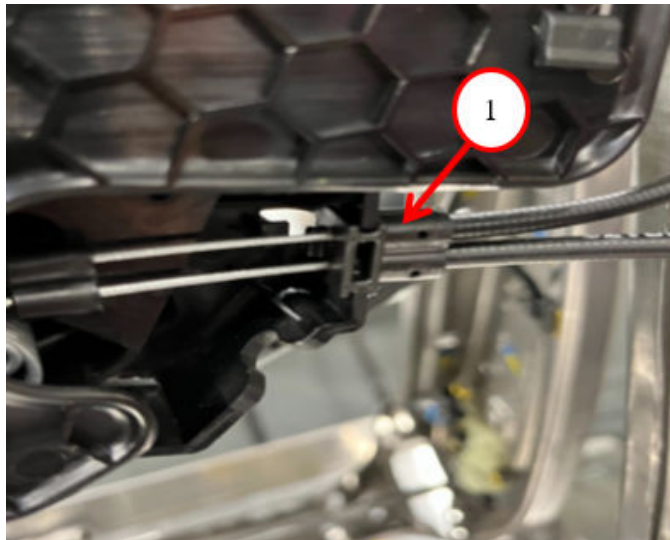
**Fig. 1**  
Easy Entry Cable Connection

1. Is the vehicle equipped with a plastic seat back cover?
  - YES>>> Proceed to [Step 2](#).
  - NO>>> Proceed to [Step 3](#).
2. Remove the seat back panel, if equipped. Refer to the detailed service procedures available in DealerCONNECT/Service Library under: Service Info> 23 - Body / Seats / Panel, Seat Back / Removal and proceed to [Step 4](#).
3. Unzip the seat back panel cover and proceed to [Step 4](#).
4. Locate the Easy Entry cable end fitting that connects to the ratio box [Fig 1](#).

1 - Easy Entry Cable Connector To Ratio Box

- 
5. Connect the cable connector to the ratio box.

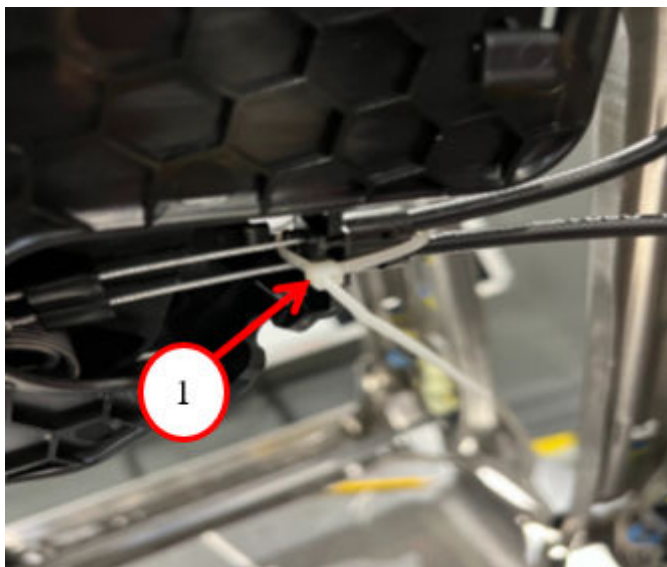
**Fig. 2**  
Tie Strap Attached

1 - Attach Tie Strap To Secure Connector To Connector Receptacle

6. Attach a tie strap in between the two cables and around the ratio box connector receptacle [Fig. 2](#).

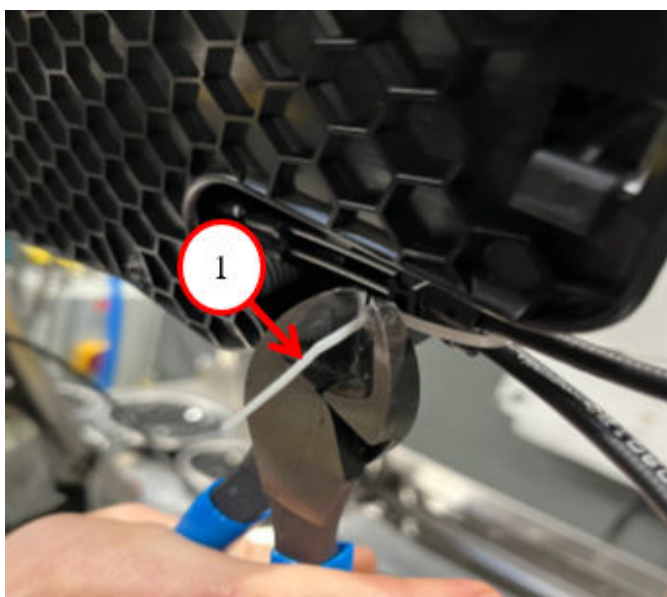
**Fig. 3**  
Remove Excess Tie Strap End

1 - Snip Off Excess Tie Strap End

7. Snip off excess tie strap end [Fig. 3](#).
