GROUP	MODEL
<b>Voluntary Emissions Service Campaign</b>	<b>2021-2024MY K5 (DL3a) w/1.6L T-GDI</b>
NUMBER	DATE
<b>SC288 (Rev 6, 06/16/2025)</b>	<b>April 2024</b>

### FUEL TANK AND/OR PCSV CHECK VALVE

### INSPECTION/REPLACEMENT + ECU SW UPGRADE (SC288/SC288A)

This bulletin provides information to inspect the fuel evaporative system and, if necessary, replace the fuel tank and/or the Purge Control Solenoid Valve (PCSV) check valve on certain 2021-2024MY K5 (DL3a) vehicles equipped with a Gamma II 1.6L T-GDI engine, produced from March 27, 2020 through January 23, 2024. This bulletin also provides information to upgrade the ECU software logic. The subject vehicles may experience fuel tank swelling due to an issue with the PCSV check valve, which results in pressurized air to flow into the fuel tank. This may cause the Check Engine Light to illuminate, and in some cases, the engine to run rough, and/or an inability to refuel. These conditions may cause the vehicle to release air pollutant which exceed Federal and California standards.

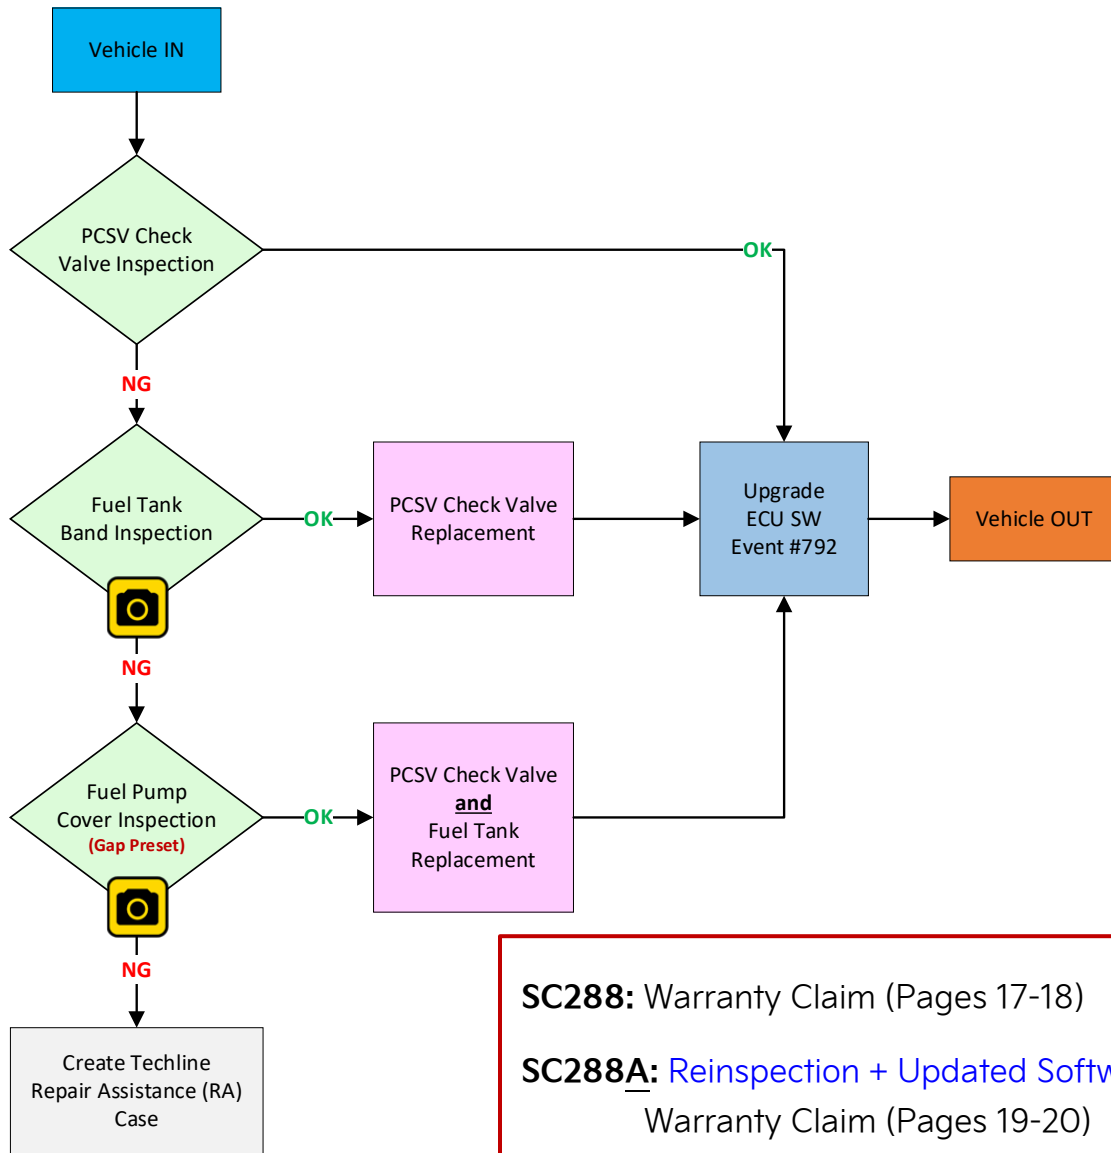
**Flowchart:**

**Path 1:** Vehicle IN → PCSV Check Valve Inspection (OK) → Upgrade ECU SW → Vehicle OUT

**Path 2:** Vehicle IN → PCSV Check Valve Inspection (NG) → Fuel Tank Band Inspection (OK) → PCSV Check Valve Replacement → Upgrade ECU SW → Vehicle OUT

**Path 3:** Vehicle IN → PCSV Check Valve Inspection (NG) → Fuel Tank Band Inspection (NG) (attach photo) → Fuel Pump Cover Inspection (OK) → Fuel Tank and PCSV Check Valve Replacement → Upgrade ECU SW → Vehicle OUT

**Path 4:** Vehicle IN → PCSV Check Valve Inspection (NG) → Fuel Tank Band Inspection (NG) (attach photo) → Fuel Pump Cover Inspection (NG) (attach photo) → Open RA TL Case

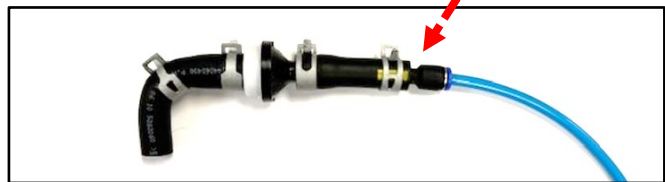
- 3b. Connect the PCSV check valve (B) to the pressurization adapter (D).
- 3c. Connect the shop air supply hose to the air supply valve (E).
- 3d. Open shop air supply valve (E).

The pressurization adapter (D) **MUST** be connected to the PCSV check valve (B) in the direction shown. If the pressurization adapter is connected incorrectly, the inspection cannot be properly conducted due to incorrect airflow to the check valve.

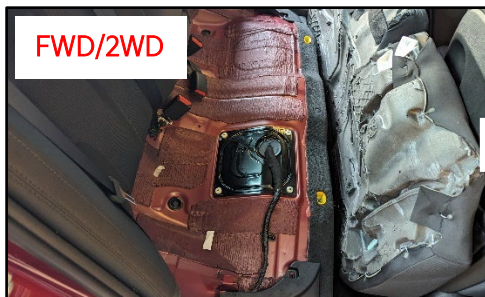
**Note:** AWD model shown on the right for reference, the FWD models shown below feature a single fuel tank service cover access.

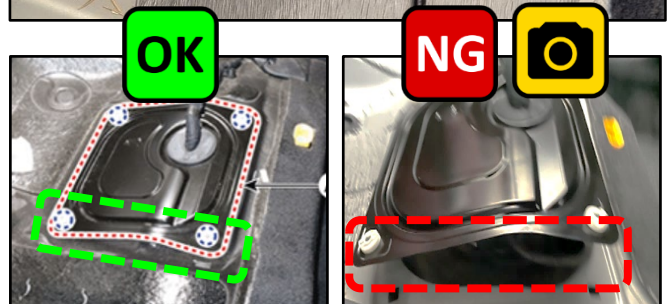
4. Inspect the seat floor to fuel pump service cover (E) (4 sides) for any gaps:

- If a gap is NOT present (OK), the cover is seated flush with the seat floor panel, then proceed to replace both the PCSV check valve and Fuel Tank (page 12). After completing the two replacements, perform the 'ECU Upgrade Procedure' (page 8).
- If a gap IS present (NG), the cover is lifted/detached from the seat floor panel, create a Techline Repair Assistance (RA) case, and **take a clear photo of the NG condition using the KDS Warranty Claim Attachment tab.**

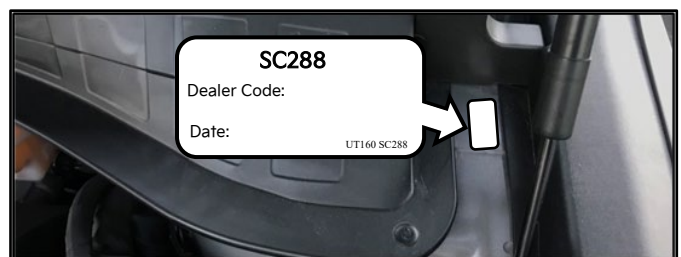
The dealer must fill in the Dealer Code and Date information fields on the Campaign Completion Label. Once complete, affix the campaign completion label under the hood of the vehicle, as shown below.

**CA and S.177 States Only:** Apply SC288 Campaign Completion Label onto the body in the area next to the shock tower, as shown. **NOTE: Be sure to clean the mounting surface to ensure proper label adhesion.**
