| <b>HYUNDAI</b><br><b>Technical Service Bulletin</b> | GROUP<br><b>ENGINE<br/>MECHANICAL</b> | NUMBER<br><b>25-EM-002H</b> |
| <b>SUBJECT:</b> CVVD ACTUATOR OIL SEAL REPLACEMENT | | |

**Description:** Certain 2020-2022MY Tucson Hybrid and Santa Fe Hybrid vehicles equipped with the 1.6T-GDI Gamma II HEV engine may experience an engine oil leak originating from the Continuous Variable Valve Duration (CVVD) Actuator Oil Seal. Follow the service procedure below to replace the CVVD Oil Seal.

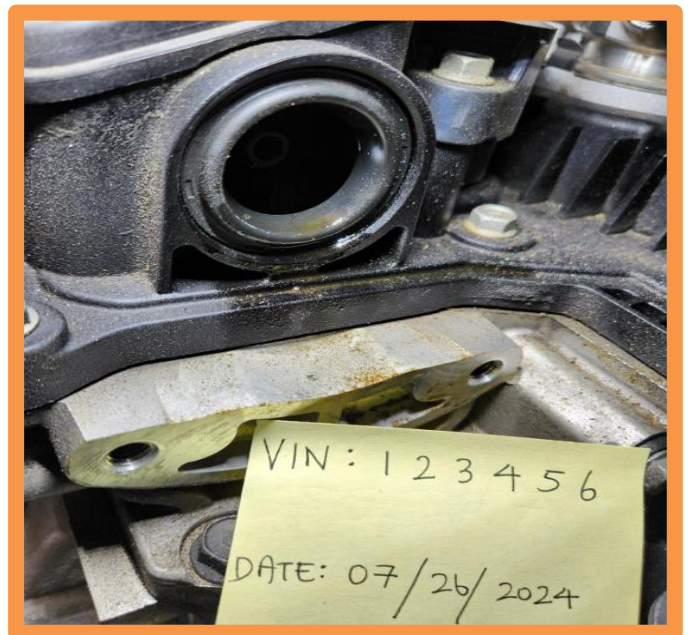
Using STUI, take a photo of the CVVD Oil Seal leak with the last 6 digits of the VIN and the date of inspection on a piece of paper.

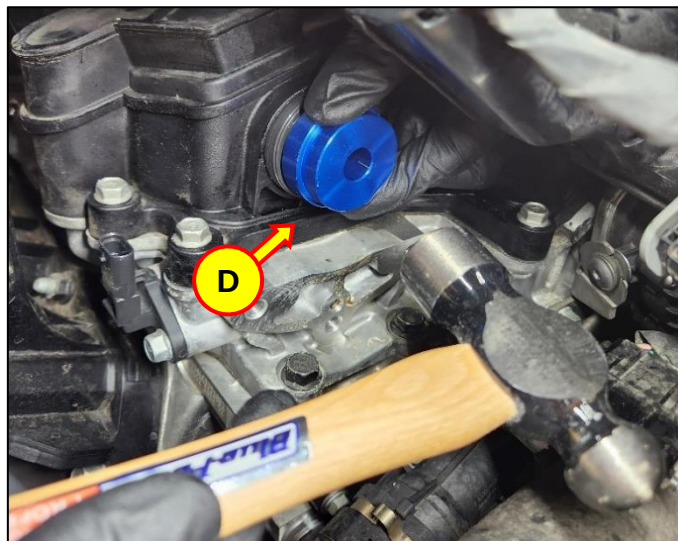
5. Using a commercially available seal installer (D) and hammer, install the new oil seal to the rocker cover until it has seated flush to the cover.

Ensure the oil seal is installed evenly.

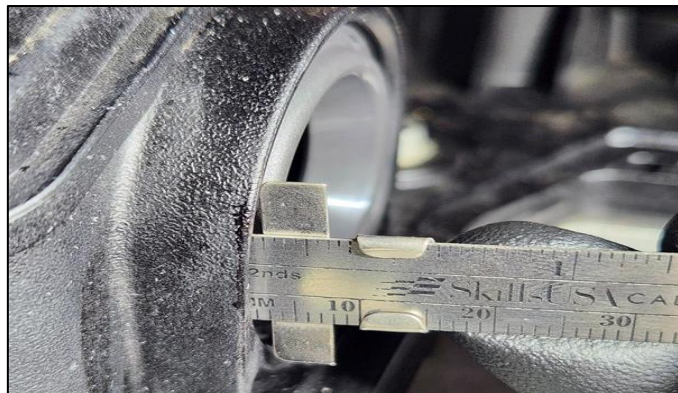
6. To verify the CVVD seal has seated evenly, you may use a small ruler to measure the depth of the seal at 4 different points.

Seal depth specification: 2–3mm
