Technical Service Bulletin

GROUP BODY ELECTRICAL	NUMBER 25-BE-014G
DATE JUNE 2025	MODEL(S) G80 (RG3) G80 ELECTRIFIED (RG3 EV)

SUBJECT: HORN REPLACEMENT & EXTENSION CABLE INSTALLATION

Description: Certain G80 (RG3) and G80 Electrified (RG3 EV) vehicles may have an inoperable horn due to an exposure to moisture from the horizontal mounting position. This bulletin provides instructions to replace and vertically mount the horns and add a LH extension cable for the LH horn.

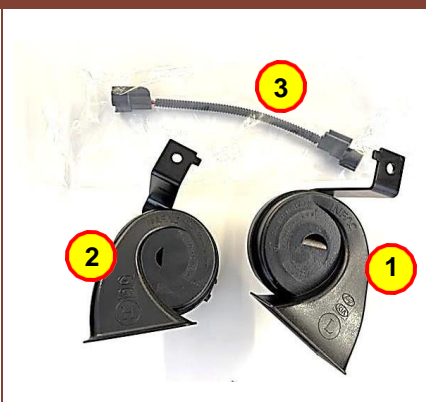
Contents: 1. LH Horn (low pitch) (QTY: 1) 2. RH Horn (high pitch) (QTY: 1) 3. LH Extension Cable (for installing the LH Horn) (QTY: 1)
	Cable Ties	N/A

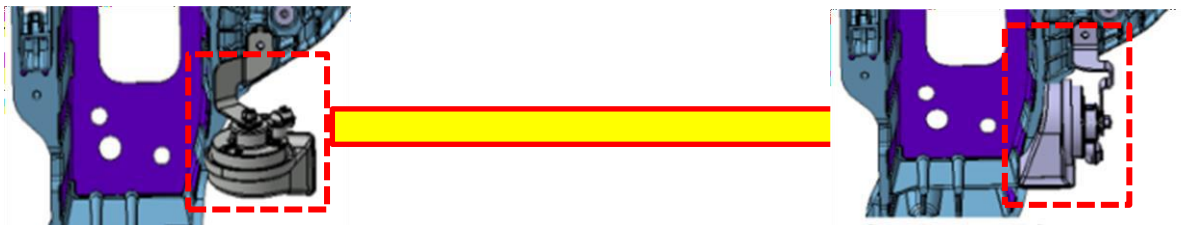
Previous horns were horizontally mounted and will **REQUIRE** the supplied horns to be **VERTICALLY MOUNTED**.

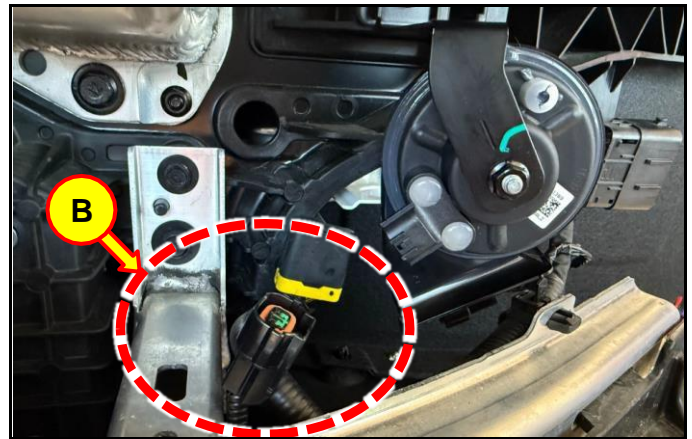
1. Install the LH horn (A) and route the LH extension cable (B) through the spaces between the front bumper rail and wiring harness.

The supplied horns will be **VERTICALLY MOUNTED**.
