# TECHNICAL SERVICE BULLETIN

Technical Service Bulletin: 10-1938  
Service Campaign: 001221

An alignment screw may have been used on the tub base flange that will cause the toilet tank to leak.

# Tub Base Flange Inspection

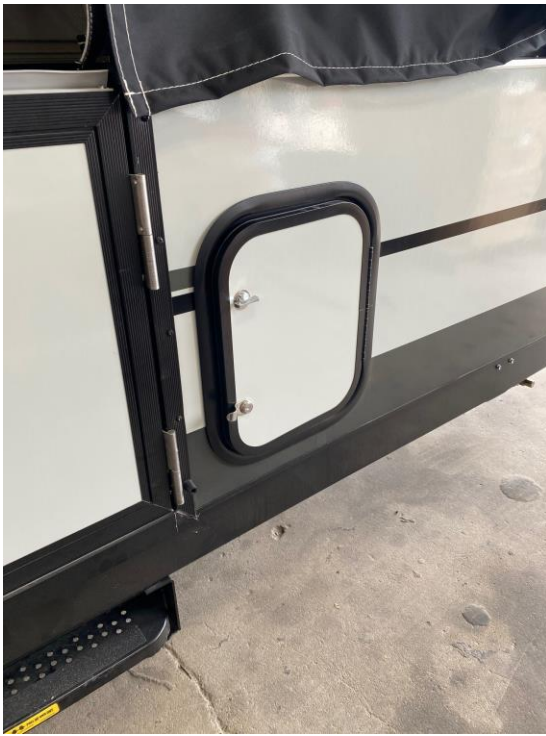
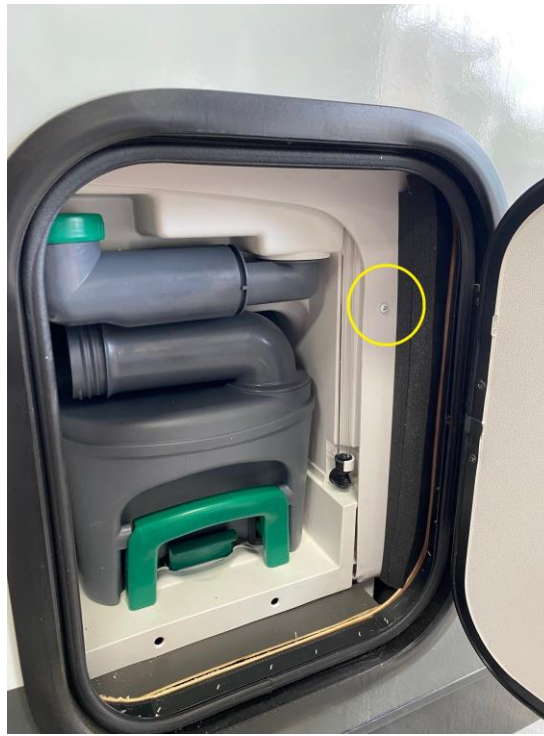
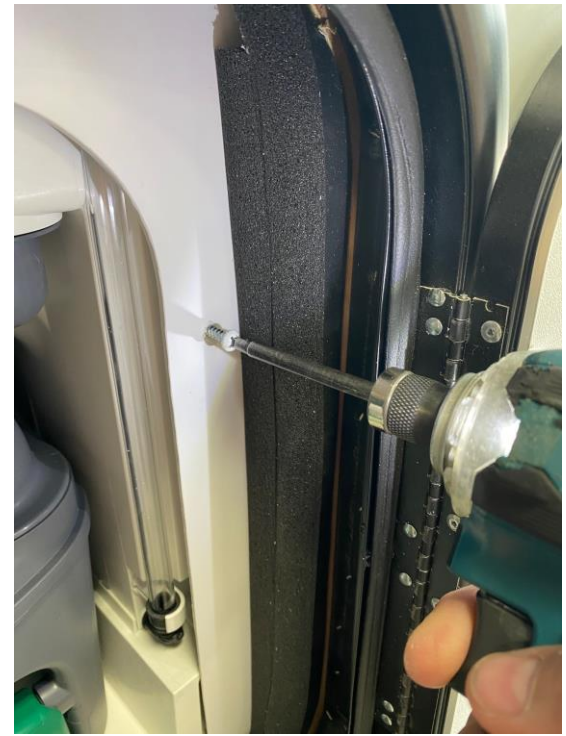
# Step 1

- Open cargo door located in front of entry door. Locate and remove screw that is mounted on the front right flange of the tub base (yellow circle).

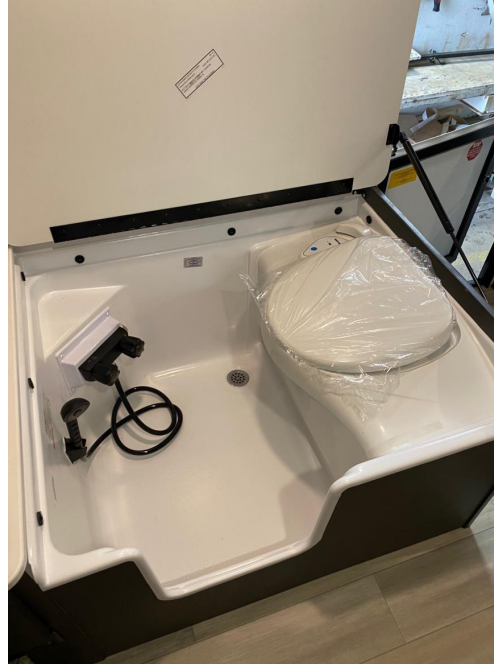
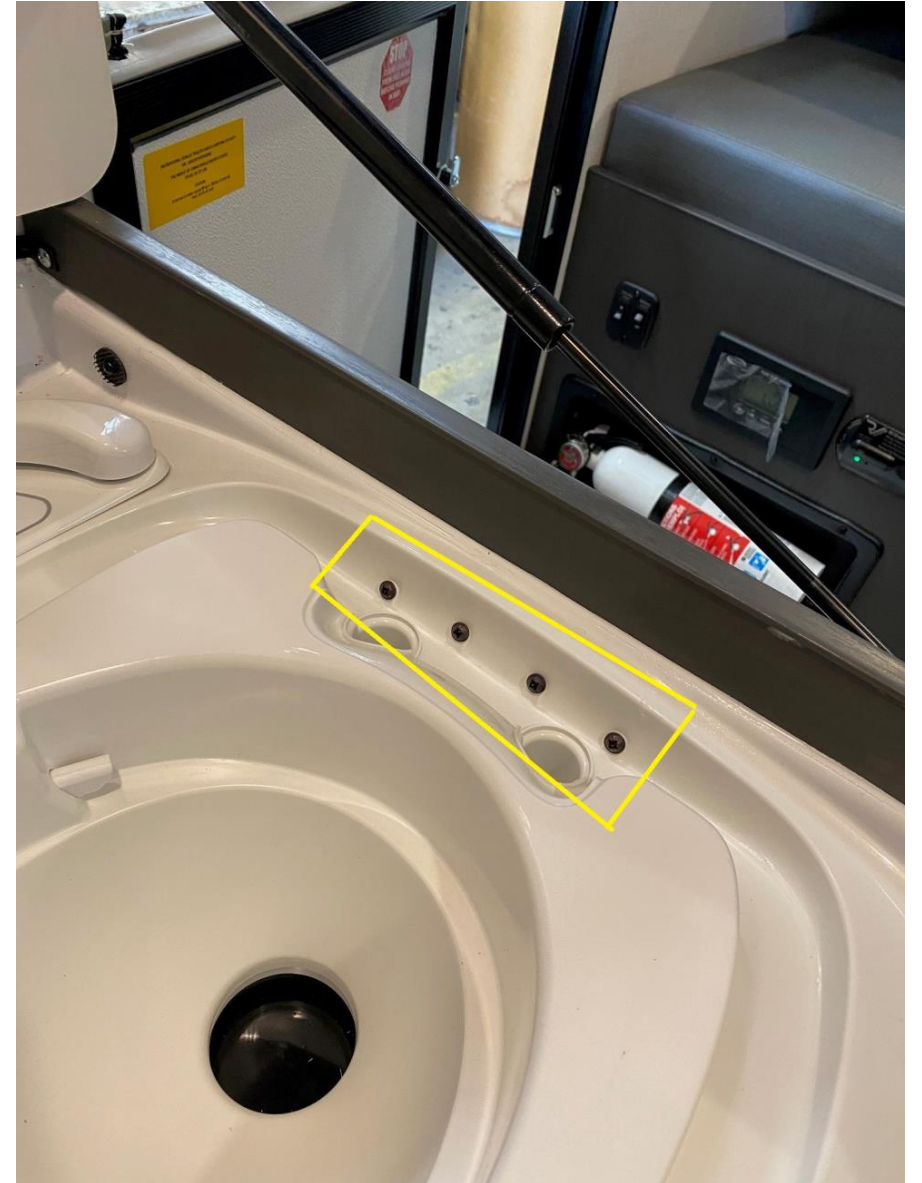
# Step 2

- Remove toilet seat
- Locate and remove the 4 mounting screws

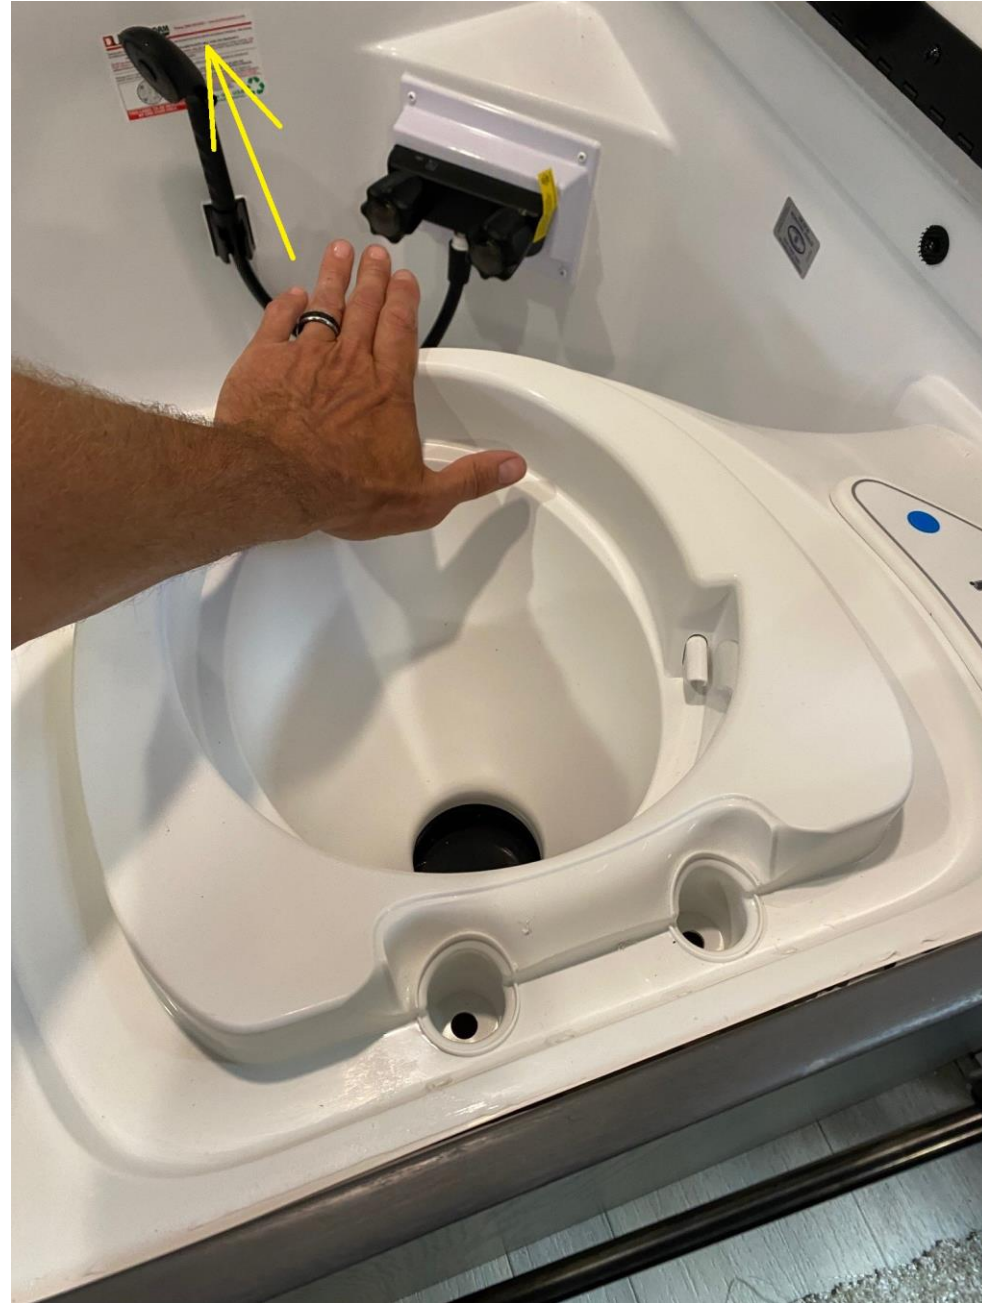
# Step 3

- While standing behind the toilet, push forward on the front of the toilet bowl.
- This will tip it towards the front and will separate the seal from the tub base

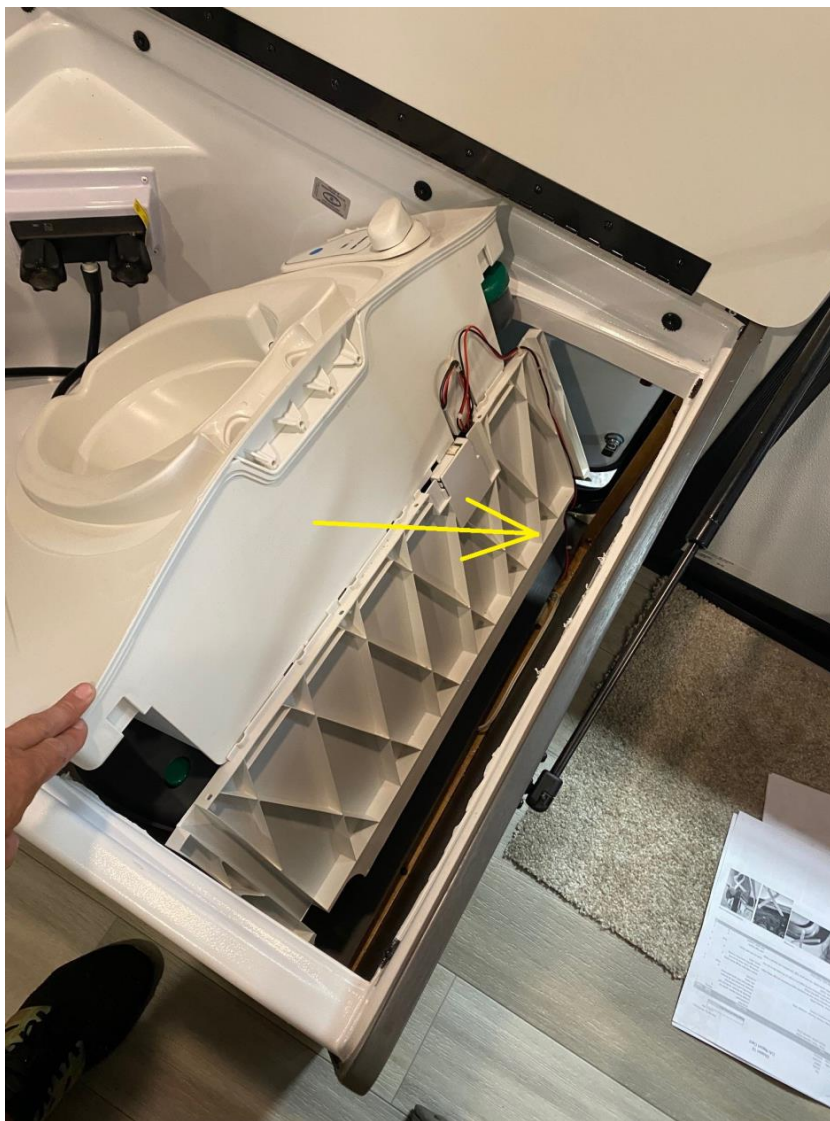
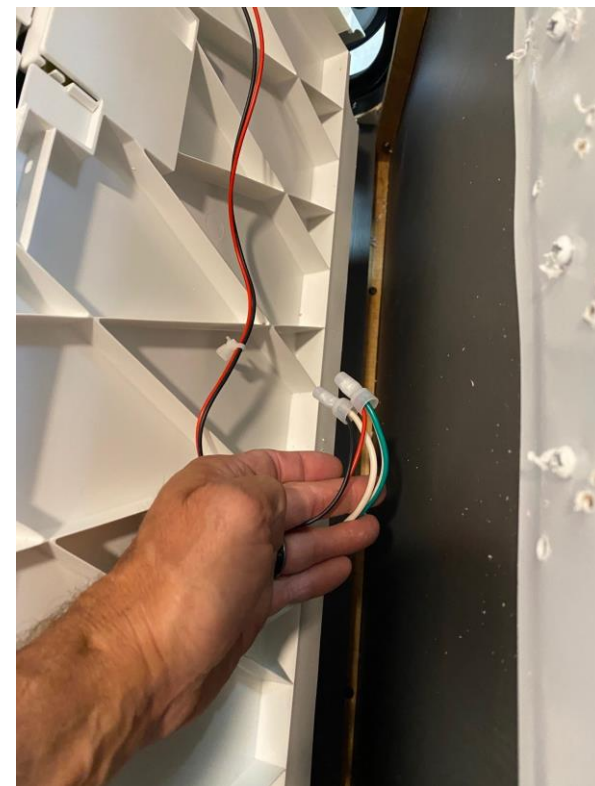
# Step 4

- Locate and disconnect the 12V wire terminals on the back side of the toilet
- Remove toilet from tub base

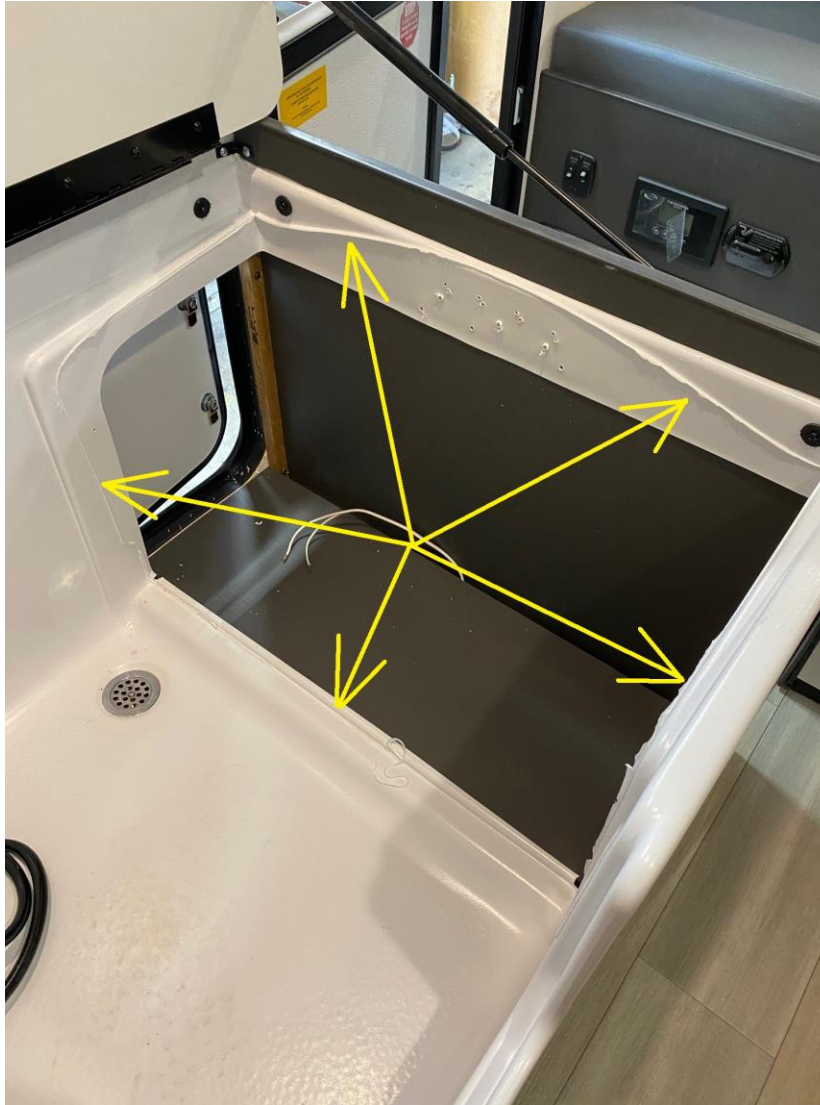
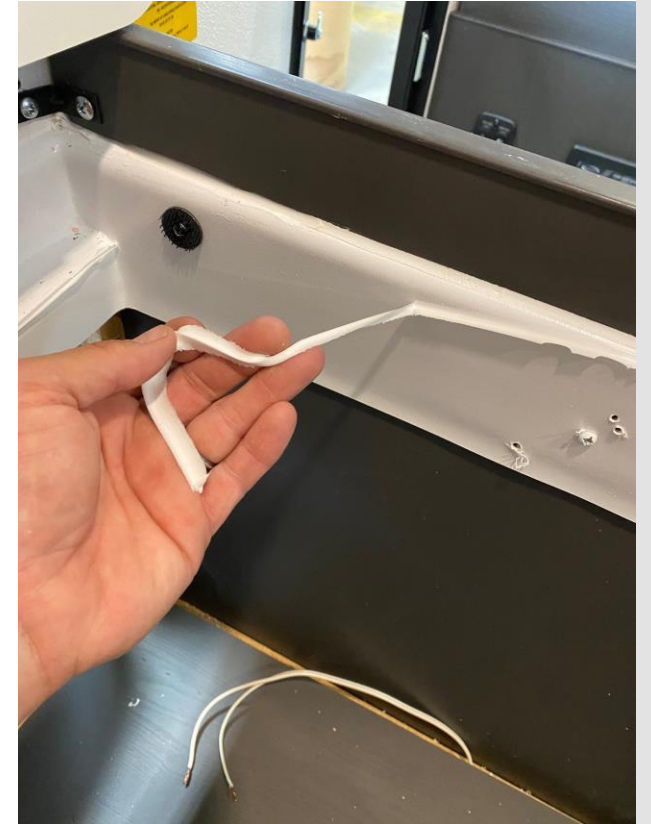
# Step 5

- Use rubbing alcohol and a rag to remove all existing sealant that is on the tub base
- Do not use heavy duty cleaners, such as lacquer thinner, as these products will damage the tub base

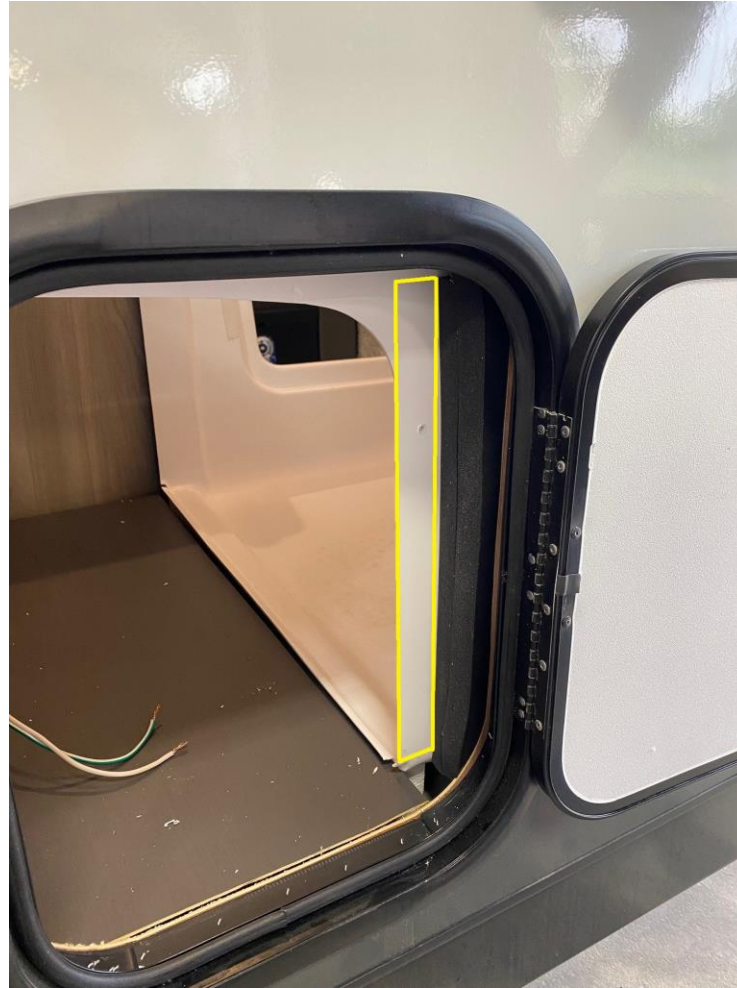
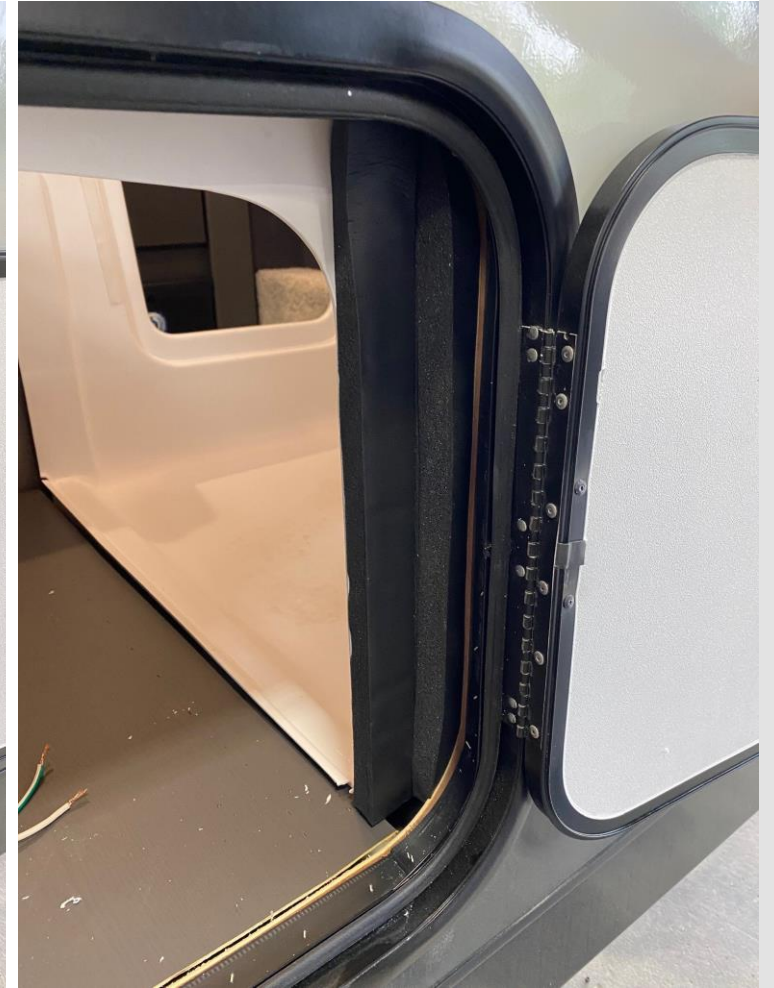
# Step 6

- Install foam strip along the edge of the tub base flange as shown

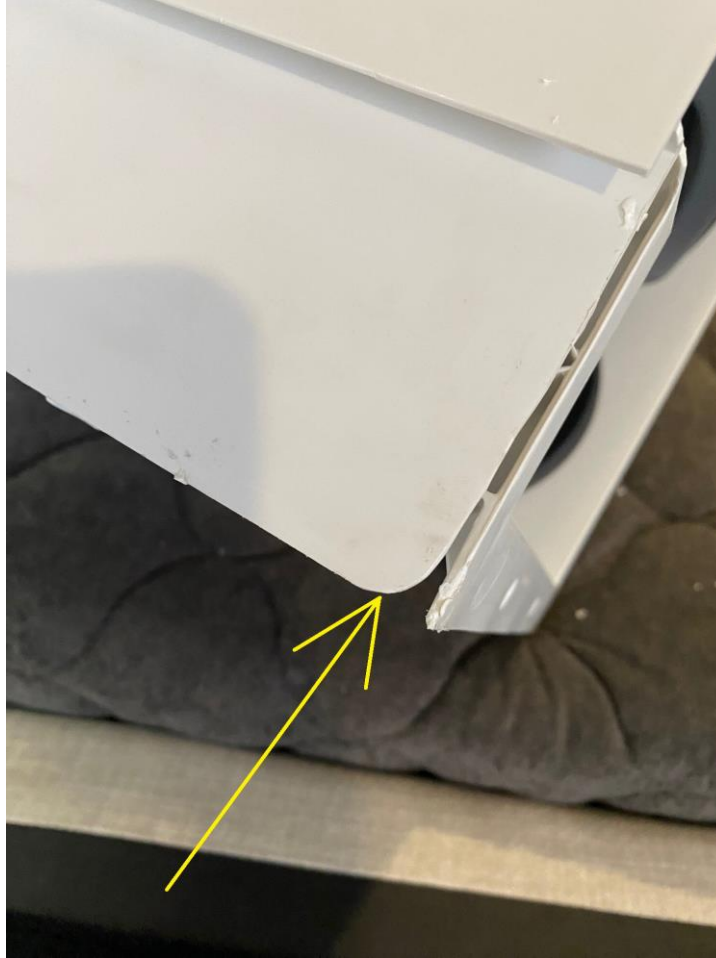
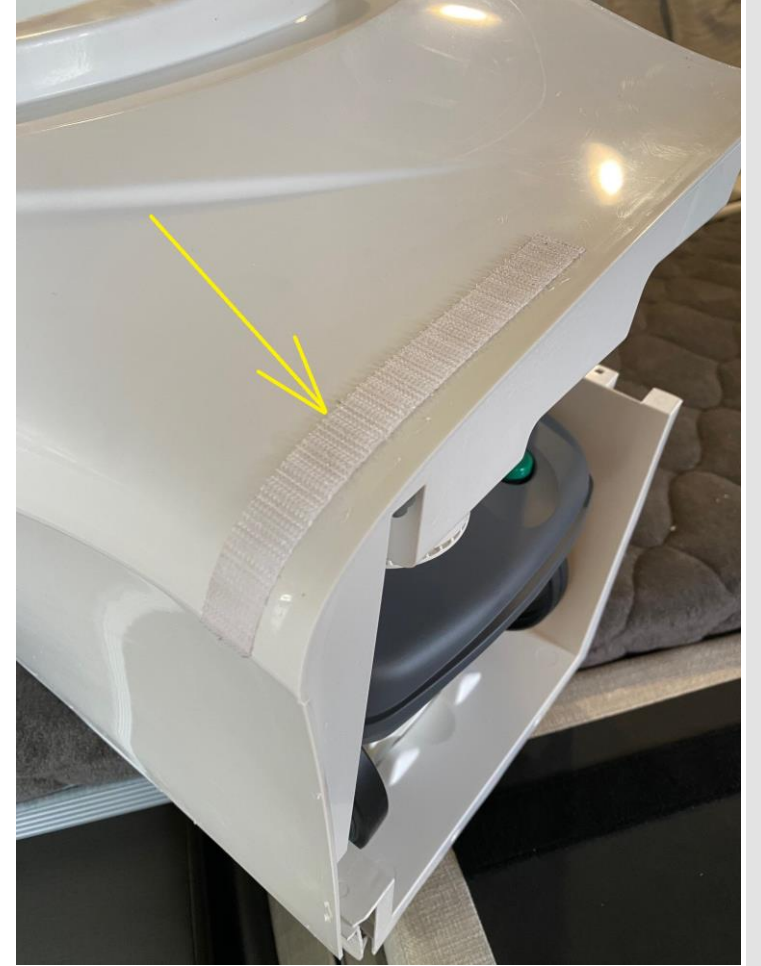
# Step 7

- Toilet will come prepped from the factory with the front corners trimmed and the Velcro installed

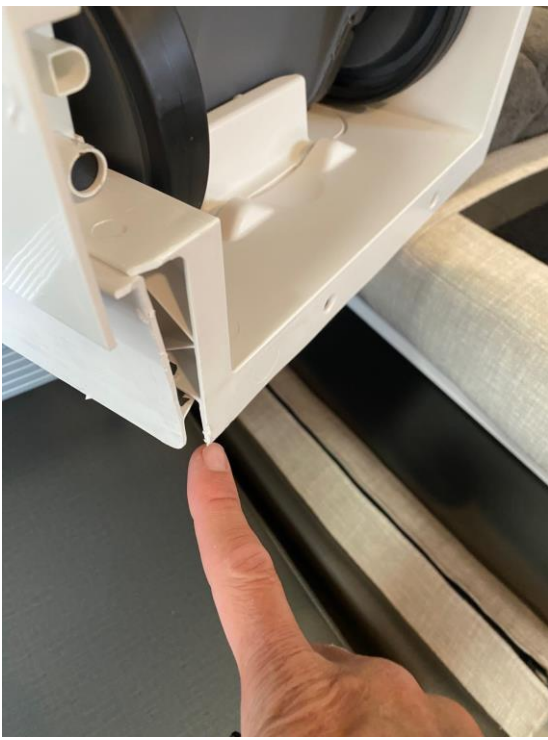
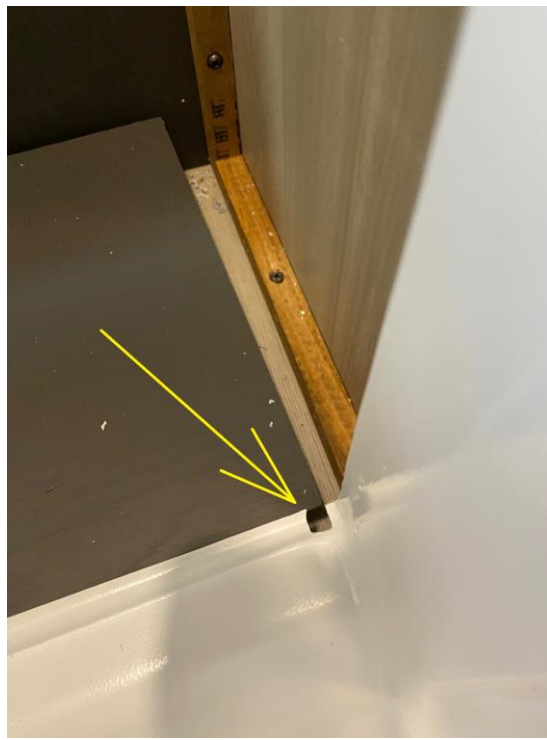
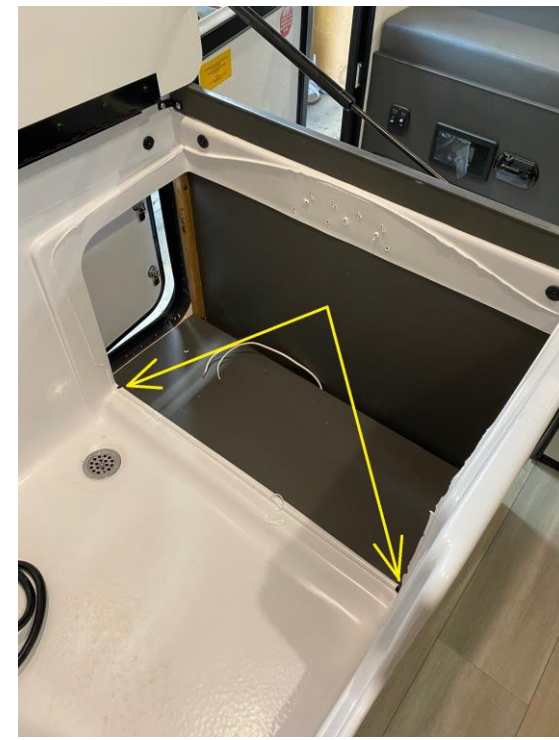
# Step 8

- When placing the toilet back onto the tub base make sure that the two front corner flanges rest into the notches on the tube base for proper fitment

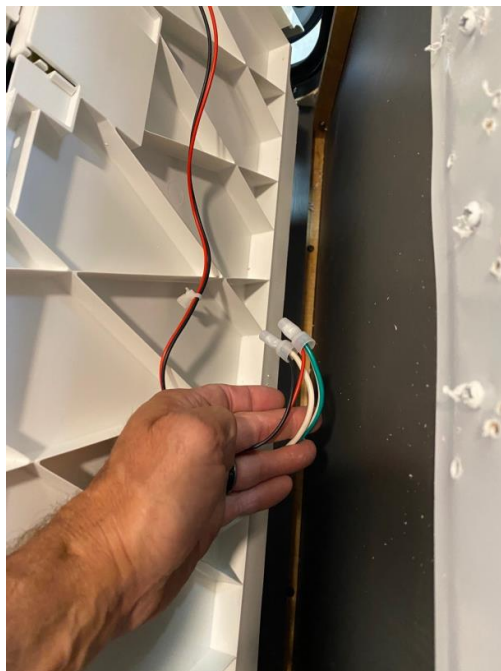
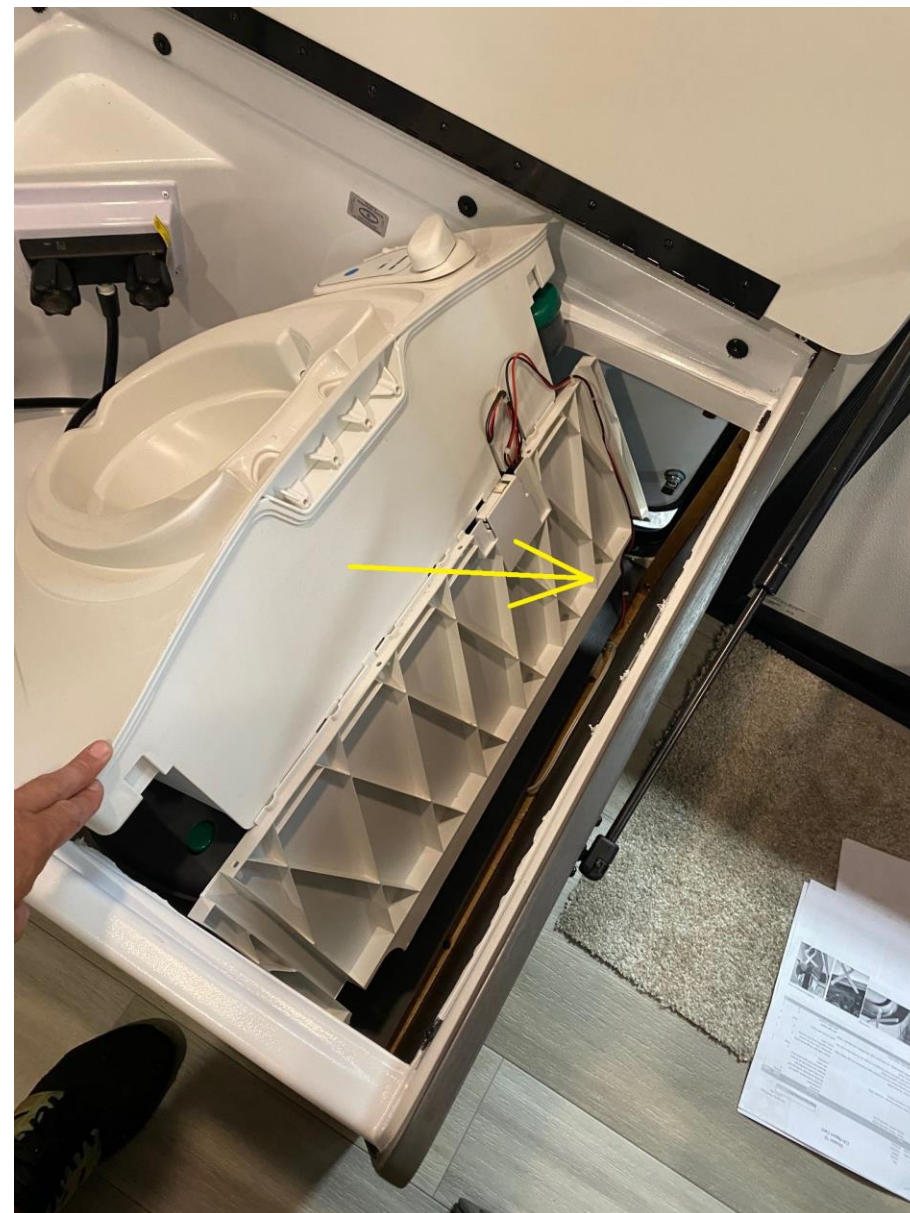
# Step 9

- Reconnect the 12V wiring and tuck it back into the corner before tipping the toilet back into position

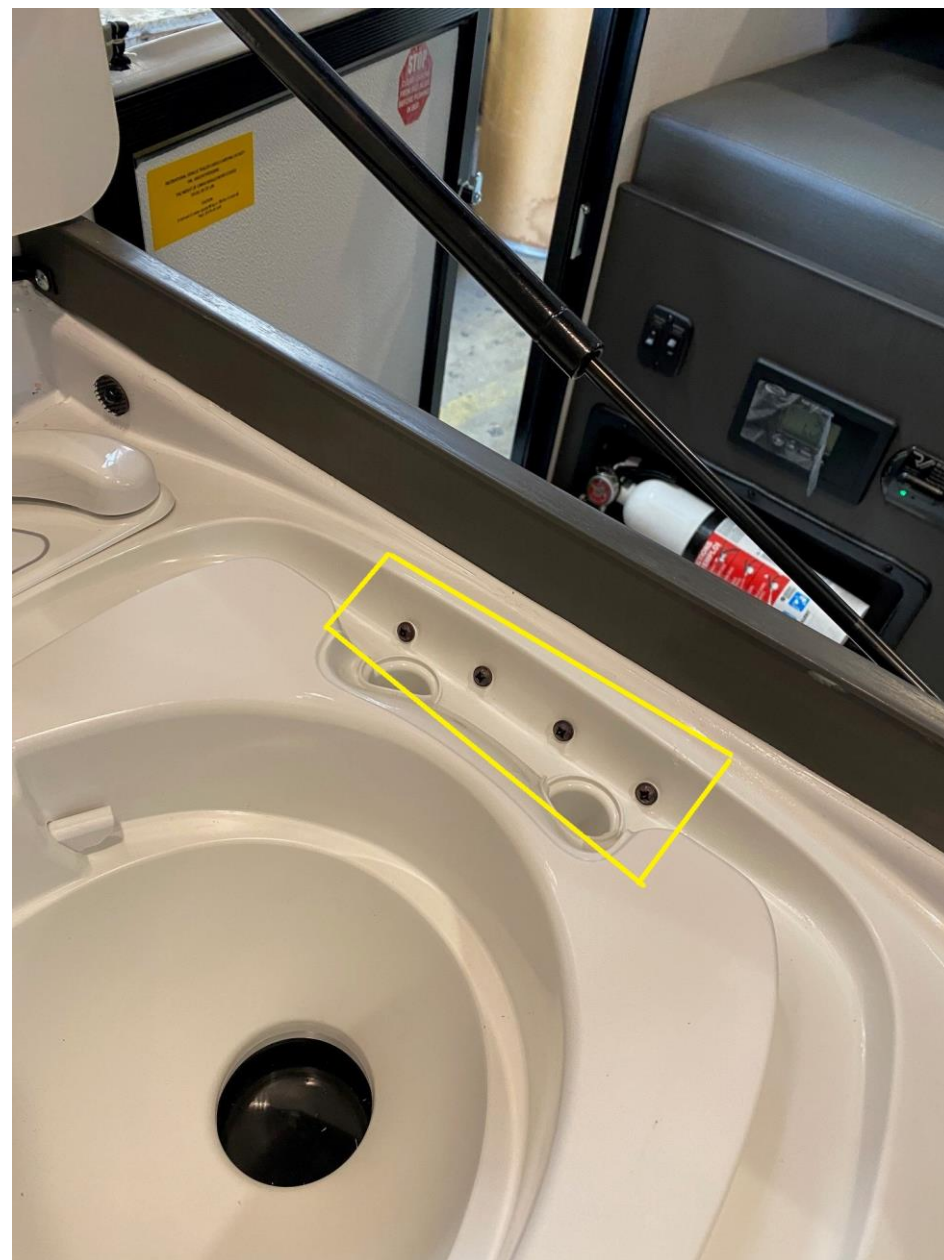
# Step 10

- Screw toilet to tub base

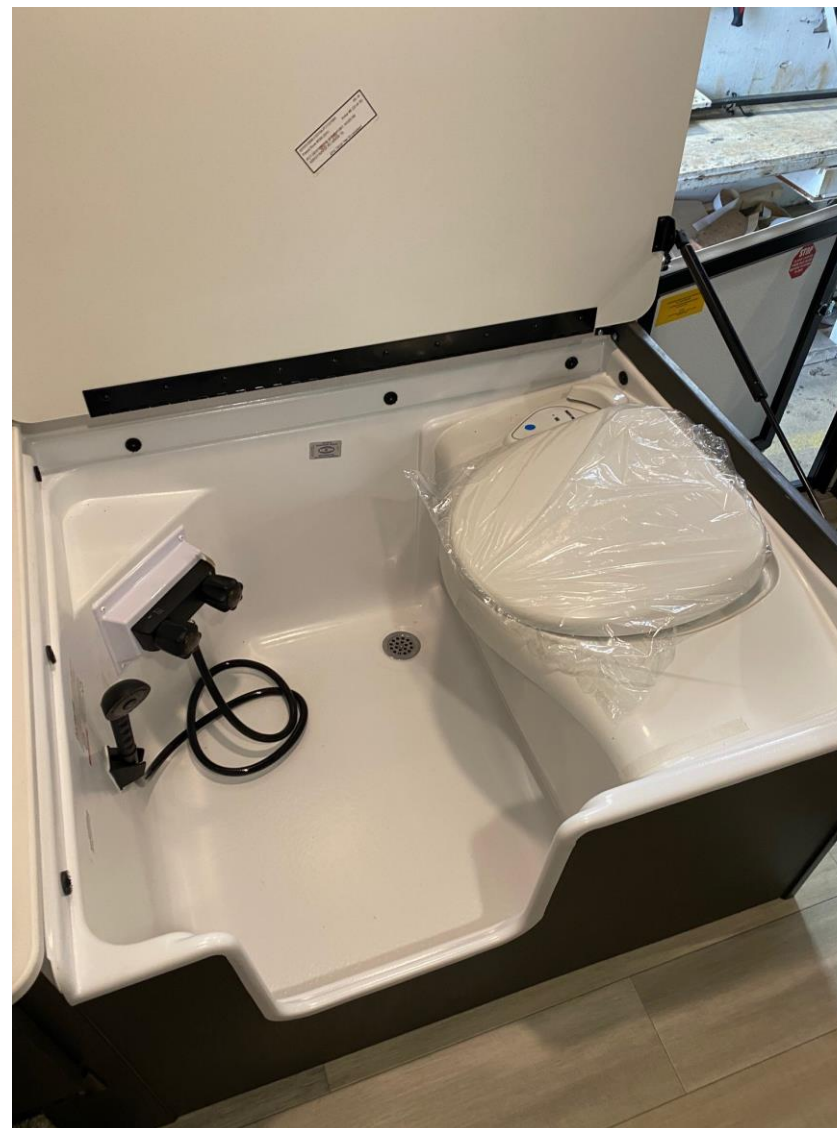
# Final Step

- Reseal the entire perimeter of the toilet to the tub base
- Install toilet lid

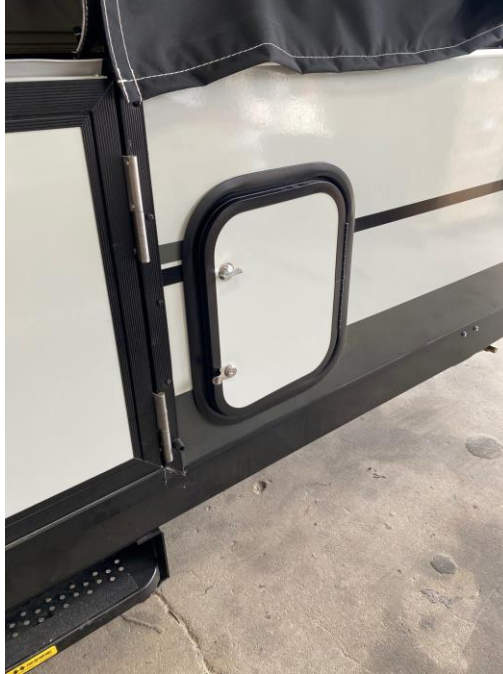
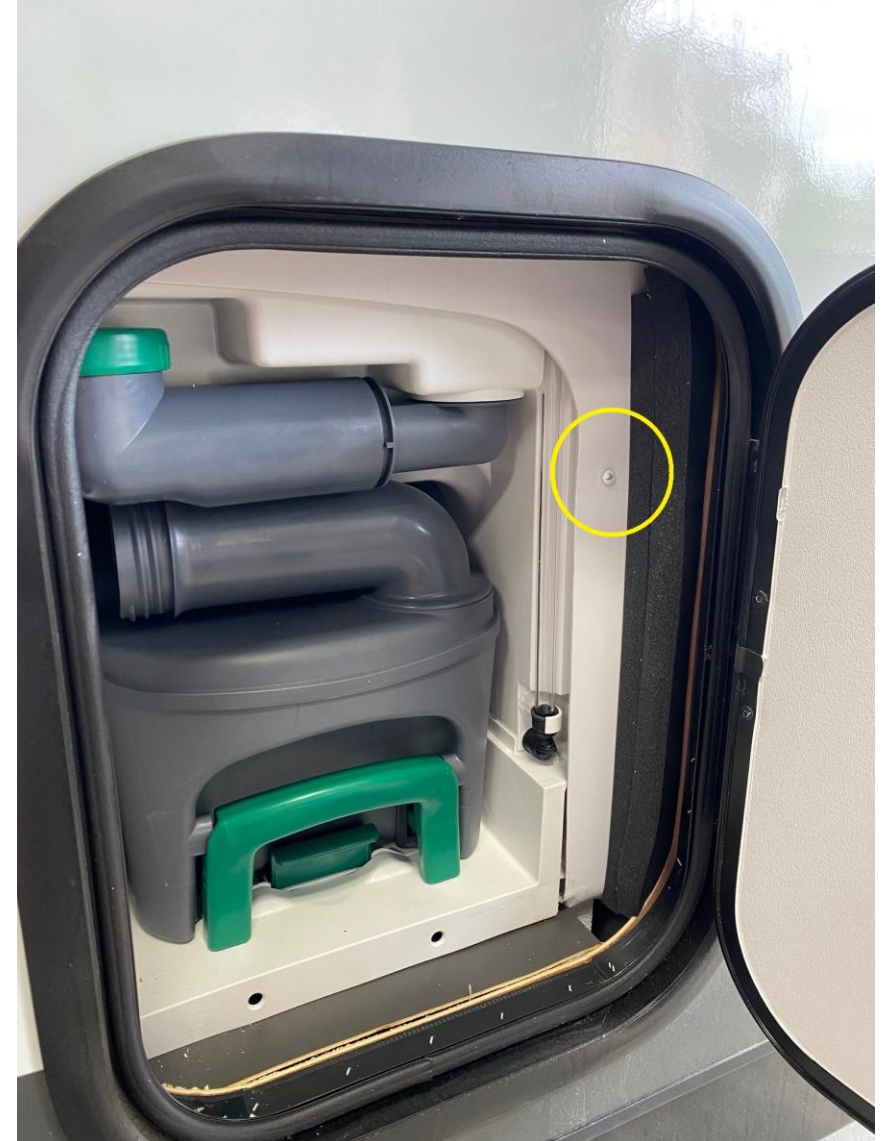
# Tub Base Flange Inspection

The following is to check and see if alignment screw was used on the tub base flange that will cause the toilet tank to leak.

- Open cargo door located in front of entry door. Look for a screw that is mounted on the front right flange of the tub base (yellow circle). If screw is present, repairs need to be made.
