## Silverware Drawer Magnets

| <b>Bulletin Type:</b> | TSB | <b>Publication Date:</b> | June 2025 |

| <b>Incident:</b> | Silverware tray magnet installed with ½" magnet instead of ¾" magnet |
| <b>Affected Units:</b> | 2026 Jayco Pinnacle FW |

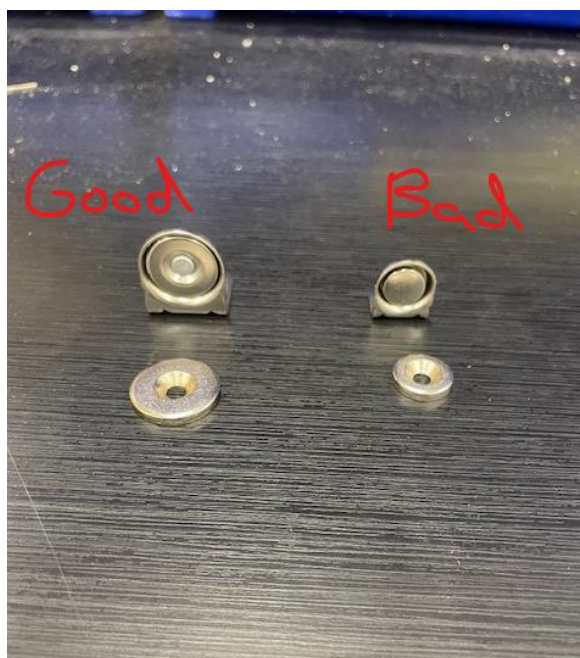
1. If the ¾" magnet on the left is installed, nothing more is needed. If the ½" magnet on the right is installed, proceed to change out with the ¾" magnet shown on the left.

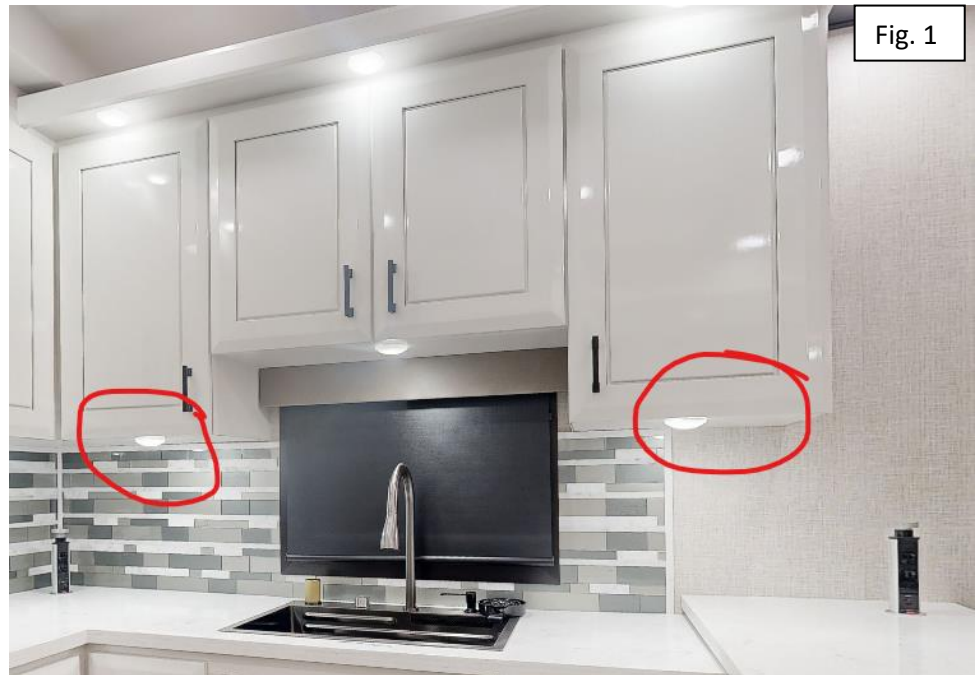
1. Figure 1 shows the location of the drawer where the magnet needs replaced.
