Service Bulletin

Bulletin No.: PIP6072

Subject: R1234YF Flush Error Message Information

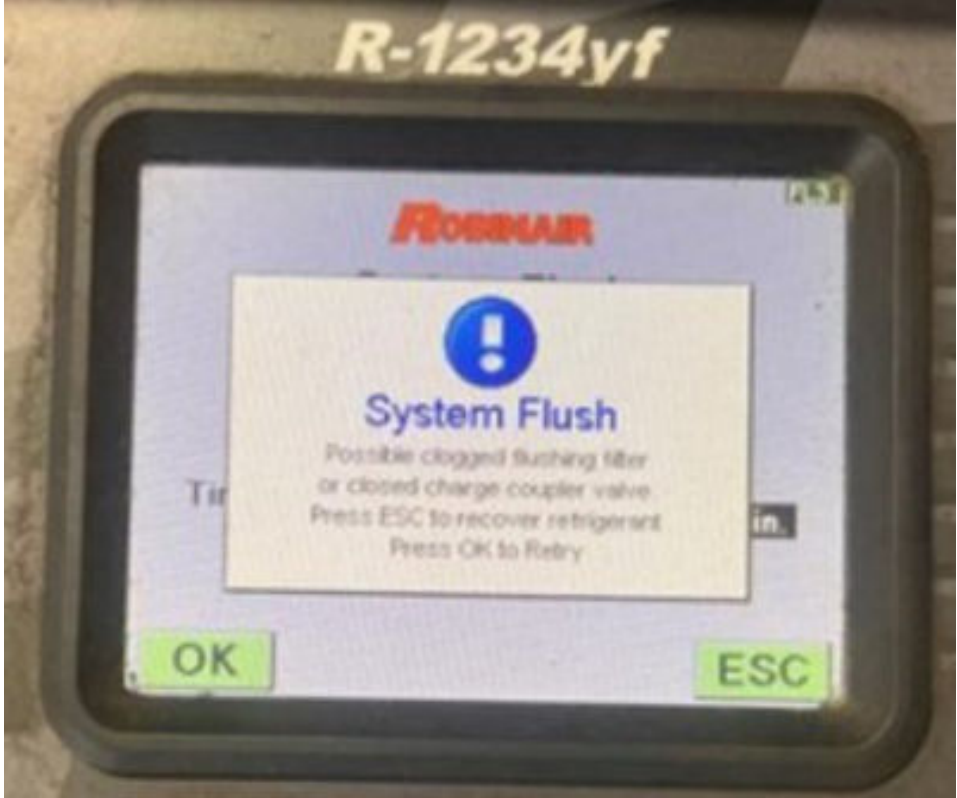
Involved Region or Country	North America
Condition	<p>While performing refrigerant flushing procedures, dealers may encounter an error message on their equipment indicating there is a possible clogged flushing filter or closed charge coupler valve when the filter is clear and the charge coupler valve is open.</p>

<p style="text-align: right;">6954820</p>
Cause	<p>A possible cause for this condition is that a restriction is detected by the equipment due to design changes between older flushing adapters (GE-45268-130) and new revisions of the adapters (GE-45268-130-A).</p> <p>When service equipment is connected to the GE-45268-130, and the knob on the back of the quick connect is tightened, the core depressor in the quick connect end blocks the passage of refrigerant through the adapter.</p>

If dealers encounter this error message and determine that it is being caused by an incorrect adapter, they are encouraged to order the appropriate adapter through the Dealer Equipment and Special Tools portal in Global Connect whenever possible.

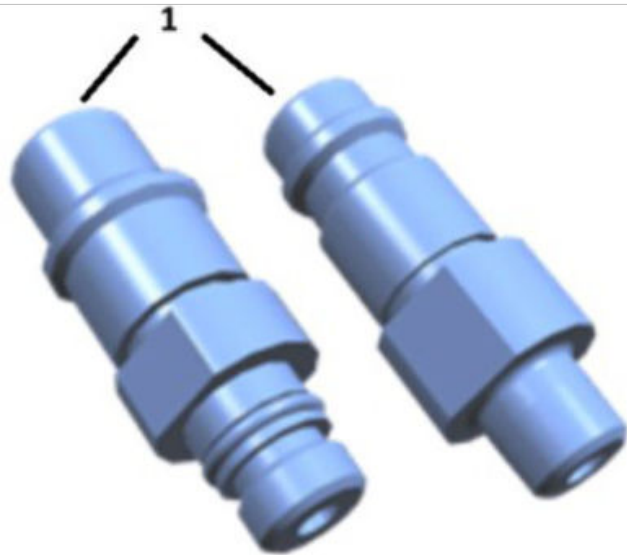
6954821

The passage through the middle of the GE-45268-130-A adapter is the size of a 1/4 inch drill bit and the prior adapter GE-45268-130 has a smaller opening.

1 Above shows the portion of the adapter that should have a 1/4 inch opening

Our suppliers are working to remedy this situation by modifying their inventory of the GE-45268-130 adapter to meet GE-45268-130-A standards by enlarging the passage through the adapter or by acquiring the correct revision of the adapter to make them available for dealers.
