MAS004770 MCL 25-32

Levante / Grecale Rear Window Wiper Water Pipe Repair Kit

MODELS AFFECTED: M182 Grecale, M182 Levante (ALL MODEL YEARS)

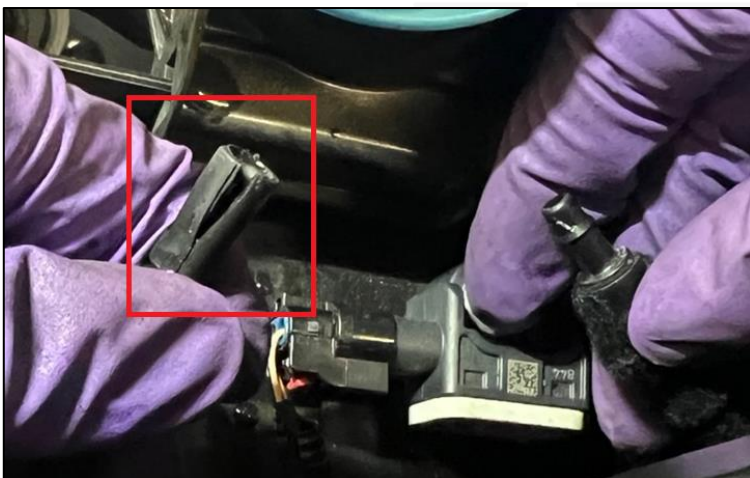
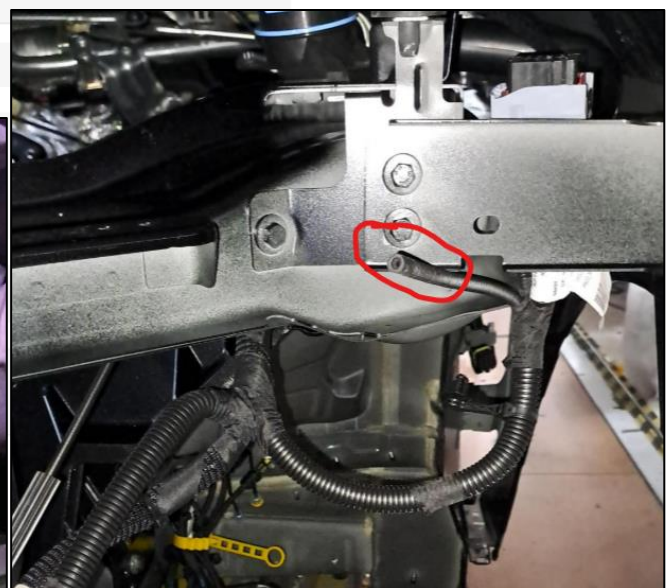
Washer fluid leakage may occur due to a faulty delivery pipe connection.

In previous cases, because the pipe is routed inside the corrugated engine compartment harness, replacing the entire harness was required.

To simplify repairs, a dedicated pipe repair kit is now available.

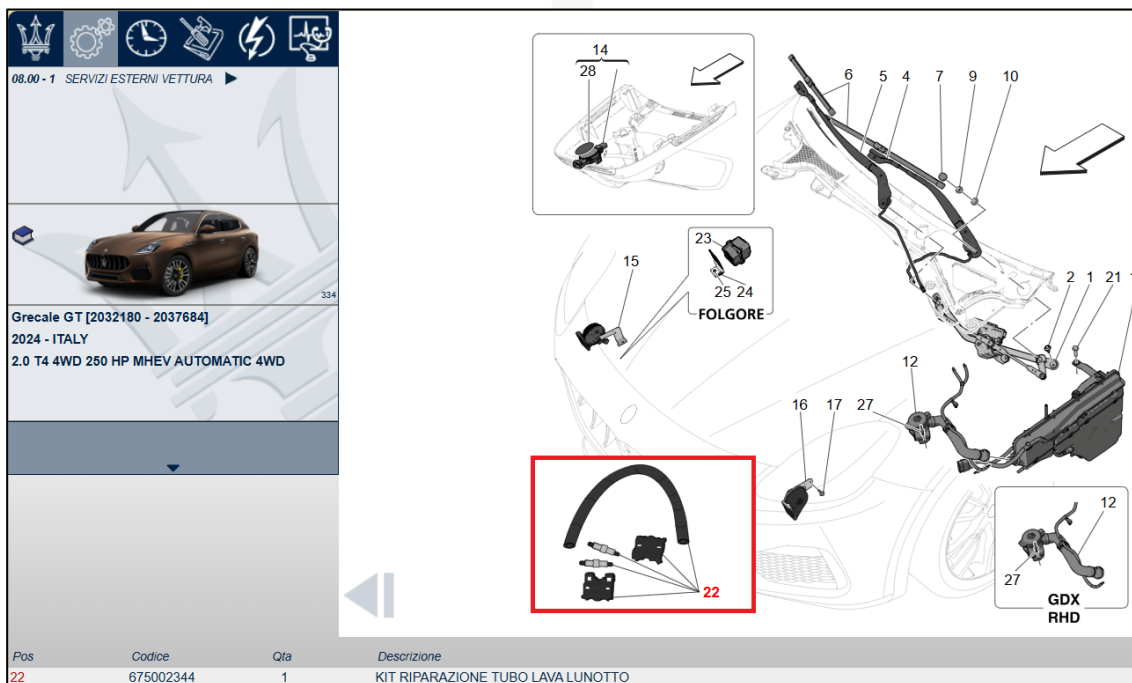
To avoid replacing the engine compartment wiring harness, the following P/N is available:

- #675002344 = REAR WINDOW WASHER PIPE REPAIR KIT (Spare Parts Catalog -> Section #08.00-1 -> Component #22).
