SIB 31 01 25

SERVICE SOLUTION: Right Telescopic Fork Cover Allegedly Leaking

Model	Model Description
K67	S 1000 RR
KM3	M 1000 R
KM9	M 1000 XR

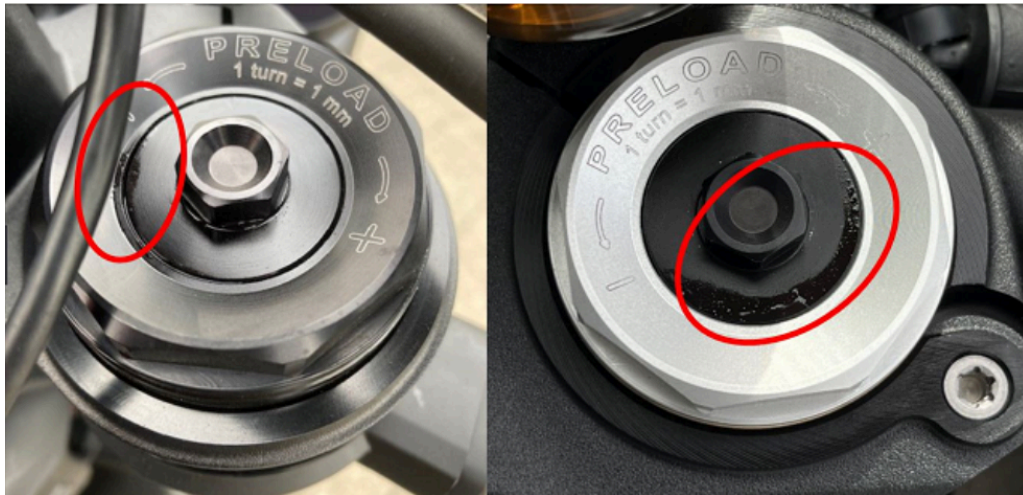
On several M 1000 XR, M 1000 R and S 1000 RR vehicles with Front telescopic fork covers (Part numbers 31 42 1 754 557 and 31 42 1 757 701) lubricant residue is visible on the right fork cover.

This is assembly grease, not a leaking fork cover. Several covers have been leakage tested and no leak was found.

In the event of a complaint. Explain to the customer what the alleged leak is and proceed to clean the cover with a suitable cleaning agent.
