Field campaign

Topic	Incorrect Spec Puddle Lamps Fitted Bentayga Series 25MY (SC25/27)
Market area	Bentley: worldwide (2WBE),China 796 VW Import Comp. Ltd (Vico), Beijing (6796)
Brand	Bentley
Transaction No.	2078053/2
Campaign number	ED50
Note	
Type	
US code

Bentayga Series 25 Model Year

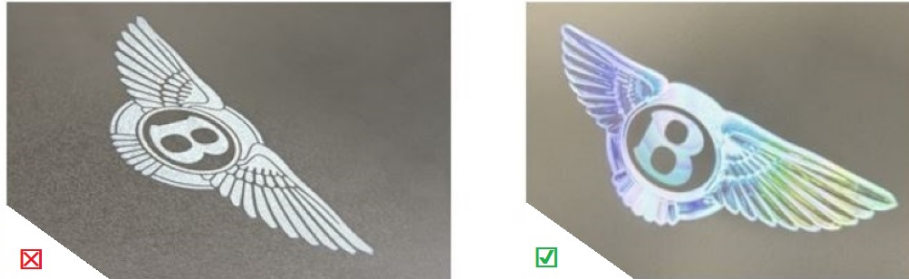
The specific vehicles should have been fitted with 'Animated Movie' lamps. However, 'Standard Wings' lamps were fitted instead (Figure 1).

Figure 1 Not OK and OK condition of the puddle lamps

Replace the fitted puddle lamp to the correct specification for each door. Please refer to the Work section and conduct all instructions to completion

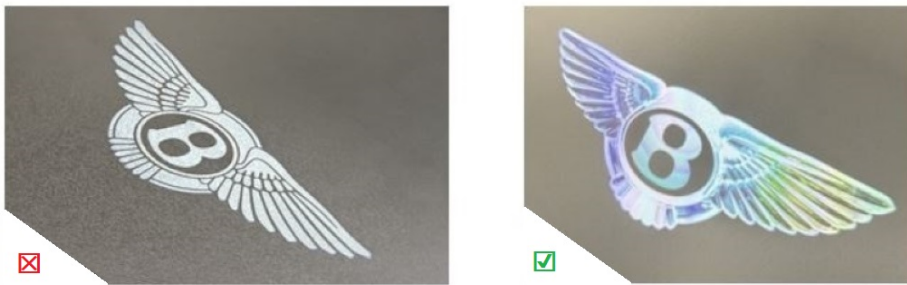
The specific vehicles should have been fitted with 'Animated Movie' lamps. However, 'Standard Wings' lamps were fitted instead (Figure 1).

Figure 1 Not OK and OK condition of the puddle lamps

- Open the door.
- Confirm that the 'Animated Movie' lamps are not active, See figure 1.
- Raise a Technical DISS and wait for approval and release of the correct specification parts.
