Technical Service Bulletin

Topic	HVAC refrigerant leakage suspected or reports of a damp/musty smell within the cabin - Diagnosis guidelines
Market area	Australia E04 Bentley rest Asia and Australia (6E04),China 723 Volkswagen (Anhui) Automotive CO (6723),China 796 VW Import Comp. Ltd (Vico), Beijing (6796),Germany E02 Bentley rest Europe (6E02),Japan E03 Bentley Japan (6E03),Korea, (South) E08 Bentley South Korea (6E08),United Arab Emirates E06 Bentley Middle East and Africa (6E06),United Kingdom E01 Bentley UK (6E01),United States E05 Bentley USA and rest America (6E05)
Brand	Bentley
Transaction No.	2069806/6
Level	EH
Status	Released for publishing
Release date	Jun 26, 2025

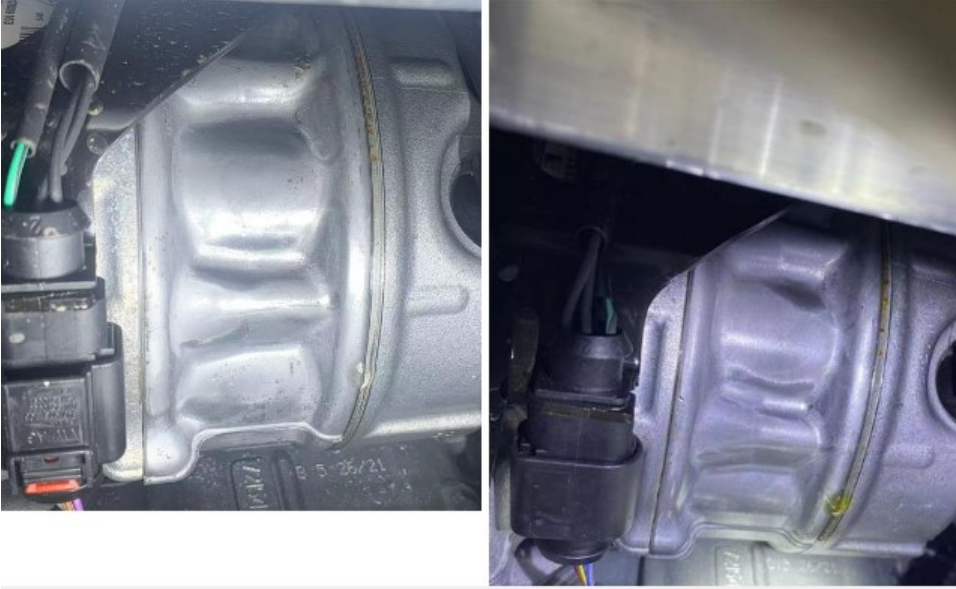
Figure 1

please refer to the examples shown below (Figures 1,2 and 3) of leaks found on the HVAC compressor

The leaks in these scenarios were repaired after component replacement however as the parts were not at fault the actual fix of the leak would have been resolved by replacing O-rings only

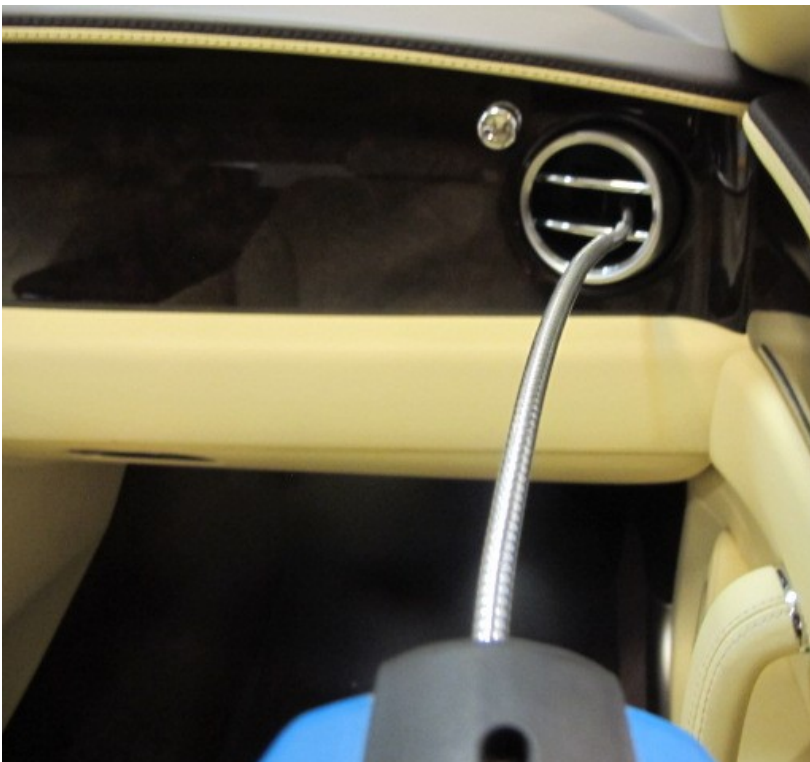
Figure 4

In the event the HVAC sniffer tool traces a HVAC leak from any of the outlets (Figure 4)

The operative **MUST** first ensure that a leak is not evident within the plenum chamber or around the centre console (Figures 5 and 6) as refrigerant could be leaking into the plenum chamber/cabin, and recirculated back into the cabin which

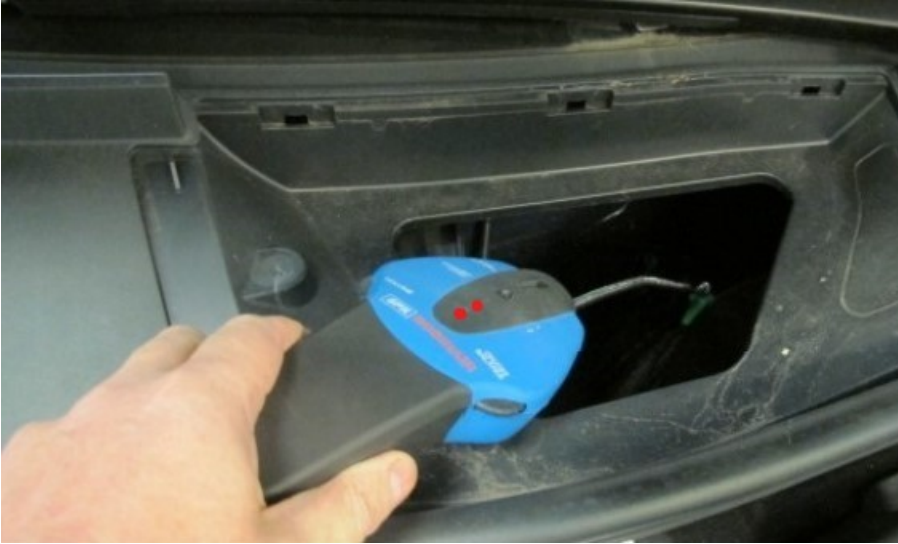
Figure 5

could lead to misdiagnosis and/or incorrect part replacement.
