# Technical Service Bulletin

<b>Topic</b>	Front Exterior Lighting Steamed Up/Leaks   12-24MY
<b>Market area</b>	Australia E04 Bentley rest Asia and Australia (6E04),China 723 Volkswagen (Anhui) Automotive CO (6723),China 796 VW Import Comp. Ltd (Vico), Beijing (6796),Germany E02 Bentley rest Europe (6E02),Japan E03 Bentley Japan (6E03),Korea, (South) E08 Bentley South Korea (6E08),United Arab Emirates E06 Bentley Middle East and Africa (6E06), United Kingdom E01 Bentley UK (6E01),United States E05 Bentley USA and rest America (6E05)
<b>Brand</b>	Bentley
<b>Transaction No.</b>	2050542/8
<b>Level</b>	EH
<b>Status</b>	Released for publishing
<b>Release date</b>	Jun 30, 2025

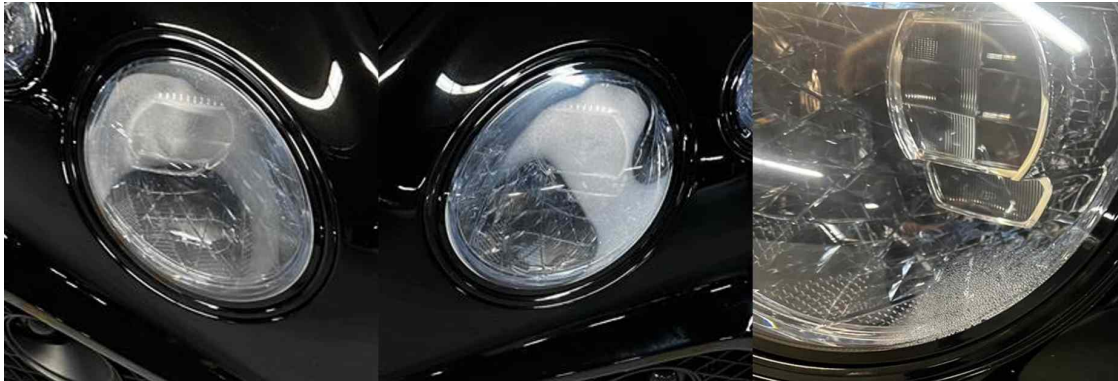
Figure 1

1. The lens of the headlights/front fog lamps are steamed up/damp from the inside with minor drips (Figure 1).

**Customer statement for 1 (Figure 1):** The lenses of the headlights/front fog lamps are steamed up/damp from the inside with minor drips.

1. Damp air settles on the inner lens of the headlights/fog lamps, with recognisable misting in certain weather conditions (comparable with the steaming up of spectacle lenses when entering a warm room in winter or of the bathroom mirror after a shower).
2. Leak on the headlights/front fog lamps. For example through open covers, a damaged seal of the cap or similar.

1. In case of a headlight complaint the light emission surface on the lens must be clear after a journey of 5-10 minutes with sufficient ventilation (for example country road/motorway) and switched-on dipped beam .

**The remaining inside surfaces may still have some condensation on them after the drive; this is not a problem.**

The time for the clearing process depends on the outside temperature, the relative air humidity and the vehicle speed (at higher speeds the ventilation of the headlights is better).

**NOTE: This is normal, in this case, a replacement of the headlights will NOT fix the problem and lead to a repeat repair.**

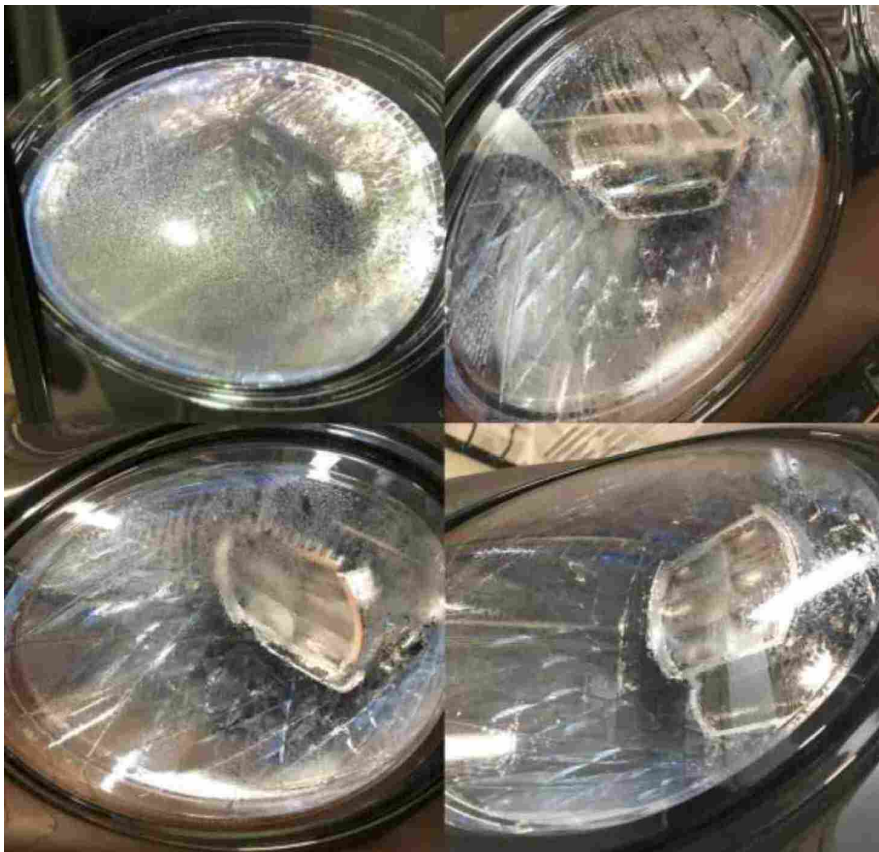
Figure 2

2. Water is in the headlight as water marks/large droplets (Figure 2).

**Customer statement for 2 (Figure 2):** Water is in the headlights/fog lamps, big drips on the complete lens. Leak on the headlights/front fog lamp.

2. In case of an obvious water ingress/leak (a lot of drips on the inside of the lens, Figure 2) use the test plan attached to establish the cause.

Dry the affected light with filtered, oil-free compressed air.

In case of water ingress (damaged seal/lens) perform the appropriate repairs according to the repair manual/parts catalogue and check whether the connectors or connections of any control units fitted, are damaged by corrosion.

Ask the customer to keep an eye on the situation. If despite the above repair, the customer complains again about leaking headlights/front fog lamps and water ingress or lots of drips can still be recognised after the checks, referring to Rep. Gr 94 - Replace the headlamps according to the repair manual/parts catalogue.
