**Volvo Car USA LLC**
**Technical Journal**

Technical Journal Title <b>Coolant Pump Dry Coolant Mix Residue</b>		Ref. No. <b>TJ 36923.7.0</b>	
Issuer (Dept.) <b>Technical Service</b>		Issue Date <b>5/6/25</b>	Status Date <b>5/16/25</b>
Car Market <b>United States and Canada</b>	Partner <b>3 US 7510 Volvo Car USA</b>	Function Group <b>2621</b>	
Function Description <b>Coolant pump, complete</b>		Page <b>Page 1 of 4</b>

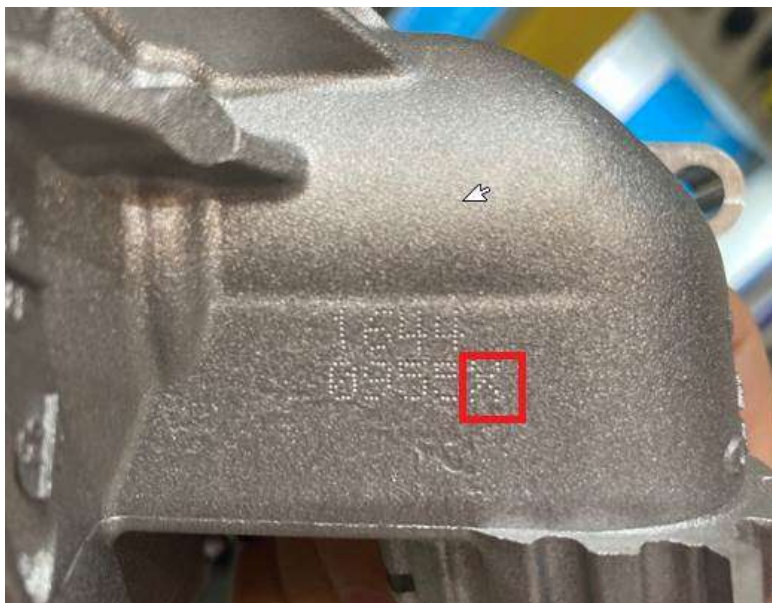
TJ 36923

If the coolant pump has a small sign of dry green/white coolant mix (see example as in attached picture TJ\_36923\_1) without a DTC set, follow advice under "Service".

If the coolant pump has a small sign of dry green/white coolant mix **but no other symptoms** (e.g. warning message(s), visible coolant leakage under the vehicle, etc.), this is considered OK, do not replace any parts.
