Rear Wheel Area Screeching or Scraping

Supersedes 24-059, dated July 31,-2024, to revise the information highlighted in **yellow**.

AFFECTED VEHICLES

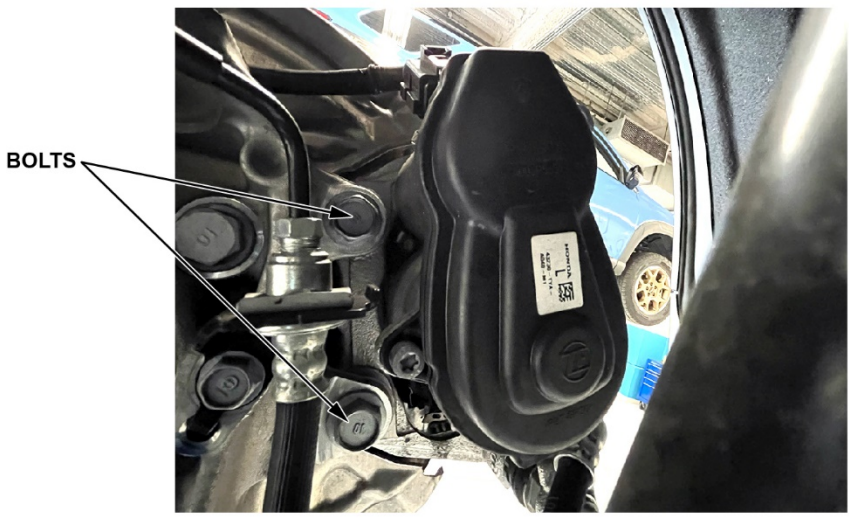
6. Remove the rear caliper and use a short piece of wire to hang the caliper assembly **108 N·m (80 lb-ft)**.
NOTE: To prevent damage **DO NOT** twist the brake hose excessively.

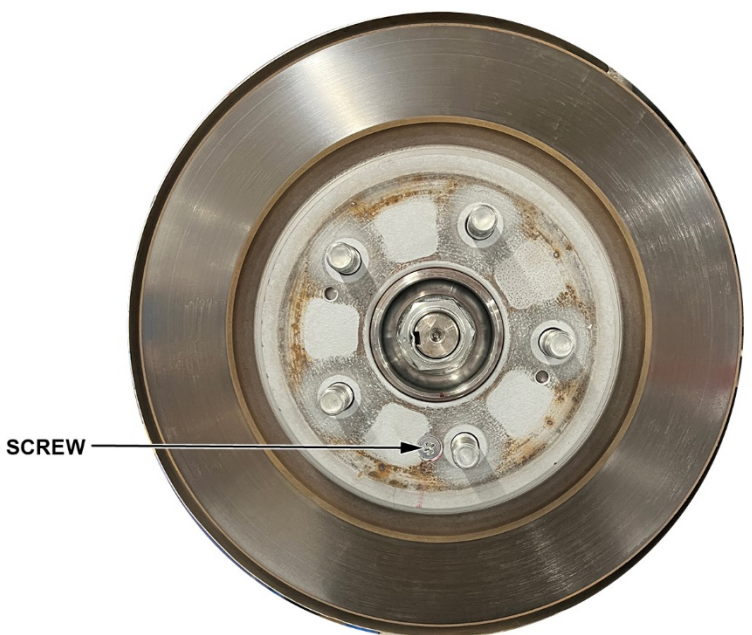
7. Remove the screw holding the rear disc, then remove the rear disc **9.5 N·m (7 lb-ft)**.
