Rear Wheel Area Screeching or Scraping

Supersedes 24-025, dated July 31, 2024, to revise the information highlighted in **yellow**.

AFFECTED VEHICLES

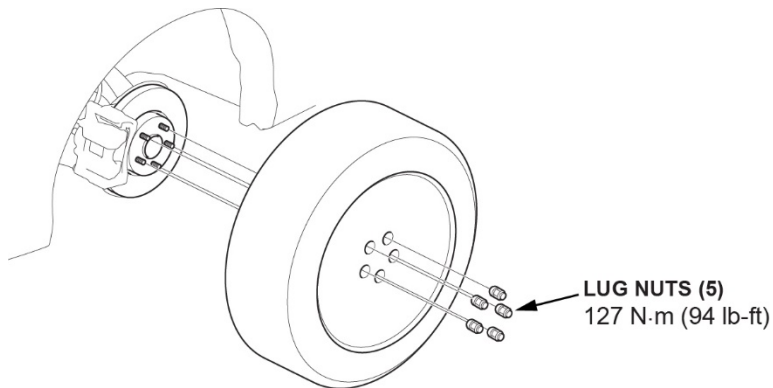
4. Remove both rear wheels.

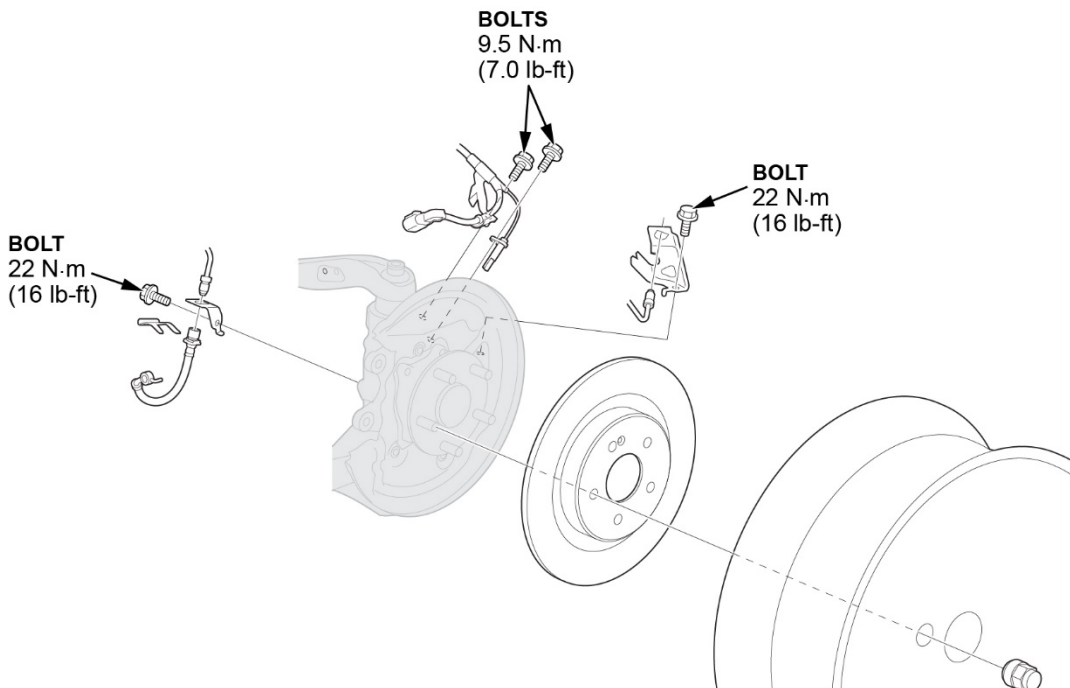
5. Remove the bolts from the rear brake brackets.

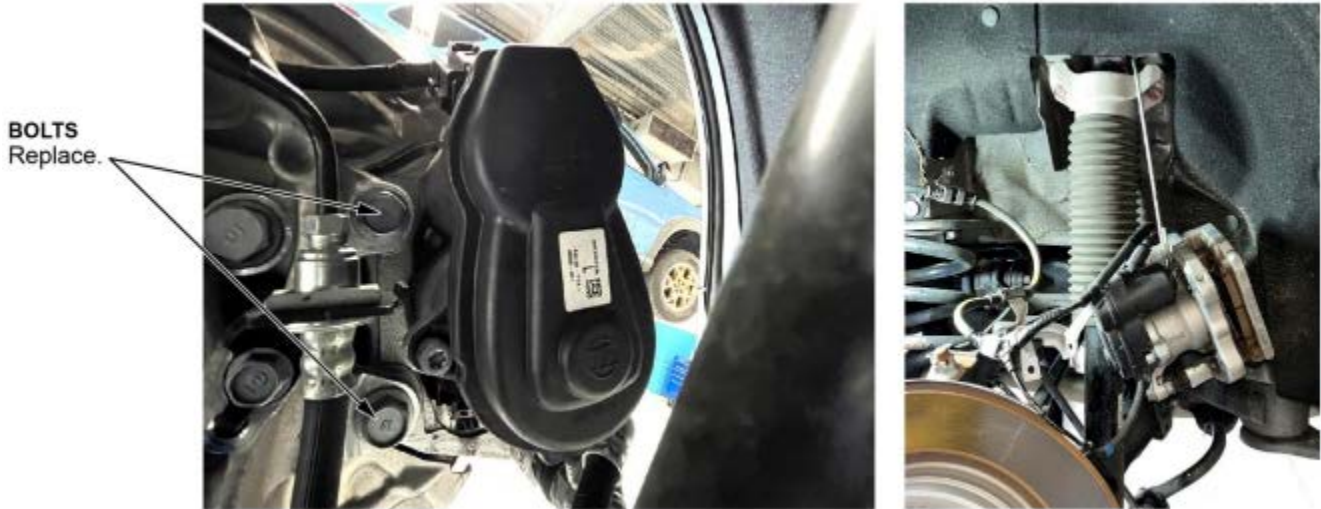
6. Remove the rear caliper and use a short piece of wire to hang the caliper assembly **108 N·m (80 lb-ft)**.
NOTE: To prevent damage **DO NOT** twist the brake hose excessively.

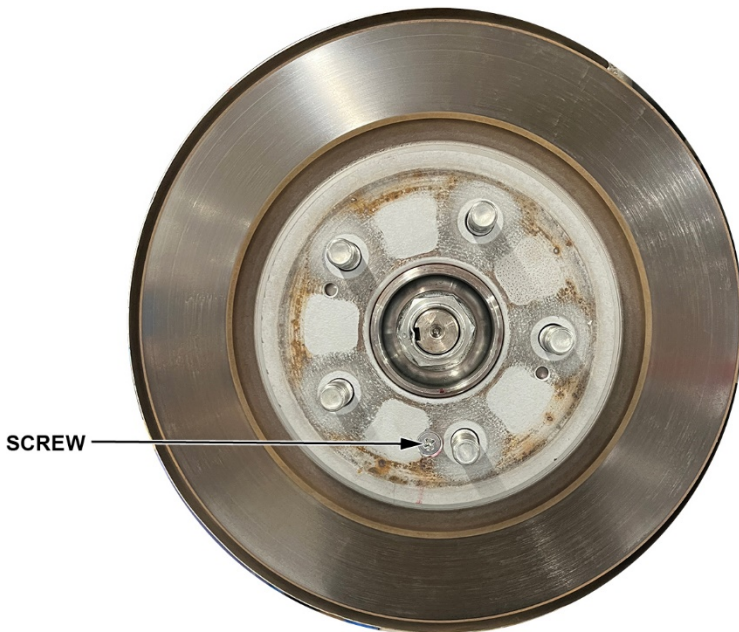
7. Remove the screw holding the rear disc, then remove the rear disc **9.5 N·m (7 lb-ft)**.

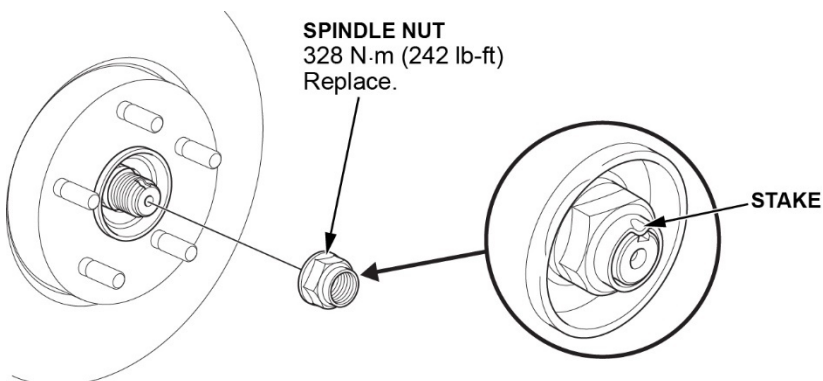
8. **AWD Only:** pry up on the stake on the spindle nut, then remove the spindle nut.

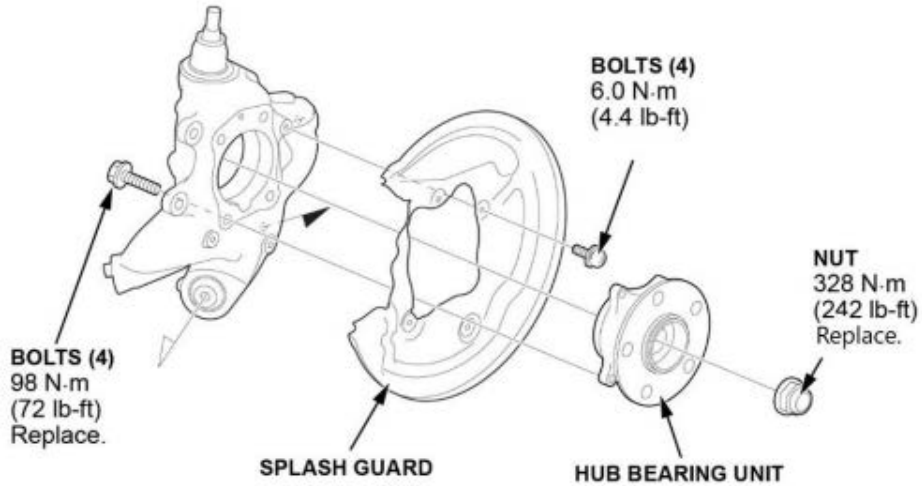
9. Remove the hub bearing unit and the splash guard.

NOTE: Keep the wheel bearing/encoder away from any magnetic field, as this can damage or erase the encoder.

10. Install the new splash guard **6.0 N·m (4.4 lb-ft)**.
