GROUP	MODEL
ENG	2021-2022MY Sorento P/HEV (MQ4 P/HEV)
NUMBER	DATE
256	July 2025

TECHNICAL SERVICE BULLETIN

CONTINUOUS VARIABLE VALVE DURATION (CVVD) ACTUATOR OIL SEAL REPLACEMENT

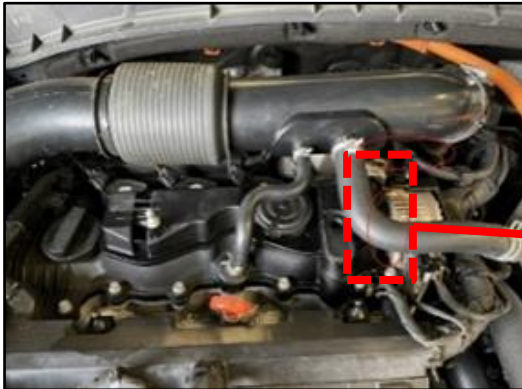
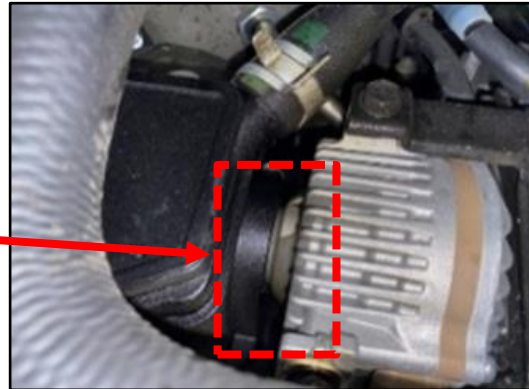
This bulletin provides information to replace the Continuous Variable Valve Duration (CVVD) Actuator seal on some 2021-2022MY Sorento P/HEV (MQ4 P/HEV) vehicles produced from September 02, 2020, through February 24, 2022. The affected vehicles may experience a slow oil leak coming from the CVVD actuator oil seal and potentially associated oil smell due to the oil seal material degrading over time. To correct this, follow the procedure outlined in this publication to replace the CVVD actuator oil seal with an improved part on the applicable vehicle.

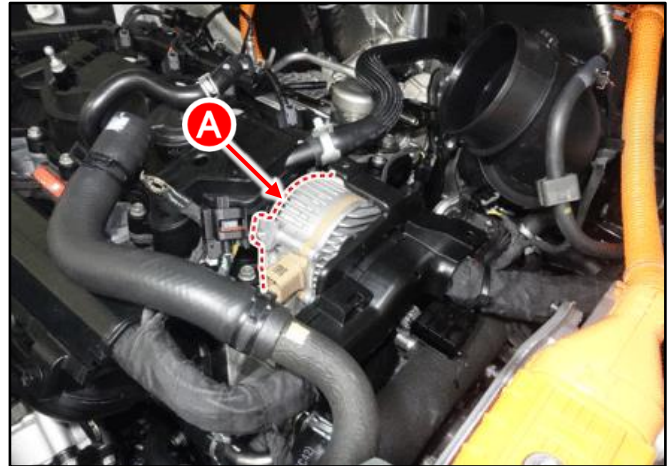
Tightening torque for CVVD Bolts (F - H):
13.8 - 18.1 lb.ft (19.0 - 24.5 N.m)

4. Using a flathead screwdriver or a seal puller, remove the CVVD oil seal (B) from the cylinder head cover (C).

DO NOT scratch or damage the inside of the seal mounting area on the cylinder head cover (C).

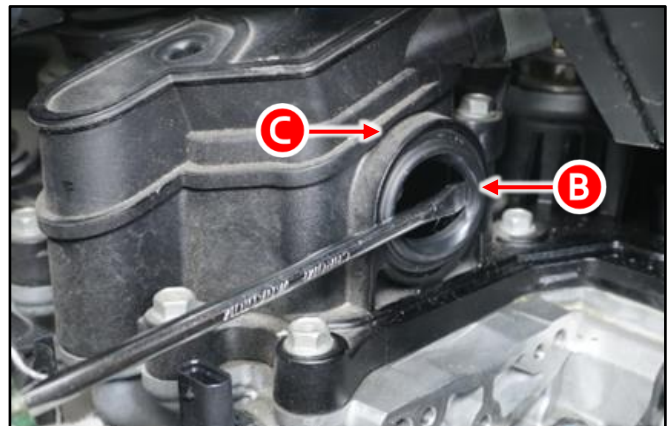
6. Thoroughly clean the seal mounting area using a clean cloth.

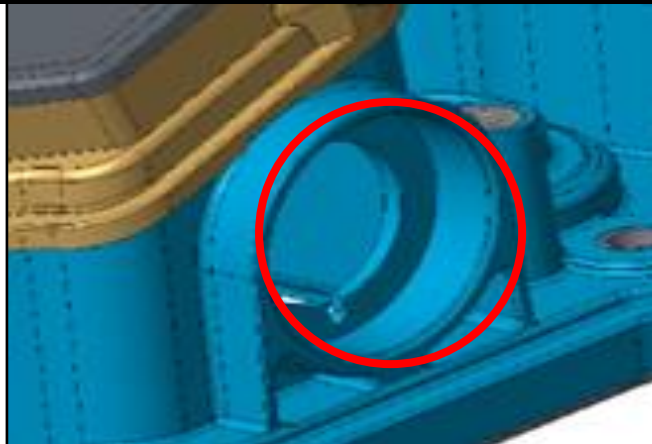
7. Install the new seal (B) on the engine cylinder head cover (C).

When installing, ensure that the new seal (B) is seated properly. If the seal is not seated deep enough or too deep, it can cause oil to leak.

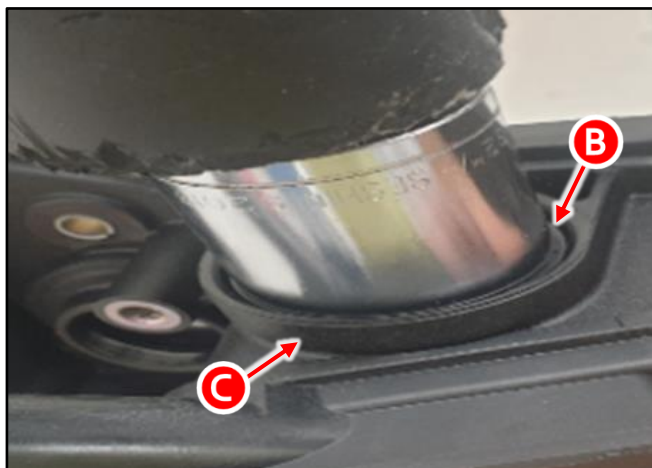
8. Thoroughly clean any oil or debris from the CVVD actuator (A).

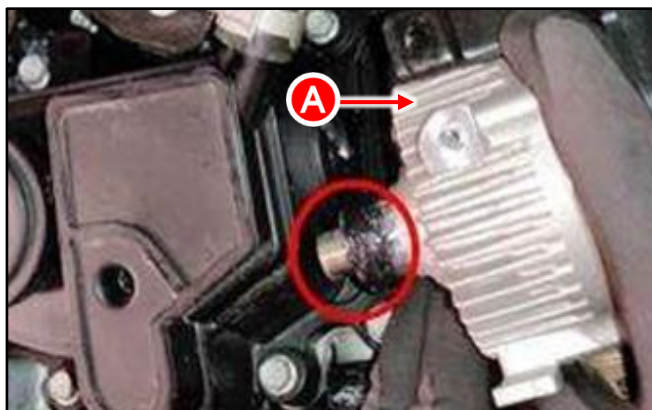
9. Reinstall the CVVD actuator (A).

When installing the CVVD actuator, ensure that the dowel pin (D) is inserted into the cam carrier hole after inserting the shaft (E).
