TECHNICAL INSTRUCTIONS

CONSUMER ADVISORY 21TG01

12-VOLT BATTERY SIZE AND INSTALLATION INSPECTION

CERTAIN 2013 - 2018 RAV4

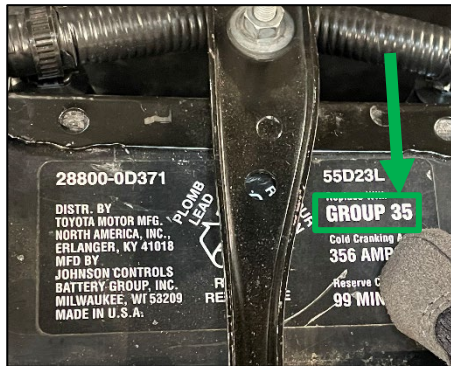
North American produced OE battery (VINs starting with "2")

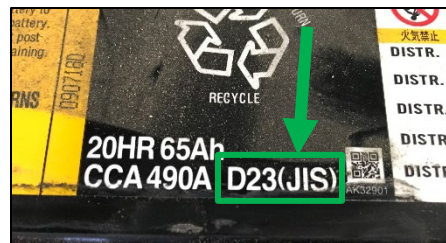
Japan produced OE battery (VINs starting with "J")

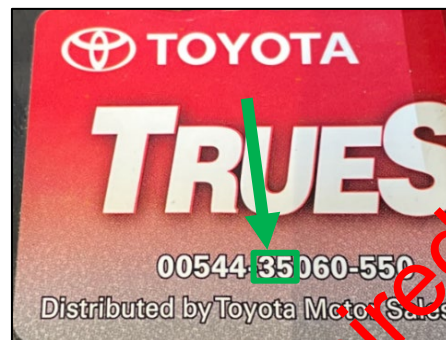
TrueStart replacement battery

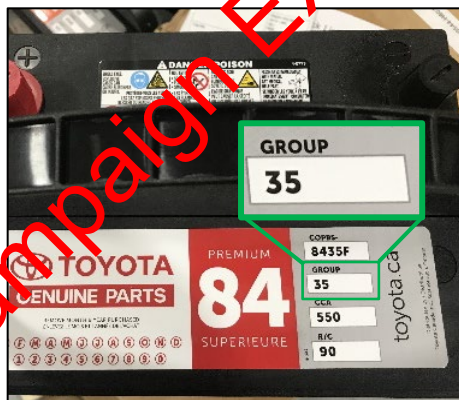
TCI (Canada) replacement battery

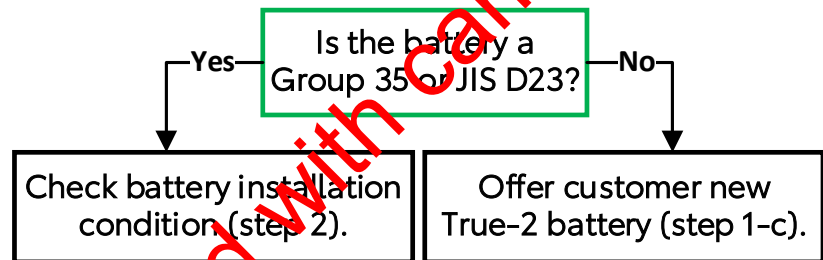
b. Confirm that the battery installed is a group 35 or JIS D23.

- If the label is too dirty to read, clean with a rag.
- TrueStart / True-2 battery group numbers are contained in the part number (see image to the left). For example, XXXXX-35XXX-XX or XXXXX-X35XX-XX.
- If the vehicle is built in Japan (VIN begins with "J"), the OE battery will not show the group number. Instead, look for JIS number D23.

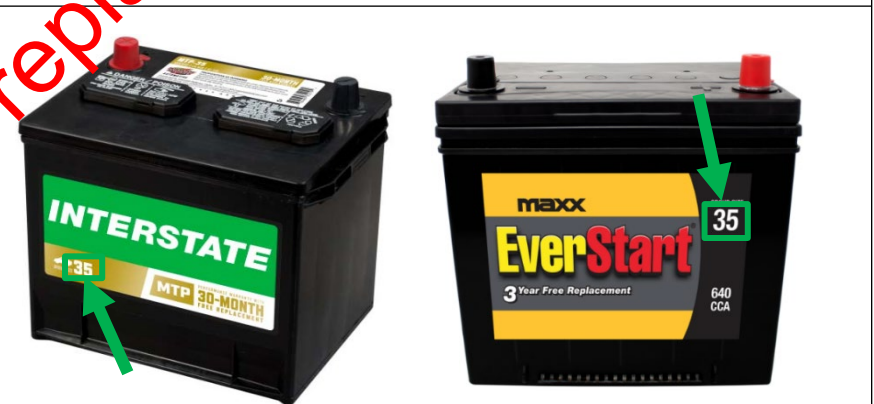
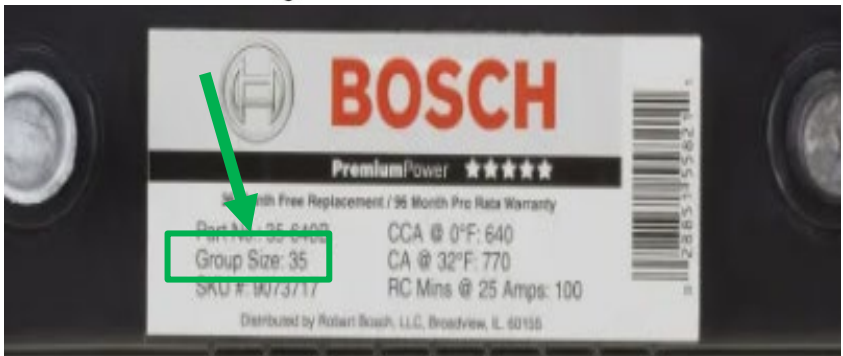
Aftermarket group 35 battery examples

c. If the battery is not a group 35 or JIS D23, offer to replace it with a Toyota True-2 battery at a discounted cost. Be sure to take a picture of the incorrect size battery and the RO together in the engine compartment before removing the battery (refer to Dealer Letter for additional sublet instructions).

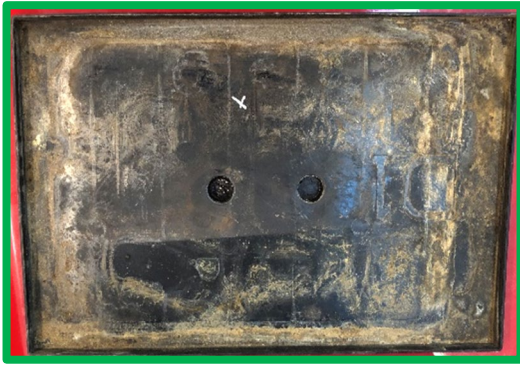
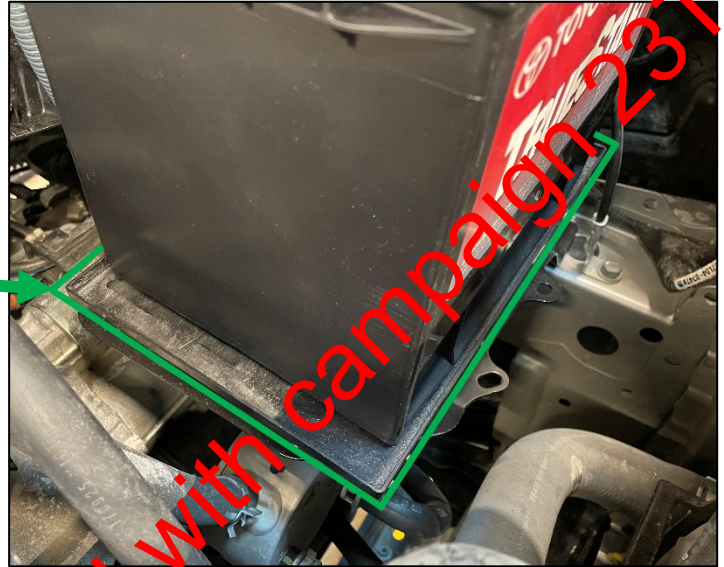
a. Check the battery tray.

- i. Ensure that the battery tray is installed.
- ii. Replace the tray if it is missing, or damaged/deformed to the point where it will not properly secure the battery.

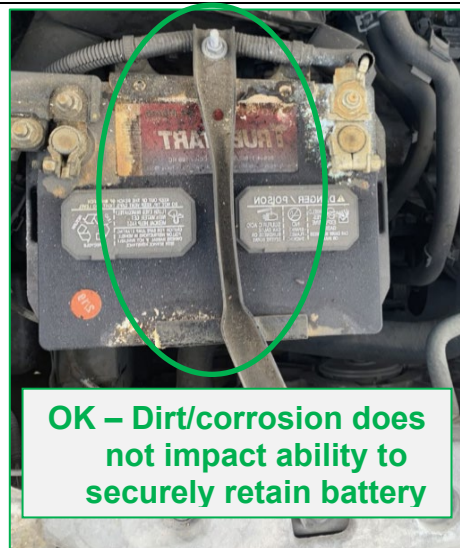
OK – Dirt/corrosion does not impact ability to securely retain battery

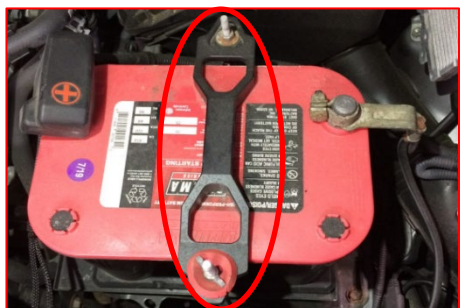
NG – Not a genuine Toyota hold-down clamp

- b. Check the battery hold-down clamp.
 - i. Ensure that the battery hold-down clamp is installed.
 - ii. Replace the hold-down clamp if it is missing, not a genuine Toyota part, or deformed/corroded to the point where it cannot properly secure the battery

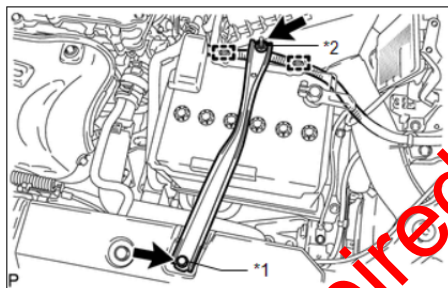
*1	Bolt
*2	Nut

- c. Check the bolt.
 - i. Confirm that the bolt is installed and torqued to the specification below.
 - ii. Replace the bolt if it is damaged or corroded to the point that it cannot be properly torqued.

Torque for bolt :
 17 N·m {173 kgf·cm, 13 ft·lbf}

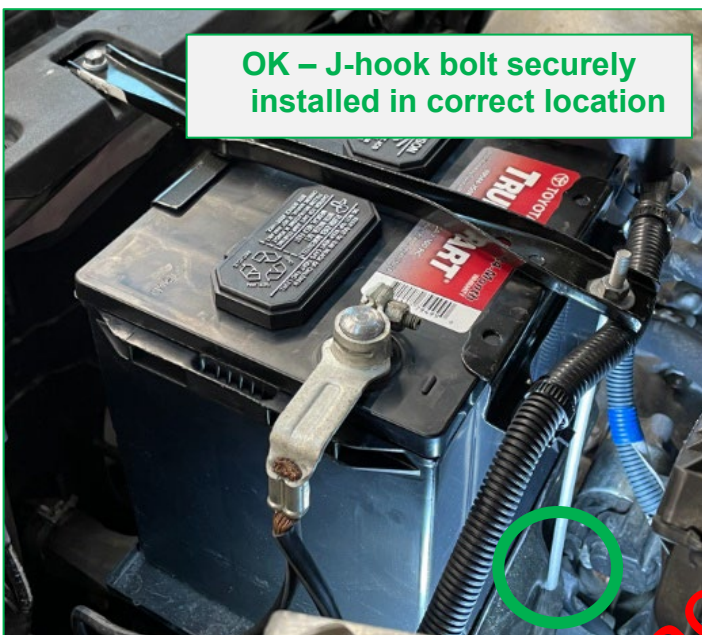
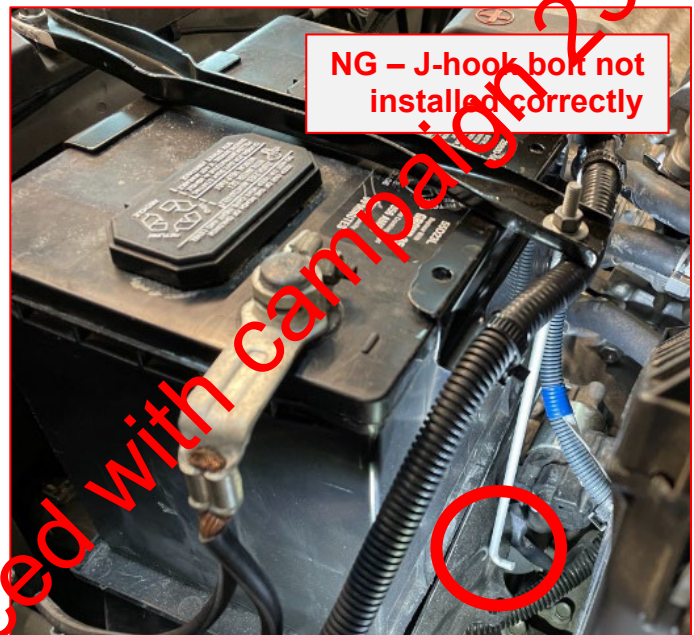
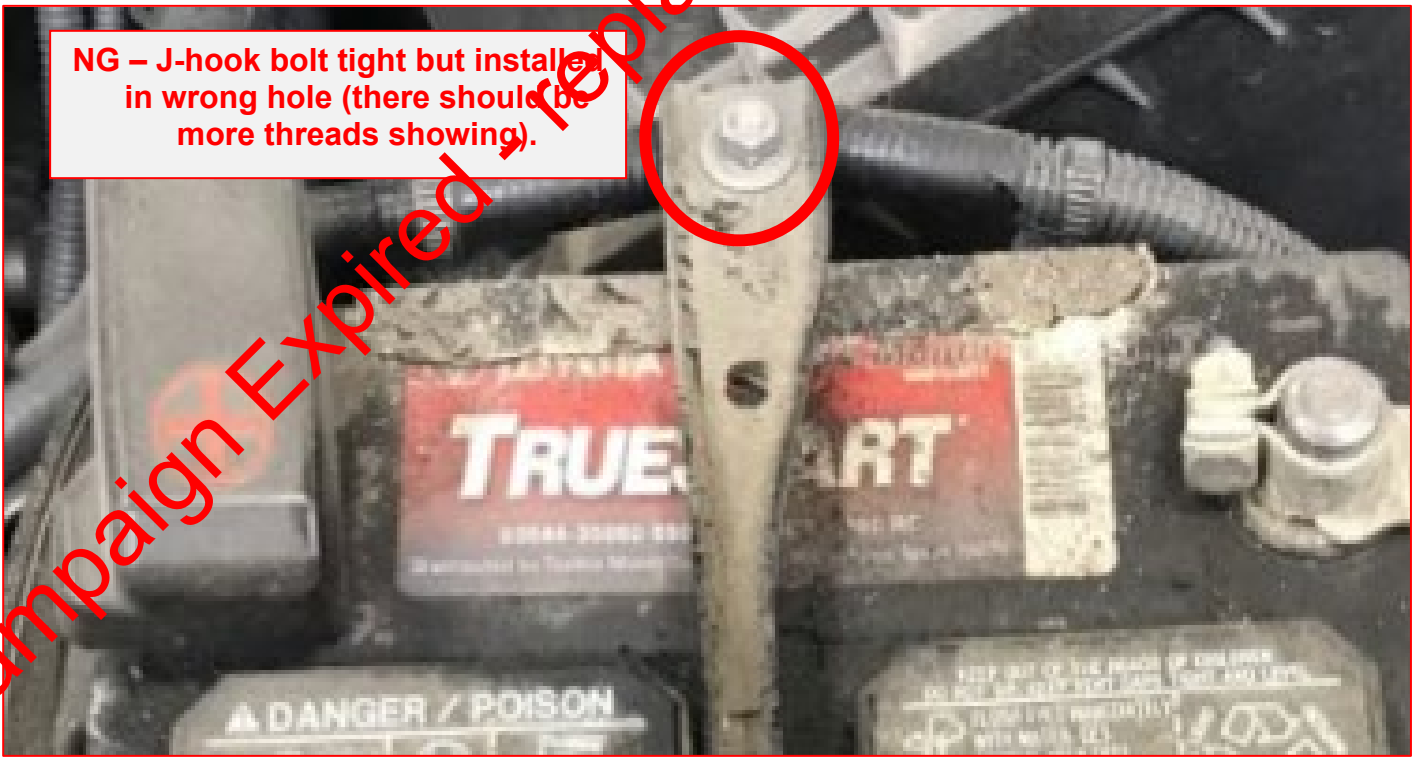
- d. Check J-hook bolt and nut.
 - i. Confirm that the J-hook bolt is installed and mounted in the correct hole.

ii. If J-hook bolt or nut is missing, not a genuine Toyota part, or deformed/corroded to the point where they cannot be properly torqued to the specification below, replace the J-hook bolt and/or nut.

Torque for nut :
4.9 N·m {50 kgf·cm, 43 in·lbf}

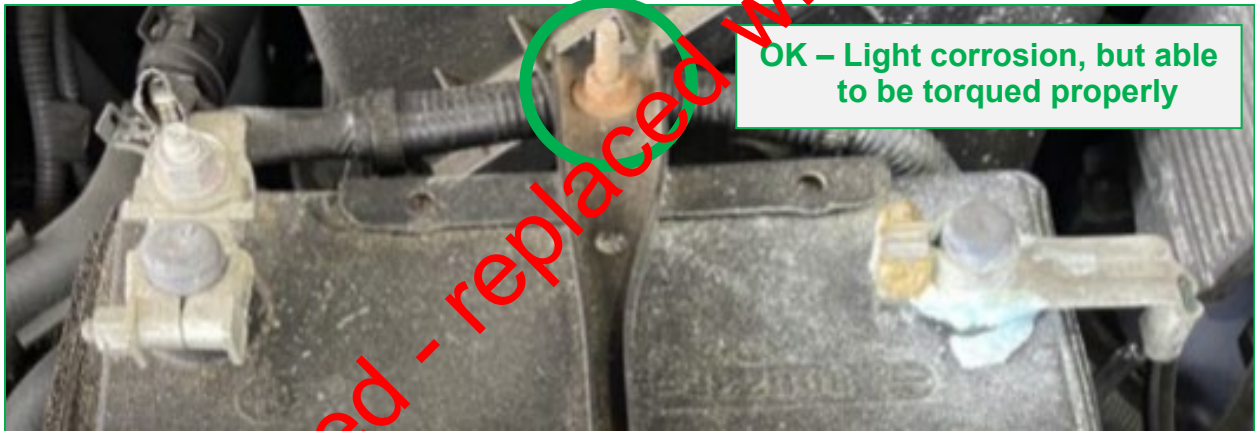
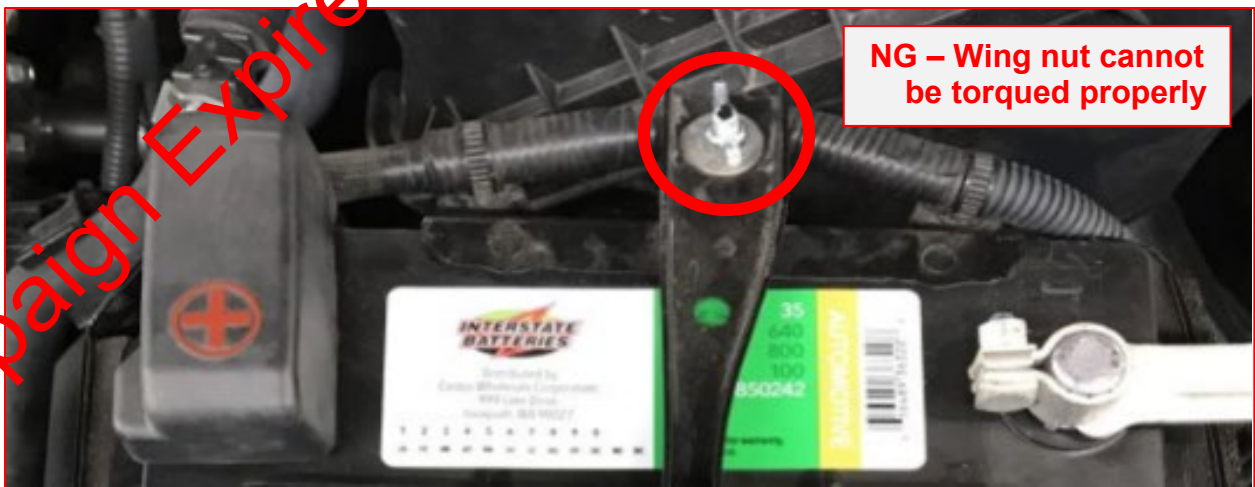
- You may be able to identify some aftermarket J-hook bolts by the threaded portion of the J-hook being longer than two (2) inches and/or the angle of the hook NOT being less than 90 degrees.
- The genuine Toyota nut has an integral washer.
